CHAPTER FIVE

5.0 STABILITY OF CUT SLOPES IN THE STUDY AREA

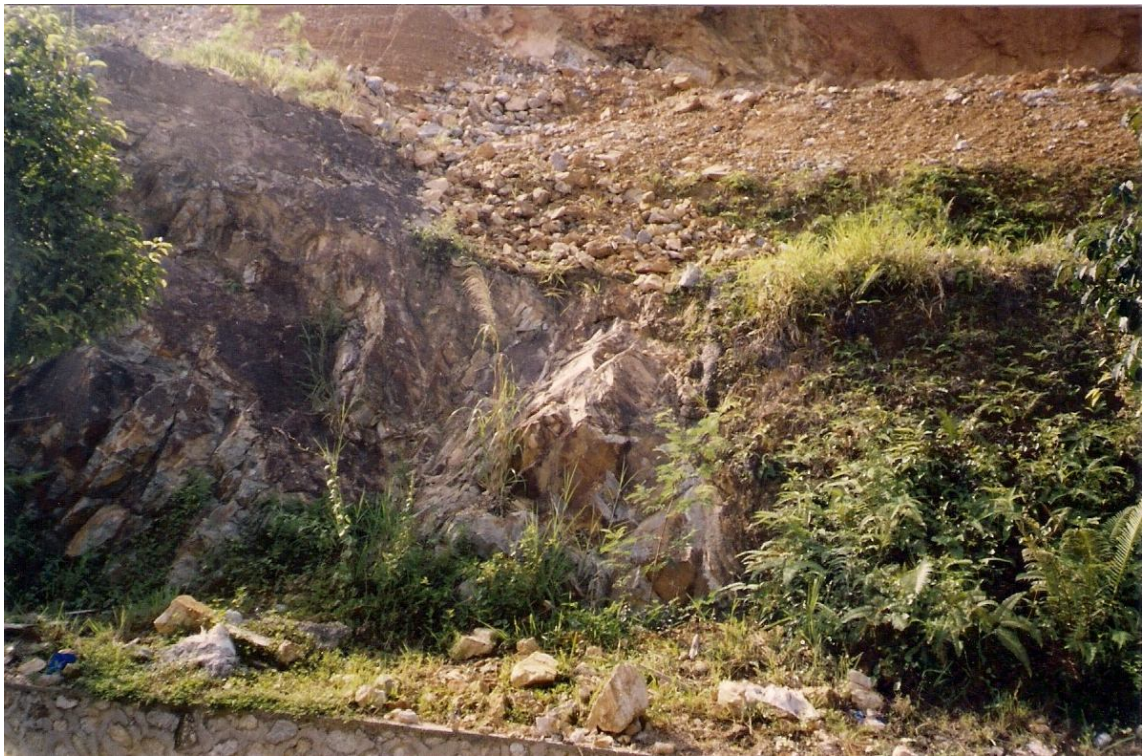
Pronounced failures occurred in Jalan UP 5/7, Jalan UP 3/1, Jalan UP 3/2, and adjacent to Sri Baiduri apartment. Other minor failures encountered involved small volumes of materials, with the failed materials sometimes retaining its original shape after failure, though usually disaggregating to form shallow heaps at the foot of the affected cut (Raj 1983). The older unbenched slope cuts of steep slope angles were however affected by shallow slips (fig. 5.1).

Fig.5.1. Shallow slips at older unbenched cuts.

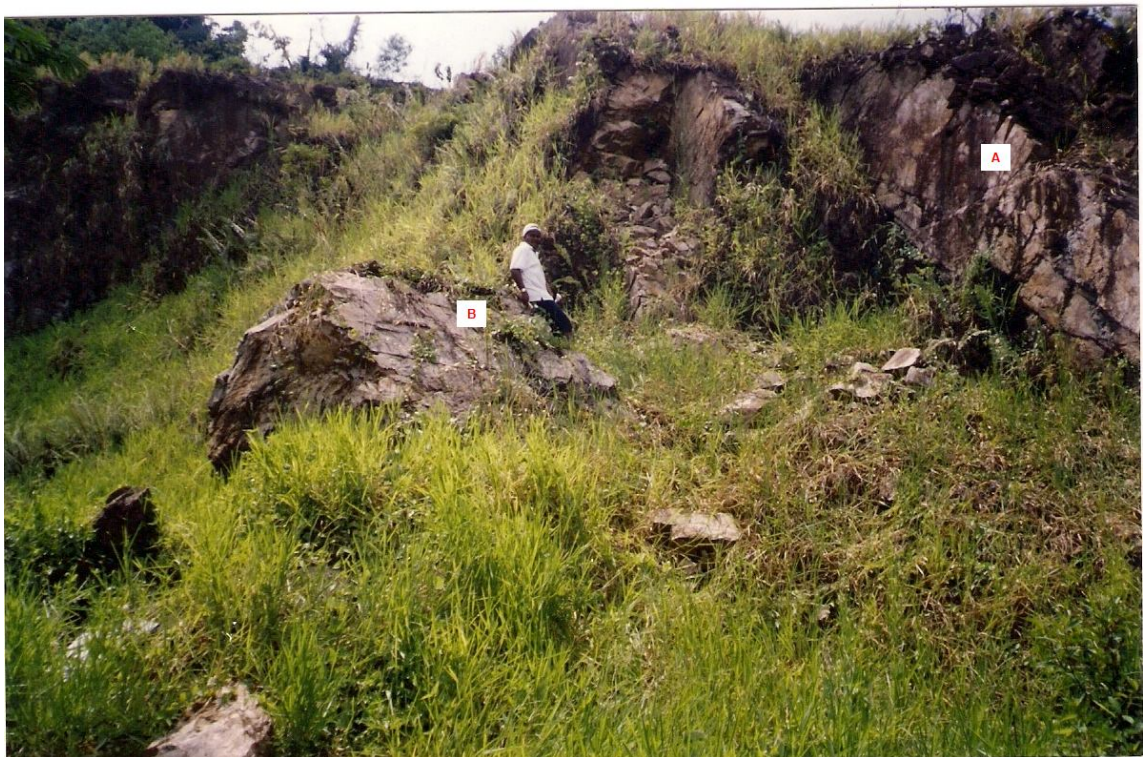
The type of failure encountered in Jalan UP 5/7, Vierra Ukay is Topple within the slightly weathered zone. The failure here was initiated by rapid layer separation with movement in the direction of the excavation. It is closely observed that there were presence of cross joints which were associated with the block weight and stress relief forces. Figure 5.2 shows the overturning of the rock block.

Fig.5.2. Topple in Jalan UP5/7. The rock block in position “B” overturned from position “A” due to cross jointing, the block weight, and stress relief forces.

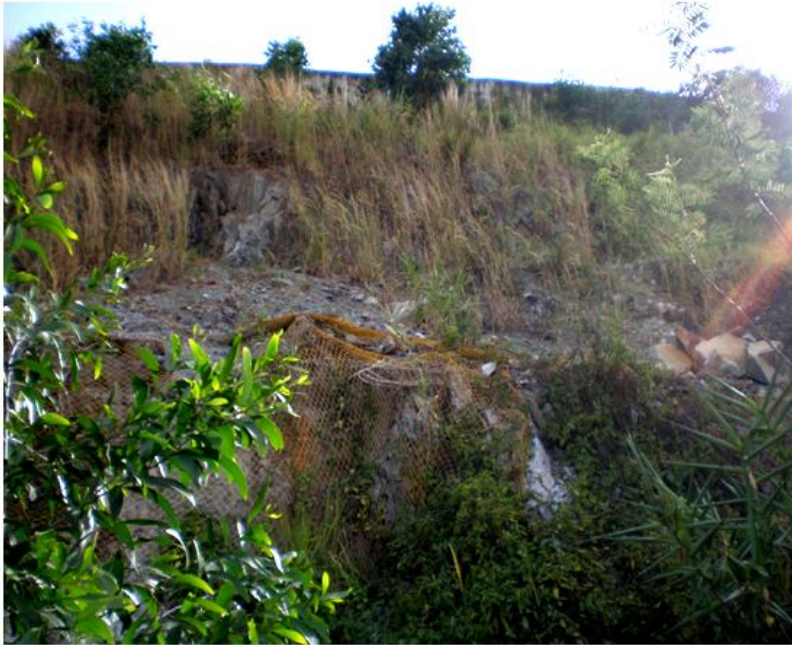
Complex failure was observed in Jalan UP 3/1 beneath Summer Set Villa, on an unbenched slope cut of up to 80m high. It is of the opinion of the writer that this failure occurred because of the heavy vibrations resulting from the general constructions of the numerous houses and streets of Summer Set Villa, as well as water movements down the slope . Intense, short period rainfall and prolonged high rainfalls are major causal factors; the gradual disintegration of the bedrock encouraging infiltration and, starting with hair-line cracks that subdivide the weathered materials into angular fragments. The failure at this location involved rockfalls and planar sliding. Hanging nets were employed as protection for blocks tumbling from above (fig.5.3a and 5.3b). It is observed that a portion of the rockfall detached itself and underwent a planar sliding. Figure 5.4 is a schematic diagram that clearly shows the profile of this complex failure.

Fig. 5.3a. Photograph of the complex failure involving rockfalls and planar sliding

There is possibility of future sliding and rock falls of the loose materials along the steep cut in Jalan UP 3/1 beneath Summer Set Villa. These loose materials and plant debris are constantly splashed and washed down the slope during heavy rainstorms. The free hanging nets are torn and worn out (fig. 5.3a and 5.3b) and cannot hold further tumbling blocks and loose materials.

- iv. Increase in resisting forces:- this can be achieved by pinning individual blocks, covering the slope with mesh or net, or installing rock anchors or rock bolts on dense spacing. This is advised to be carried out on the slope beneath Summer Set Villa along Jalan UP3/1, and the steep slope located between Jalan UP3/2 and Taman Ukay Perdana.

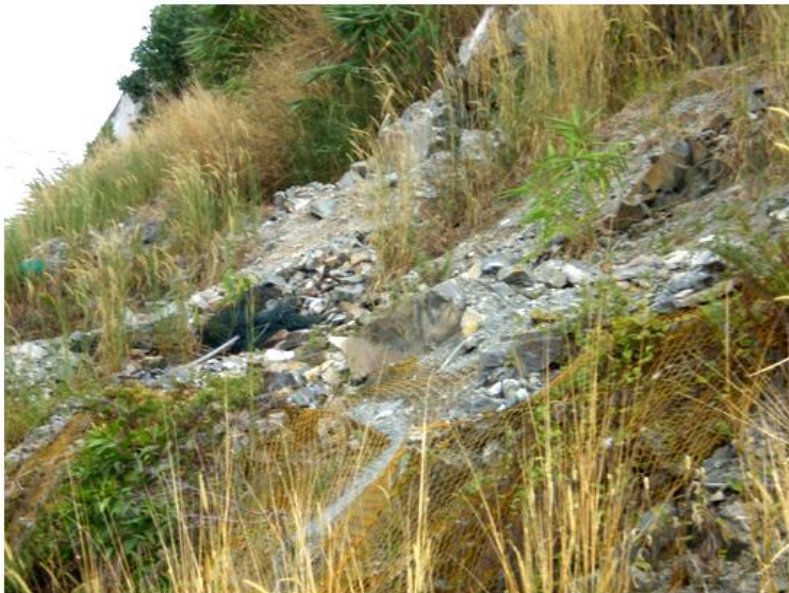
Fig. 5.3b. Hanging nets protecting the tumbling blocks at the base of the cut.

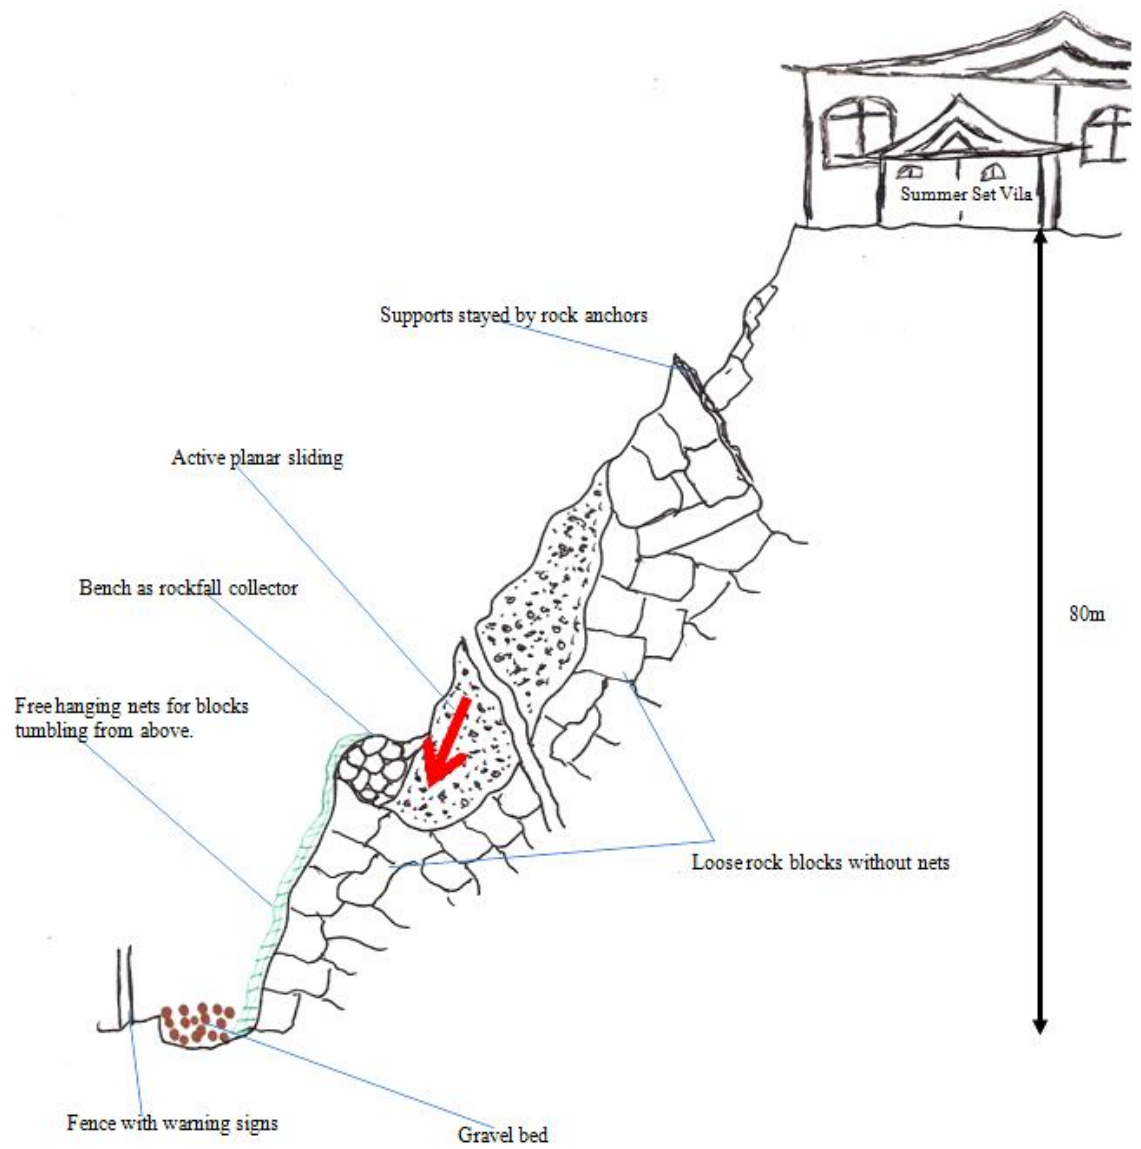
Fig. 5.4. Schematic diagram showing the profile of the complex failure at Jalan UP 3/1.

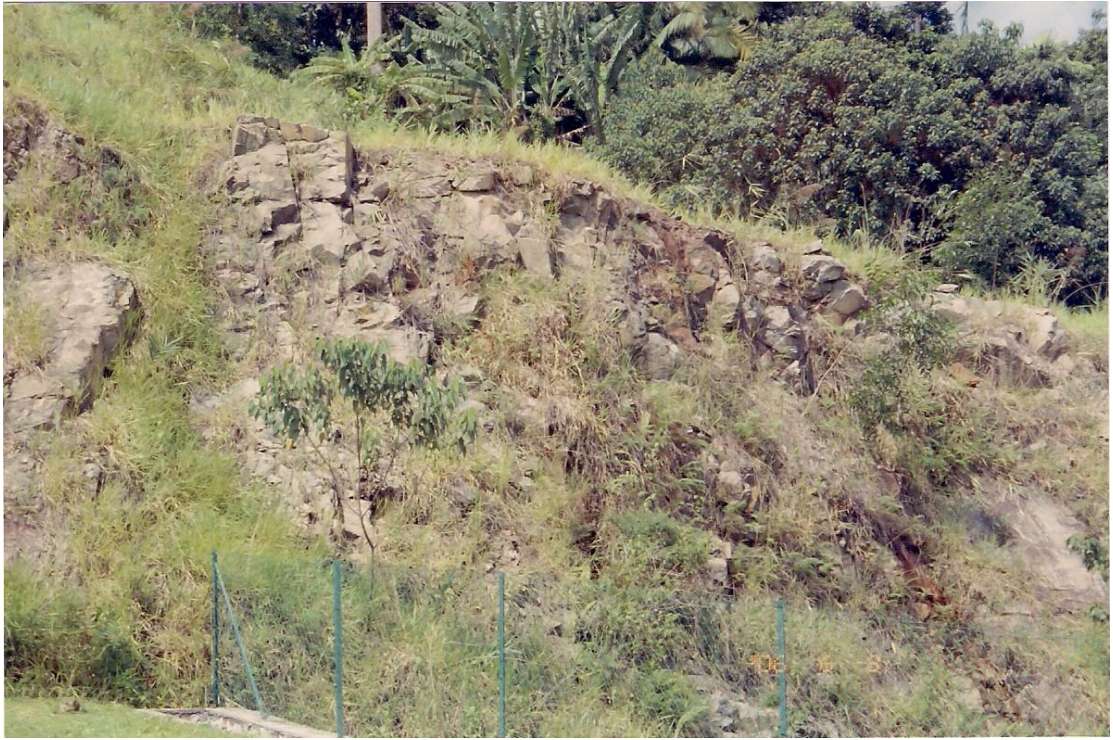
Wedge failure occurred in Jalan UP 3/2. Big rock blocks fall, break, and slide along joint planes. The geometric boundaries imposed by the orientation, spacing and continuity of the joints, as well as the free surface boundaries imposed by the excavation, define the modes of failure. Woven wire fence were built to keep the rocks from tumbling forward out of the face of the slope (fig. 5.5).

Fig.5.5. Wedge failure in Jalan UP 3/2.

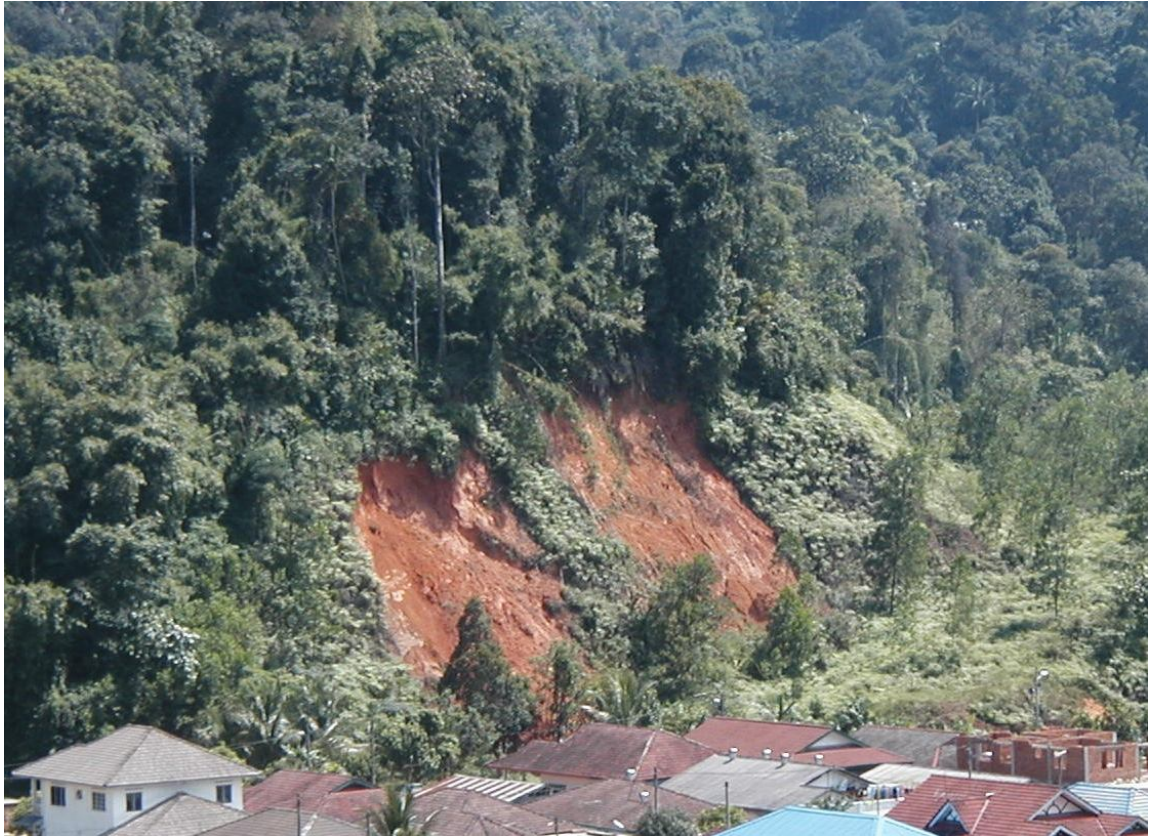
Adjacent to Sri Baiduri Apartment was a relatively earth slump (Fig. 5.6). This failure occurred during the rainy season. The clayey material which was highly to completely weathered bedrock detached and slipped down as an apparent coherent mass, but remained on the slope, leaving a scalloped hollow. A bulge of materials (toe) developed at the base of the slope and the slump scarp exposed the roots of the trees making the trees susceptible to fall.

Fig. 5.6: A slump type of failure adjacent to Sri Baiduri apartment.

- iii. Reduction of driving forces:- as suggested by Abramson et al (1996), failure hazards in Ukay Perdana can be reduced by installing more drainage hoses in areas of high and steep cuts to reduce the effect of surface water, construction of benched slopes especially behind Sri Baiduri apartment areas, behind Jalan UP 4/4, and behind Sri Wira Rivera Rise Apartment in Sierra Ukay.

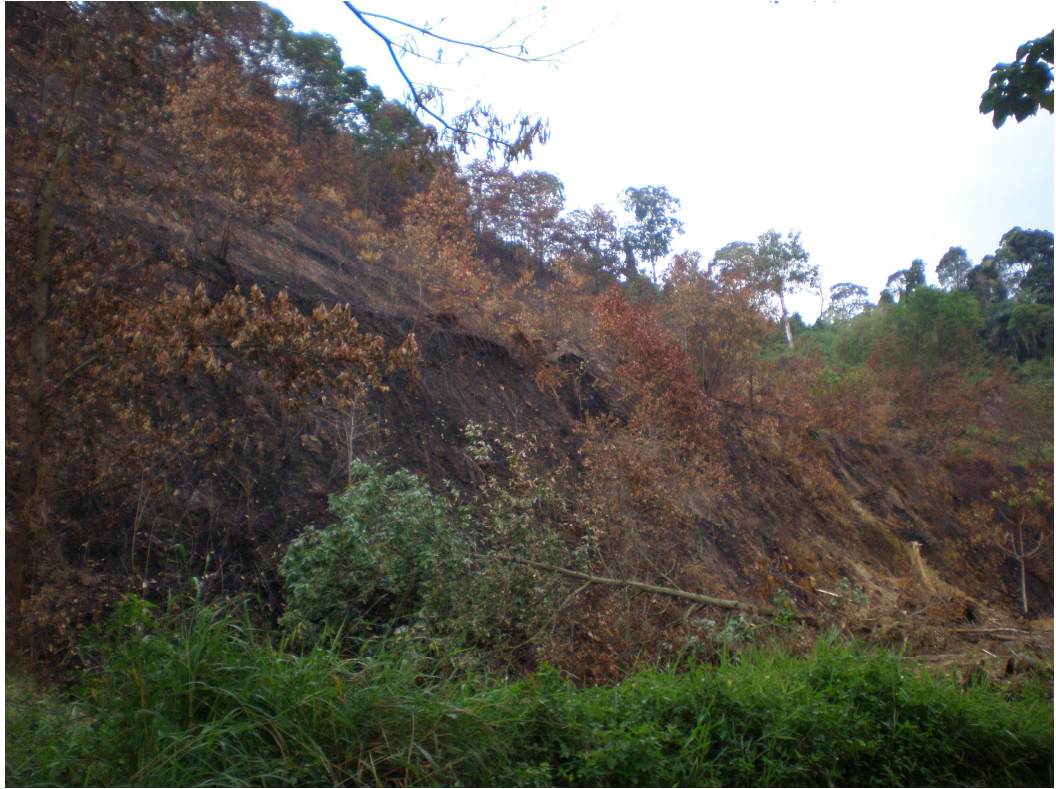
Burning and clearing of vegetation along cut slopes in Jalan UP5 Vierra Ukay (fig. 5.12) can weaken the cohesion of the rock materials and enhance penetration of surface water, and further movement of rock debris down the slope.

Fig. 5.12. Burning and clearing of vegetation in Jalan UP5.
