## CHAPTER – IV

### CORROSION IN EFFLUENT TREATMENT SYSTEM

#### 1 PALM OIL MILL

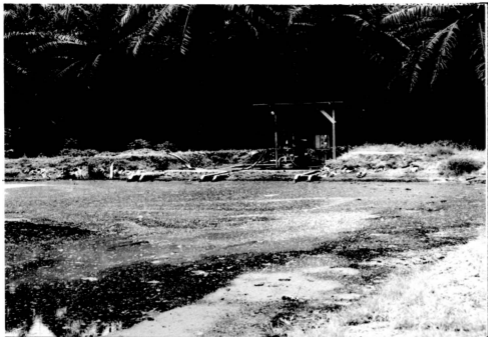
EFFLUENT TREATMENT POND WITH PUMPSET

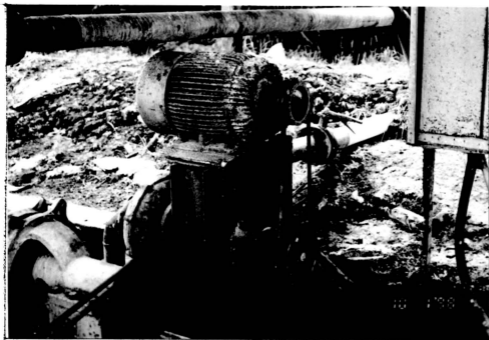
Analysis of the effluent parameters indicate that high temperature, low pH, high BOD and high solids are responsible for corrosion of steel and concrete in the treatment system. Photographs indicating the effect of these factors in a treatment system on steel and concrete is enclosed.

CLOSE UP VIEW OF CORRODED PUMPSET AND BASE FRAME

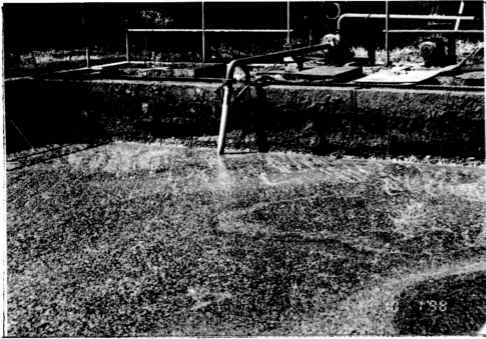
CONCRETE CORROSION IN THE SLUDGE PIT

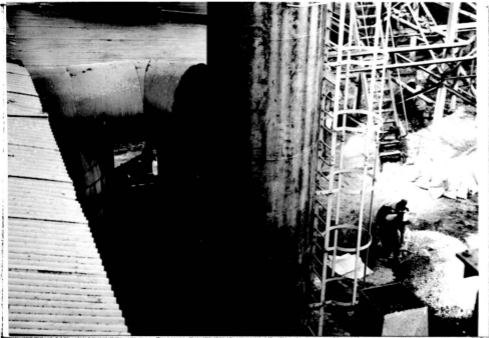
Another major area of environmental degradation from an oil palm mill is the Air Pollution resulting from Boilers and Incinerators. Corrosion of chimney, exhaust duct, induced draft fan, multi-cyclone etc is common in the oil palm mill. This is due to the environmental factors and also high temperature. The enclosed photographs clearly justifies this corrosion.

CORROSION OF BOILER STACK

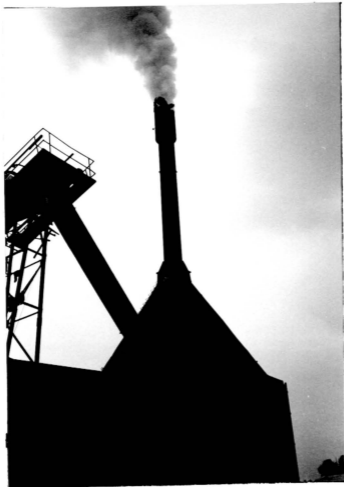
CORROSION OF INCINERATOR STACK

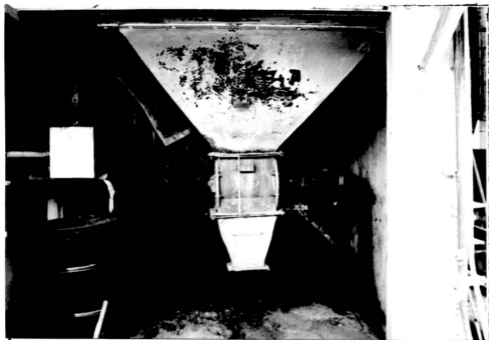
CORROSION OF MULTICLONE AND ROTARY AIR LOCK

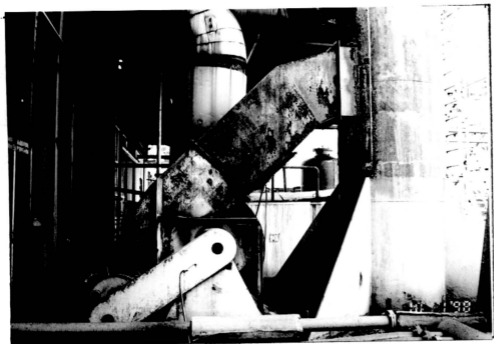
CORROSION OF EXHAUST FAN
