CHAPTER - V

CORROSION IN EFFLUENT TREATMENT SYSTEM IN

VEGETABLE OIL REFINERY

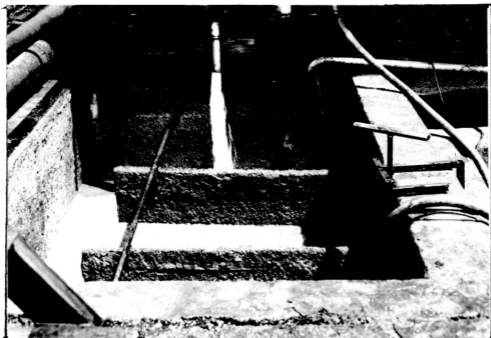
CONCRETE CORROSION IN EFFLUENT SUMP

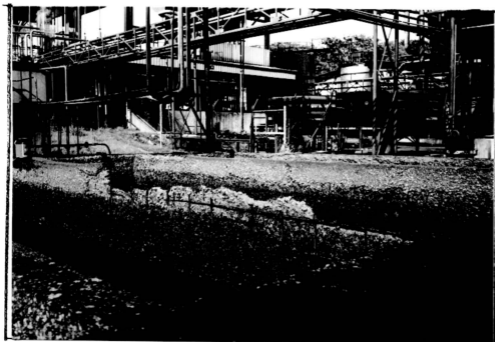
CONCRETE CORROSION IN RECIRCULATION BASIN

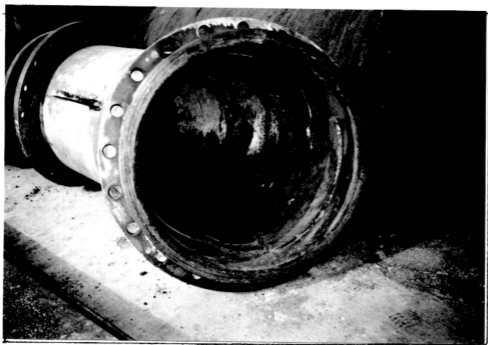
CORROSION IN STEEL PIPE

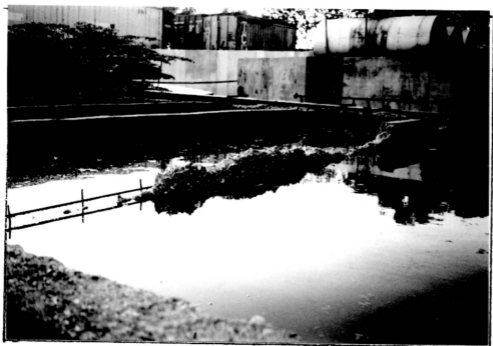
CORROSION OF EFFLUENT BASIN
