CHAPTER 5

CASE STUDIES

5.1 Case Studies Introduction

There were some units of the case studies had been visited and viewed. They were unsold units or sample houses. All of the units remained as original condition and had not yet been renovated or altered. At the time of viewing, some of the defects photographs had been captured.

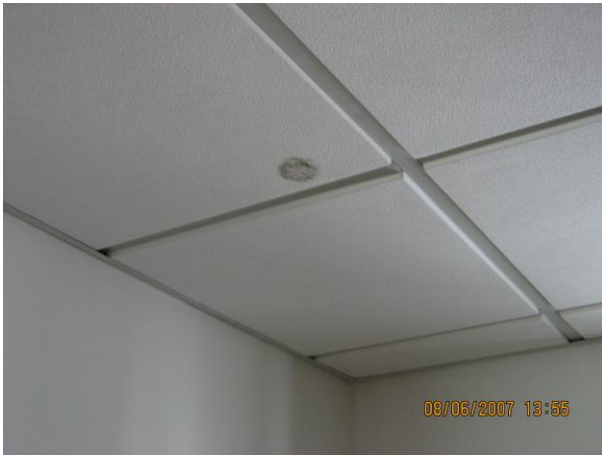
Sign of water-stained marks on the ceiling.

No.	Building Defects	Conquas 7 th Edition 2008	Qlassic CIS 7:2006
A	Kiara Designer Suite		
1.	Sign of water-stained marks on the ceiling.	Page 35, Architectural Works, Part 1: Internal Finishes, 3a (3) states that for Ceilings: No visible damage e.g spalling, leaks, cracks, etc	Page 28, Architectural Works, Internal Finishes, (III) A (3) states that for the Ceilings: No visible damage e.g. spalling, leaks, cracks, etc.

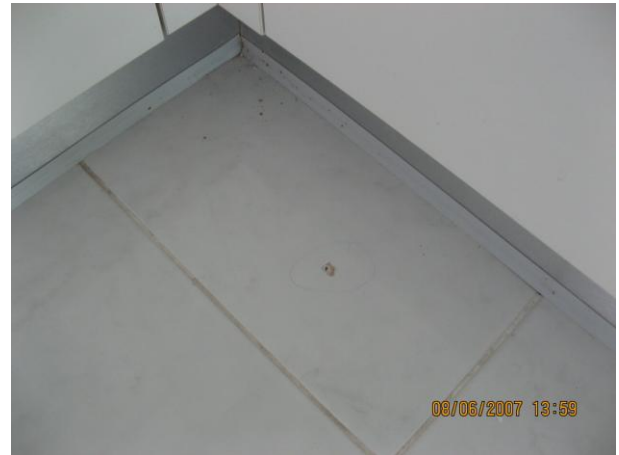
Chipped floor tiles.

2.	Chipped floor tiles.	Page 31, Architectural Works, Part 1: Internal Finishes, 1a (3) states that for Floors: No visible damage/defects.	Page 24, Architectural Works, Internal Finishes, (I) A (3) states that for the floors: No visible damage/defects.

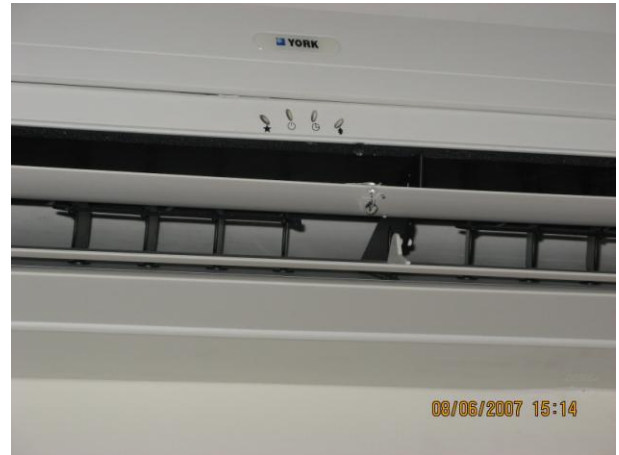
A/C water leaking.

4.	A/C water leaking.	Page 60, M&E Works, Part 5: Quality Standards for Basic M&E Fittings, 1 (4) states that for M&E Fittings: Functional and safe.	Page 43, M&E Works, ACMV Works, (II) (5iii) states that for Split unit/Window air conditioner: No Sign of leakage from pipe.

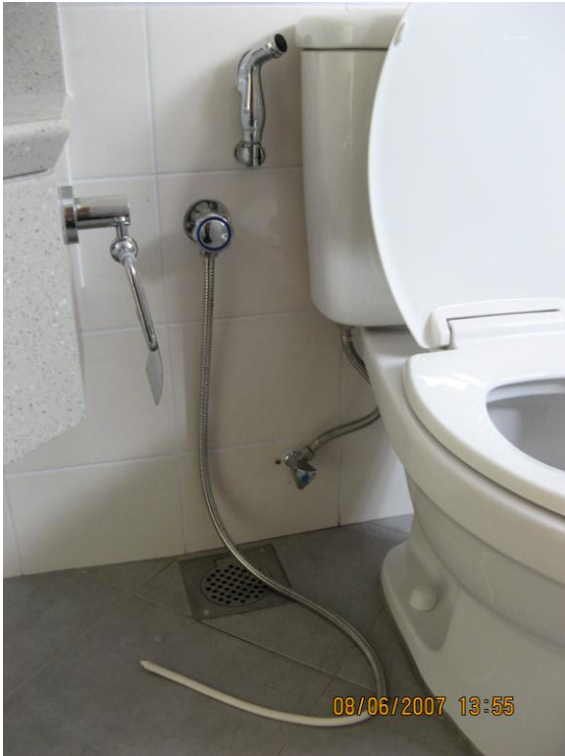
Bidet pipe broken.

No.	Building Defects	Conquas 7 th Edition 2008	Qlassic CIS 7:2006
5.	Bidet pipe broken.	Page 60, M&E Works, Part 5: Quality Standards for Basic M&E Fittings, 2c (5) states that for Plumbing & Sanitary Fittings: Fittings in working condition.	Page 49, M&E Works, Basic M&E Fittings, (V) B (iii) states that for Plumbing and Sanitary Fittings: Fitting in working condition.

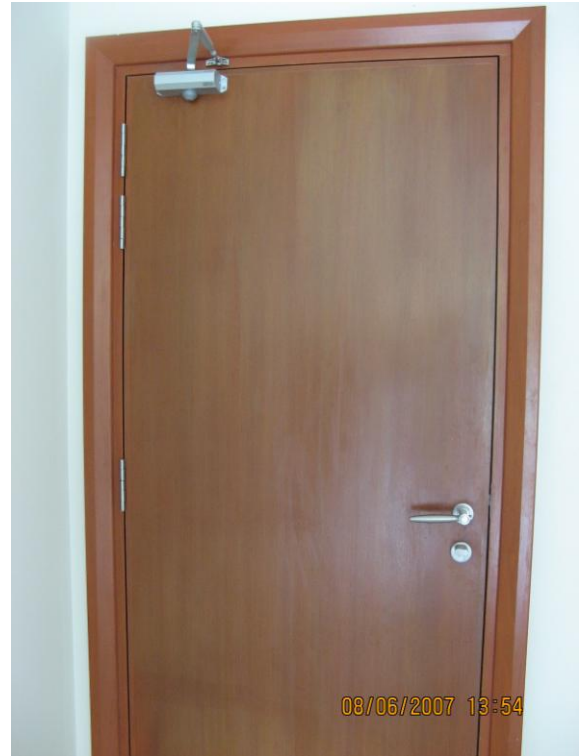
Uneven tonality of timber door.

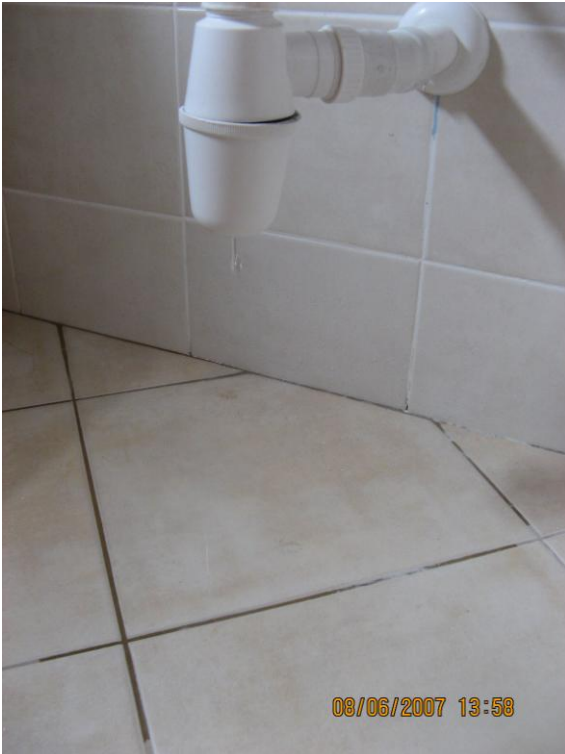
Water leakage from the water trap.

7.	Water leakage from the water trap.	Page 60, M&E Works, Part 5: Quality Standards for Basic M&E Fittings, 2c (2) states that for M&E Fittings: No leakage at joints.	Page 49, M&E Works, Basic M&E Fittings, (V) B (iii) states that for Plumbing and Sanitary Fittings: No leakage at joints.

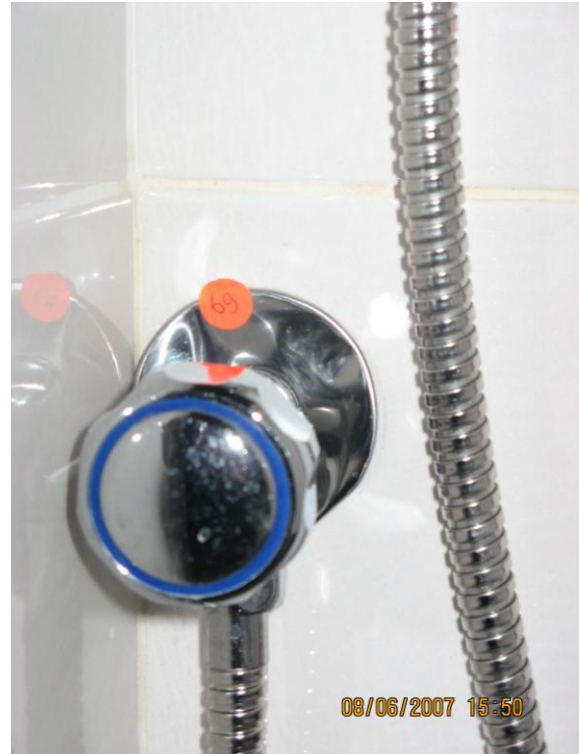
Stop cock cover dented.

8.	Stop cock cover dented.	Page 61, M&E Works, Part 5: Quality Standards for Basic M&E Fittings, 2c (3) states that for Plumbing & Sanitary Fittings: No chipping or cracks.	Page 49, M&E Works, Basic M&E Fittings, (V) B (iii) states that for Fittings: No chipping or cracks.

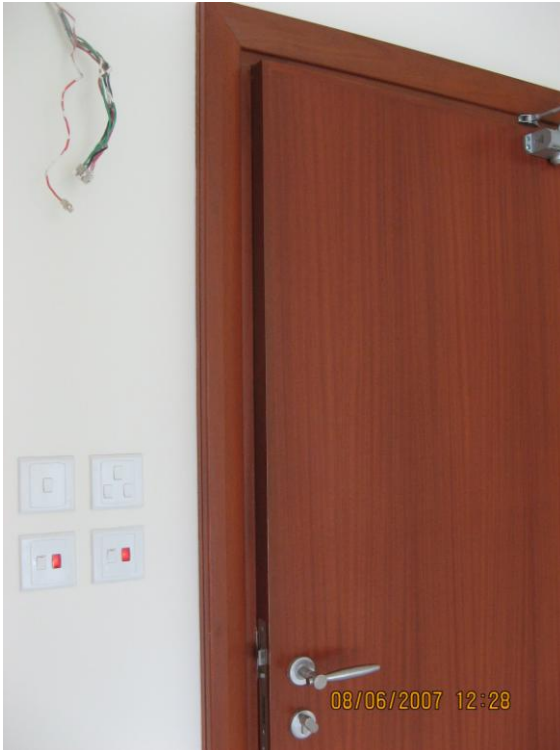
Door Misalignment and cannot be closed.

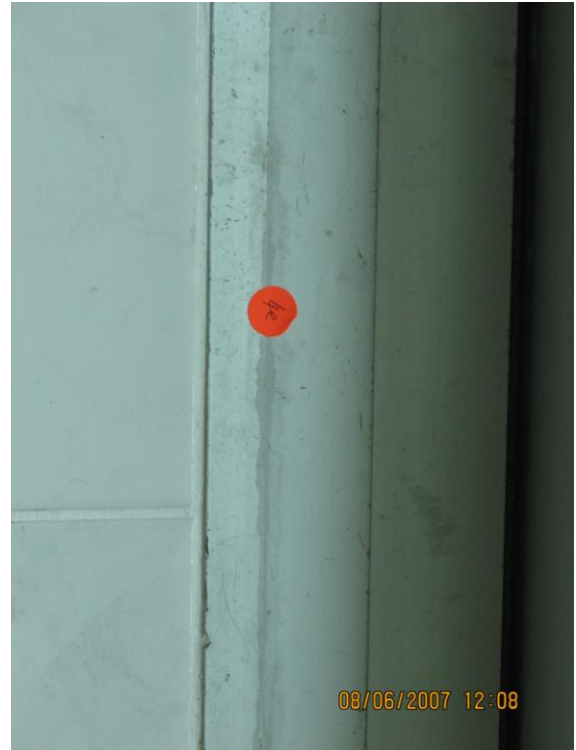
Scratches on the sliding door

10.	Scratches on the sliding door	Page 36, Architectural Works, Part 1: Internal Finishes, 4a (3) states that for Doors: No stain marks and any visible damage.	Page 30, Architectural Works, Internal Finishes, (IV) A (3) states that for the Doors: no stain marks and any visible damage.

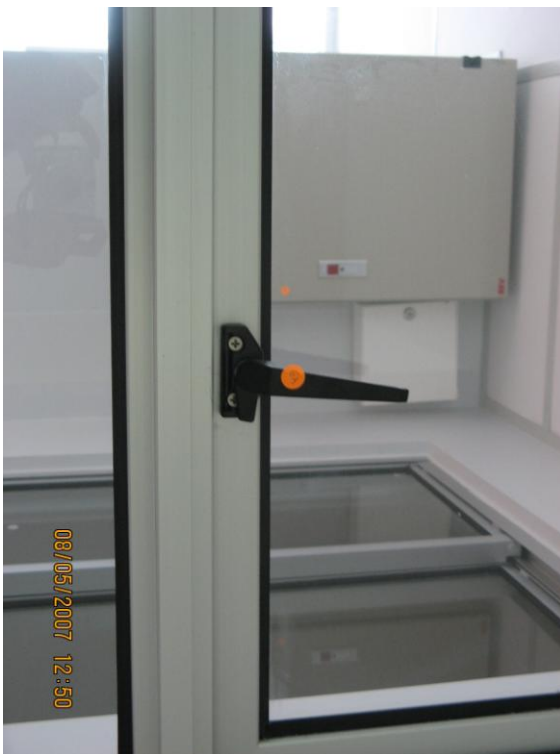
Window lever broken

11.	Window lever broken	Page 37, Architectural Works, Part 1: Internal Finishes, 5a (5) states that for Windows: Lock sets with good fit and aligned.	Page 32, Architectural Works, Internal Finishes, (IV) B (5) states that for the Windows: lock sets with good fit and aligned.

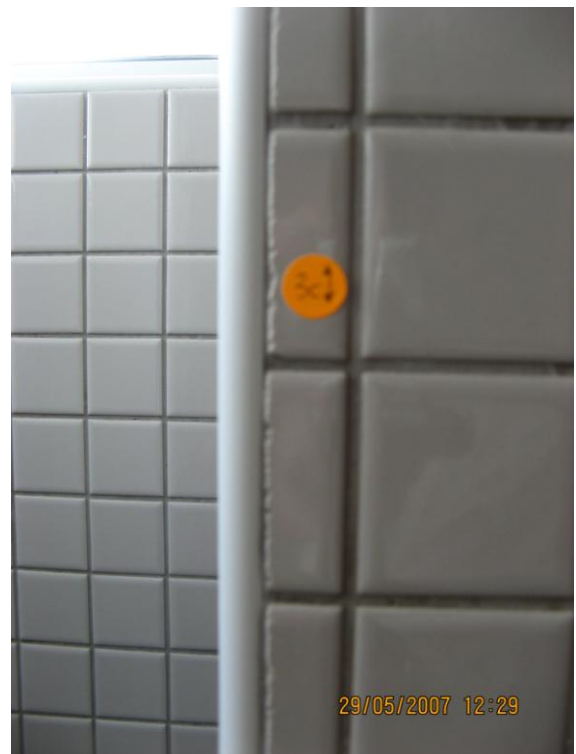
Chipped edges on the wall tiles.

No.	Building Defects	Conquas 7 th Edition 2008	Qlassic CIS 7:2006
12.	Chipped edges on the wall tiles.	Page 33, Architectural Works, Part 1: Internal Finishes, 2a (3) states that for Walls: No visible damage/defects.	Page 26, Architectural Works, Internal Finishes, (II) A (2) states that for the walls: No visible damage/defect.

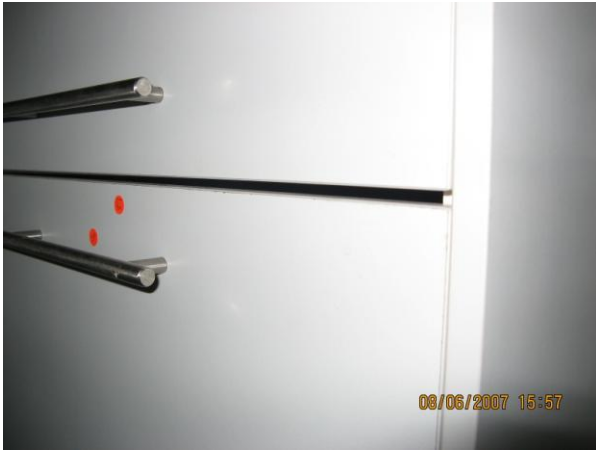
Cabinet drawer misalignment

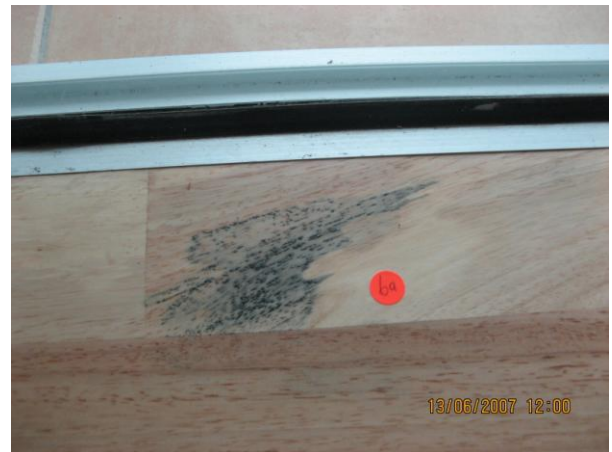
Stained on the timber flooring

16.	Stained on the timber flooring	Page 31, Architectural Works, Part 1: Internal Finishes, 1a (1) states that for Timber Floors: No stain marks.	Page 24, Architectural Works, Internal Finishes, (I) A (1) states that for the floors: No stain marks.

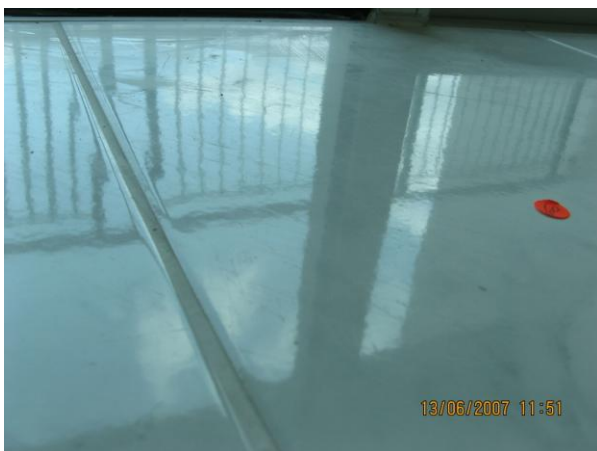
Scratches on the floor tiles.

17.	Scratches on the floor tiles.	Page 31, Architectural Works, Part 1: Internal Finishes, 1a (3) states that for Floors: No visible damage/defects.	Page 24, Architectural Works, Internal Finishes, (I) A (3) states that for the floors: No visible damage/defects.

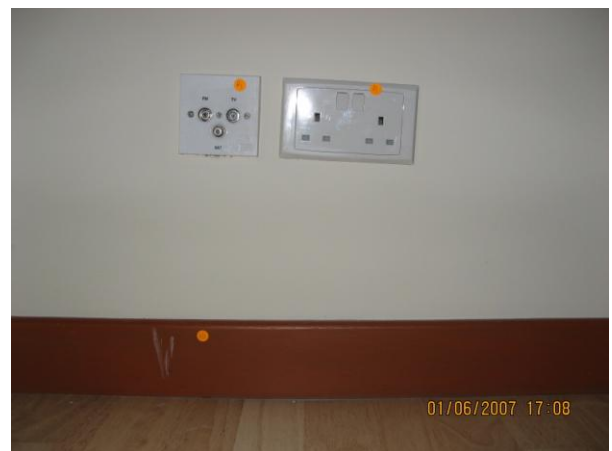
Misalignment on the power points

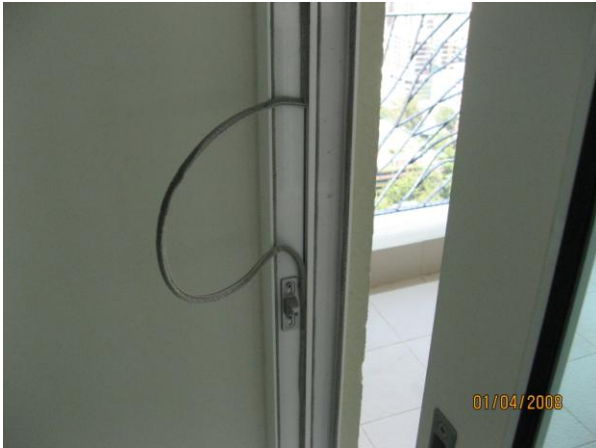
Sliding door gasket loosen

No.	Building Defects	Conquas 7 th Edition 2008	Qlassic CIS 7:2006
B	Mont'Kiara Banyan		
19.	Sliding door gasket loosen	Page 36, Architectural Works, Part 1: Internal Finishes, 4a (3) states that for Doors: No stain marks and any visible damage.	Page 30, Architectural Works, Internal Finishes, (IV) A (3) states that for the Doors: Glazing clean and evenly sealed with gasket.

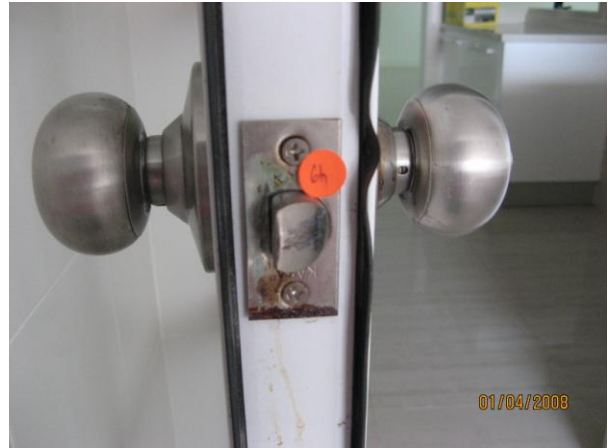
Rusty ironmongery

20.	Rusty ironmongery	Page 36, Architectural Works, Part 1: Internal Finishes, 4a (5) states that for Doors: No sign of corrosion in ironmongery.	Page 31, Architectural Works, Internal Finishes, (IV) A (5) states that for the Doors: No sign of corrosion.

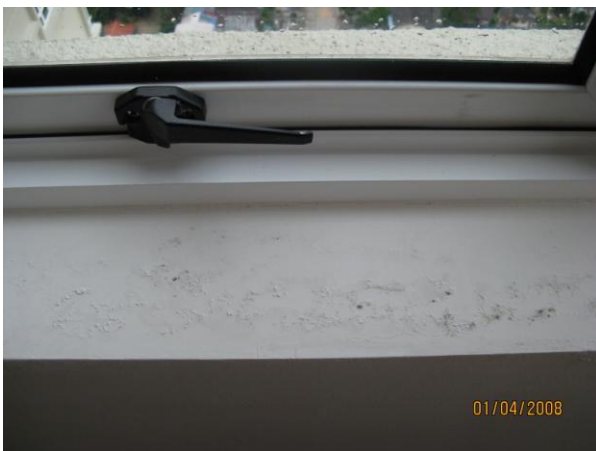
Signs of water seepage on the window sill

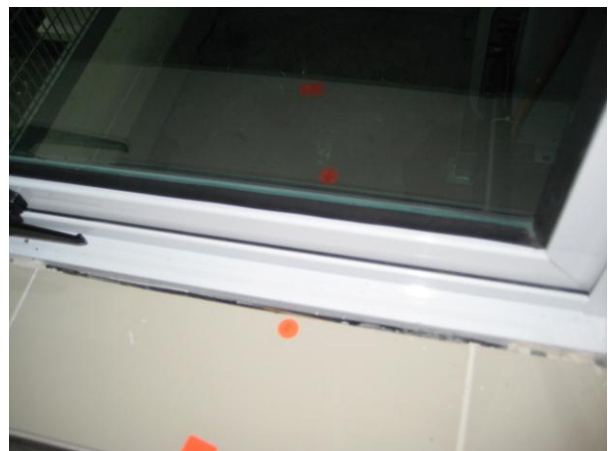
Poor workmanship of grouting work at the joint between the window frame and wall

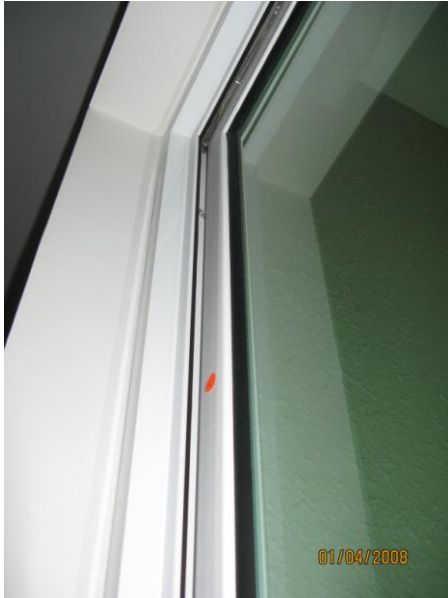
Misalignment of window

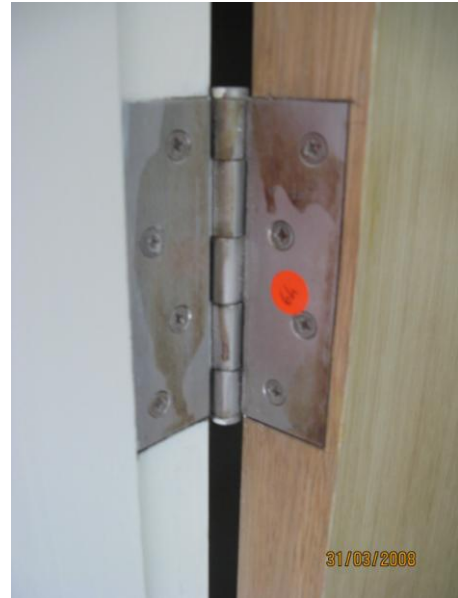
Varnish stains on the door hinges

24.	Varnish stains on the door hinges	Page 36, Architectural Works, Part 1: Internal Finishes, 4a (3) states that for Doors: No stain marks and any visible damage.	Page 31, Architectural Works, Internal Finishes, (IV) A (5) states that for the Doors: Accessories with good fit and no stains.

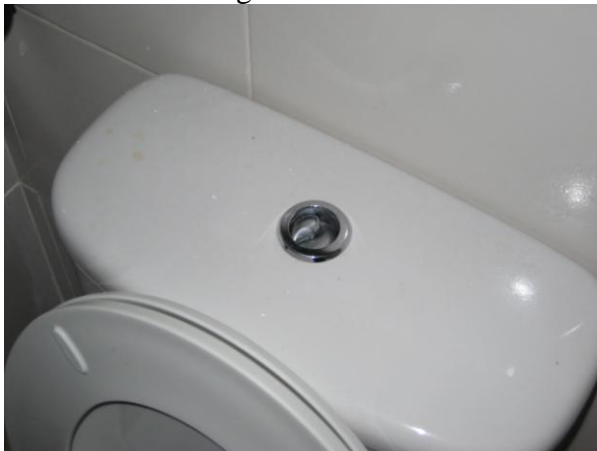
WC press button not functioning

No.	Building Defects	Conquas 7 th Edition 2008	Classic CIS 7:2006
25.	WC press button not functioning	Page 61, M&E Works, Part 5: Quality Standards for Basic M&E Fittings, 2c (5) states that for Plumbing & Sanitary Fittings: Fittings in working condition.	Page 49, M&E Works, Basic M&E Fittings, (V) B (iii) states that for Plumbing and Sanitary Fittings: Fitting in working condition.

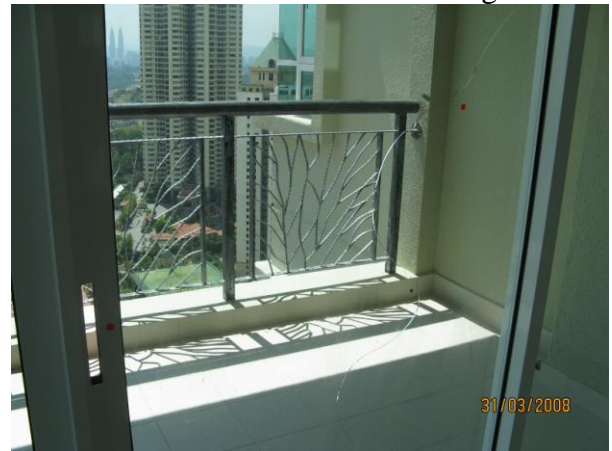
Crack on the glazing panel of the sliding door

26.	Crack on the glazing panel of the sliding door	Page 36, Architectural Works, Part 1: Internal Finishes, 4a (3) states that for Doors: No stain marks and any visible damage.	Page 30, Architectural Works, Internal Finishes, (IV) A (3) states that for the Doors: No stain marks and any visible damage.

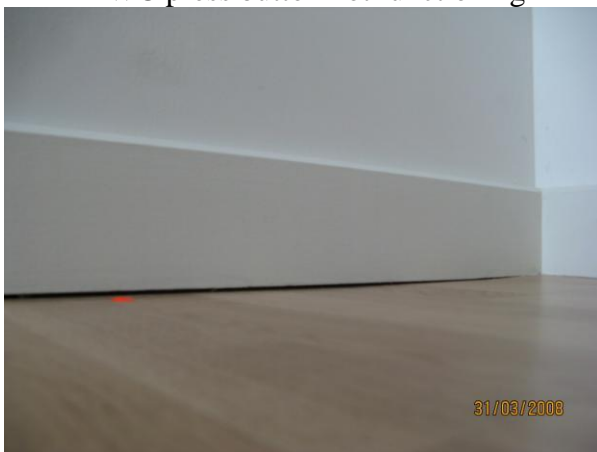
Gap at the joint between the timber skirting and timber flooring

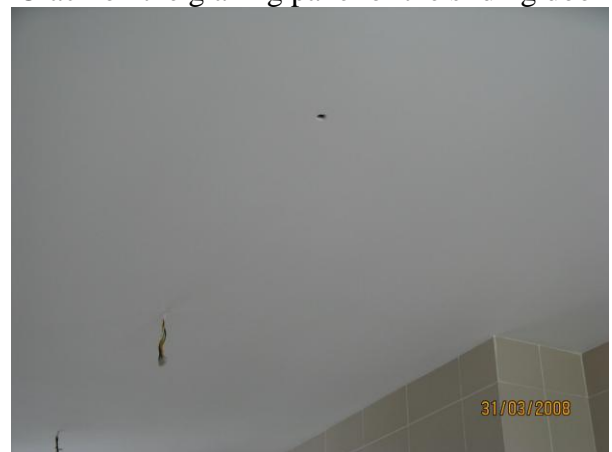
Chipped on the ceiling

28.	Chipped on the ceiling	Page 35, Architectural Works, Part 1: Internal Finishes, 3a (3) states that for Ceilings: No visible damage e.g spalling, leaks, cracks, etc	Page 28, Architectural Works, Internal Finishes, (III) A (3) states that for the Ceilings: No visible damage e.g. spalling, leaks, cracks, etc.

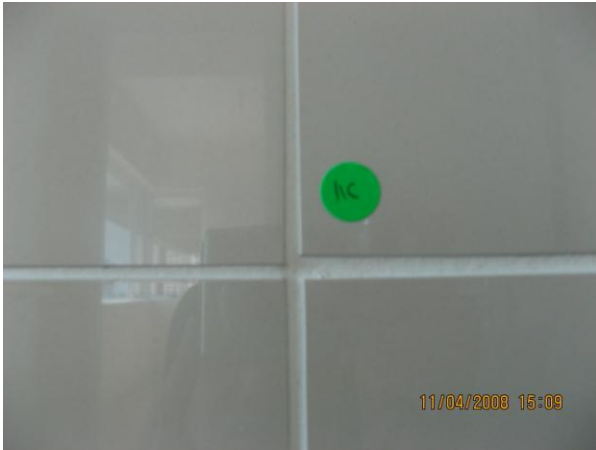
Inconsistent pointing between the wall tiles

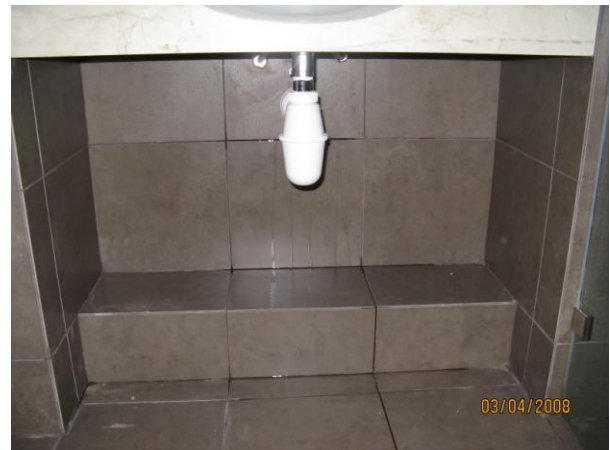
Water leakage on the wall

No.	Building Defects	Conquas 7 th Edition 2008	Qlassic CIS 7:2006
32.	Water leakage on the wall	Page 33, Architectural Works, Part 1: Internal Finishes, 2a (3) states that for Walls: No visible damage/defects.	Page 26, Architectural Works, Internal Finishes, (II) A (2) states that for the walls: No visible damage/defect.

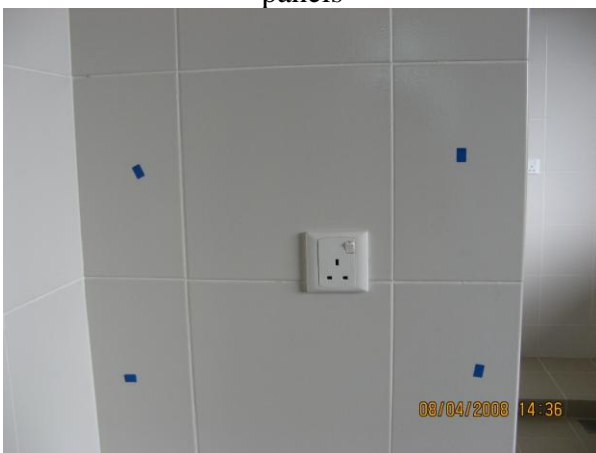
Hollowness on the wall tiles

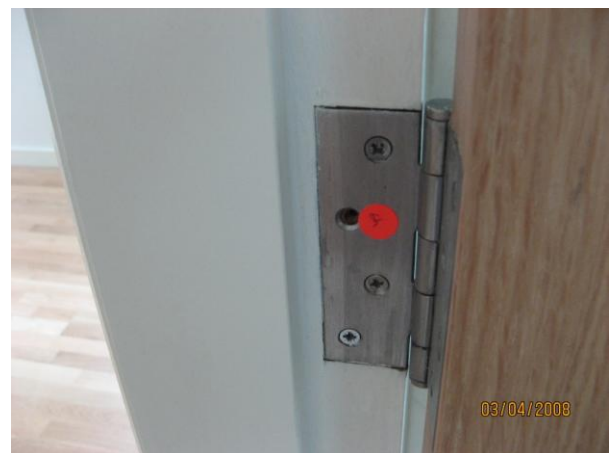
Screw missing at the hinges of the timber door

34.	Screw missing at the hinges of the timber door	Page 36, Architectural Works, Part 1: Internal Finishes, 4a (5) states that for Doors: No missing or defective accessories.	Page 31, Architectural Works, Internal Finishes, (IV) A (3) states that for the Doors: No missing or defective accessories.
C	Mont'Kiara Meridin

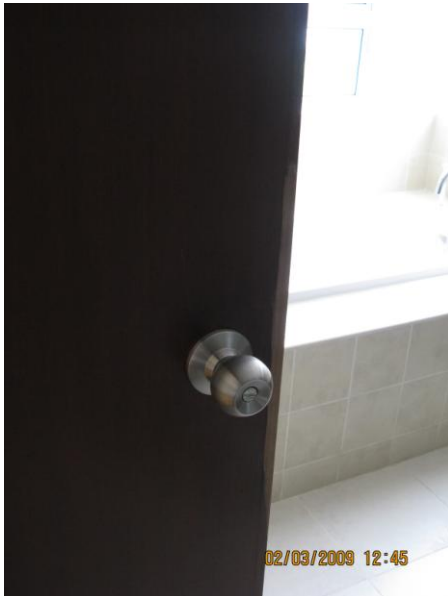
Poor workmanship of varnishing work o the timber door

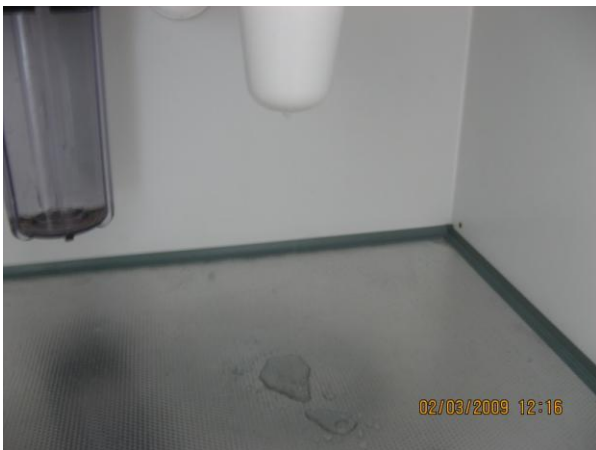
Water leakage from the water trap below the sink

37.	Water leakage from the water trap below the sink	Page 60, M&E Works, Part 5: Quality Standards for Basic M&E Fittings, 2c (2) states that for Plumbing & Sanitary Fittings: No leakage at joints.	Page 49, M&E Works, Basic M&E Fittings, (V) B (iii) states that for Plumbing and Sanitary Fittings: No leakage at joints.

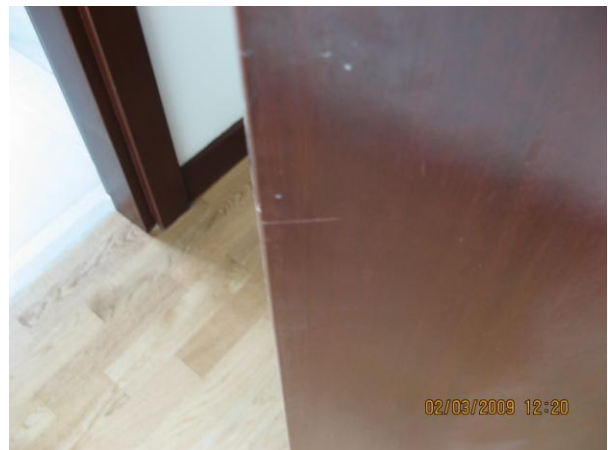
Scratches on the timber door.

No.	Building Defects	Conquas 7 th Edition 2008	Qlassic CIS 7:2006
38.	Scratches on the timber door.	Page 36, Architectural Works, Part 1: Internal Finishes, 4a (3) states that for Doors: No stain marks and any visible damage.	Page 30, Architectural Works, Internal Finishes, (IV) A (3) states that for the Doors: No stain marks and any visible damage.

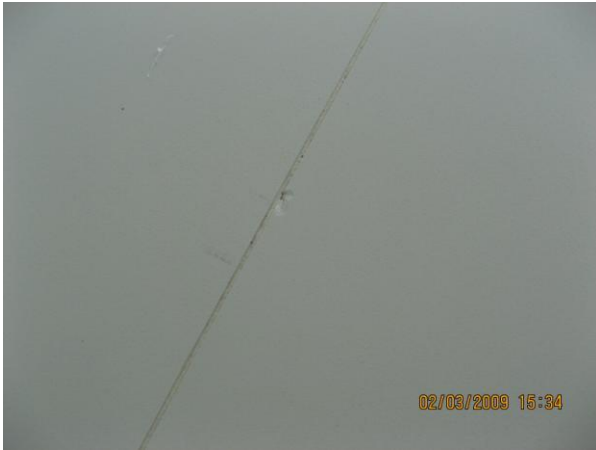
Chipped on the floor tiles

39.	Chipped on the floor tiles	Page 31, Architectural Works, Part 1: Internal Finishes, 1a (3) states that for Floors: No visible damage/defects.	Page 24, Architectural Works, Internal Finishes, (I) A (3) states that for the floors: No visible damage/defects.

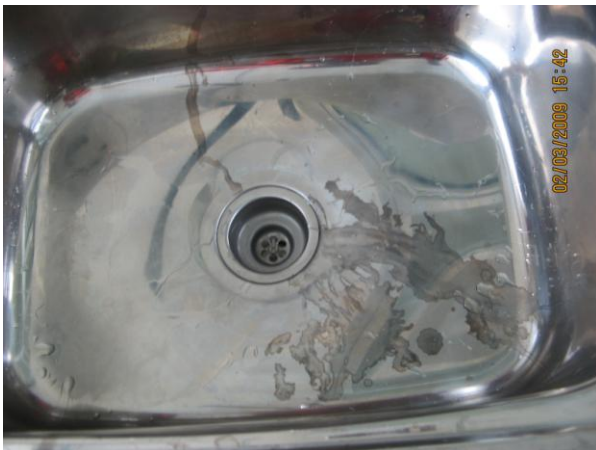
Permanent stains on the sink

41.	Permanent stains on the sink	Page 60, M&E Works, Part 5: Quality Standards for Basic M&E Fittings, 1 (3) states that for Plumbing & Sanitary Fittings: No stain marks.	Page 48, M&E Works, (V) A (3) states that for the Basic M&E Fittings: No stain marks.

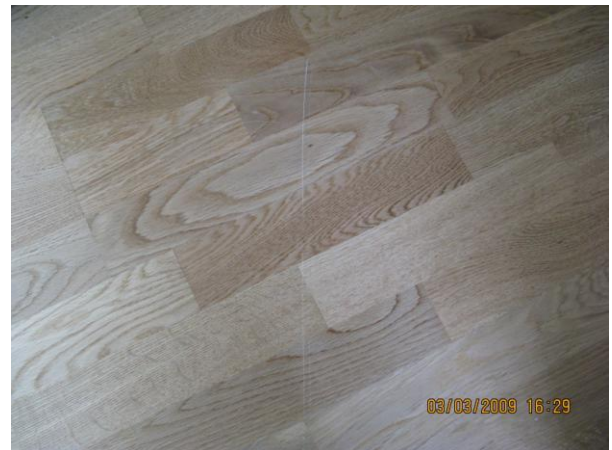
Scratches on the timber flooring

42.	Scratches on the timber flooring	Page 31, Architectural Works, Part 1: Internal Finishes, 1a (3) states that for Floors: No visible damage/defects.	Page 24, Architectural Works, Internal Finishes, (I) A (3) states that for the floors: No visible damage/defects.

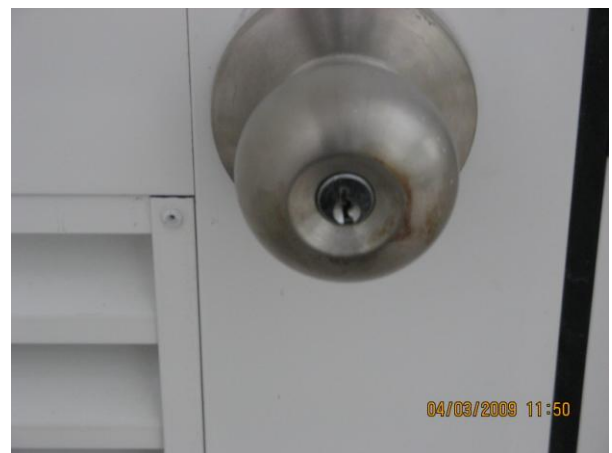
Rusty door knob

44.	Rusty door knob	Page 36, Architectural Works, Part 1: Internal Finishes, 4a (5) states that for Doors: No sign of corrosion in ironmongery.	Page 31, Architectural Works, Internal Finishes, (IV) A (5) states that for the Doors: No sign of corrosion.

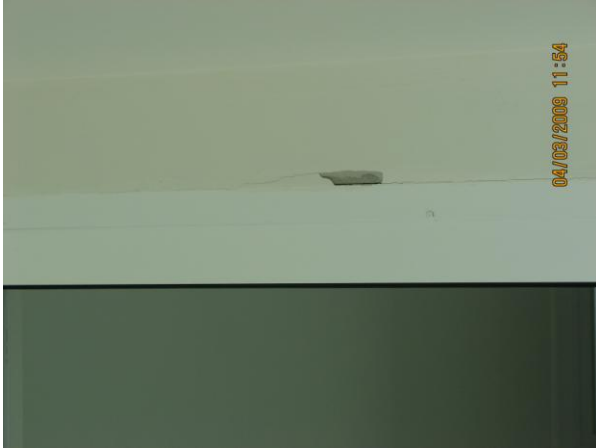
Chipped on the plaster wall

No.	Building Defects	Conquas 7 th Edition 2008	Classic CIS 7:2006
45.	Chipped on the plaster wall	Page 33, Architectural Works, Part 1: Internal Finishes, 2a (3) states that for Walls: No visible damage/defects.	Page 26, Architectural Works, Internal Finishes, (II) A (2) states that for the walls: No visible damage/defect.

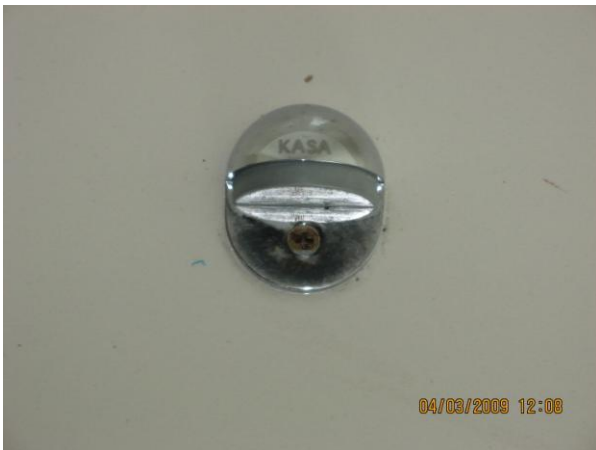
Rusty screw of the door stopper

47.	Rusty screw of the door stopper	Page 36, Architectural Works, Part 1: Internal Finishes, 4a (5) states that for Doors: No sign of corrosion in ironmongery.	Page 31, Architectural Works, Internal Finishes, (IV) A (5) states that for the Doors: No sign of corrosion.

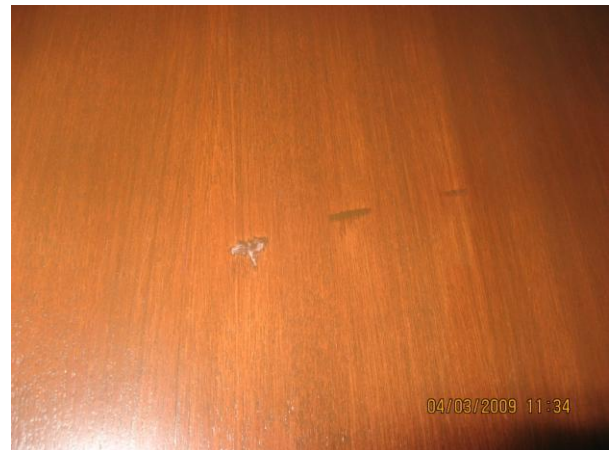
Non-matching wood filler on the timber door

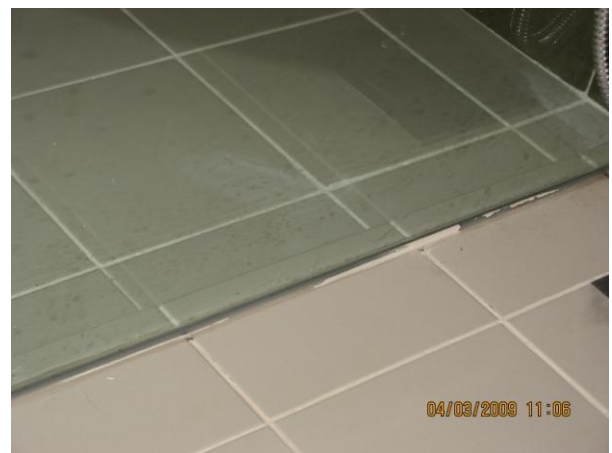
Poor workmanship of sealant work at the joint between the shower screen and tiled flooring

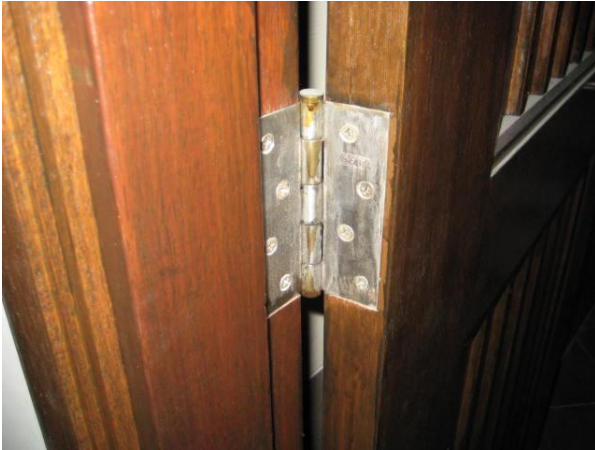
Rusty on the hinges of the timber door

No.	Building Defects	Conquas 7 th Edition 2008	Qlassic CIS 7:2006
D	Flora Murni		
51.	Rusty on the hinges of the timber door	Page 36, Architectural Works, Part 1: Internal Finishes, 4a (5) states that for Doors: No sign of corrosion in ironmongery	Page 31, Architectural Works, Internal Finishes, (IV) A (5) states that for the Doors: No sign of corrosion.

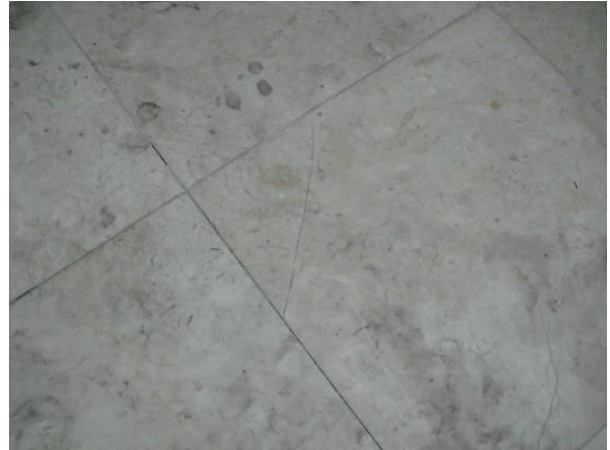
Crack on the floor tile

52.	Crack on the floor tile	Page 31, Architectural Works, Part 1: Internal Finishes, 1a (3) states that for Floors: No visible damage/defects.	Page 24, Architectural Works, Internal Finishes, (I) A (3) states that for the floors: No visible damage/defects.

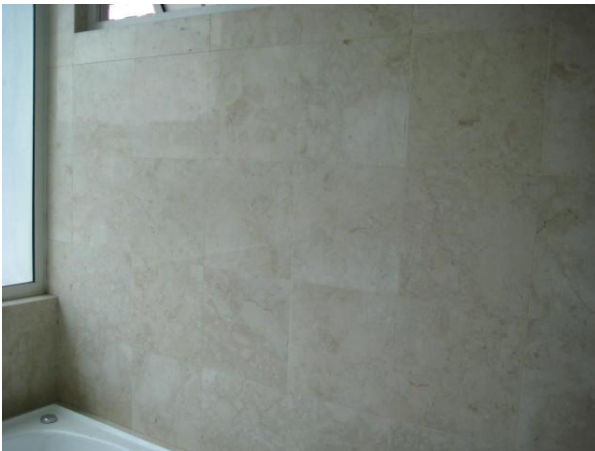
Different tonality on the wall tiles

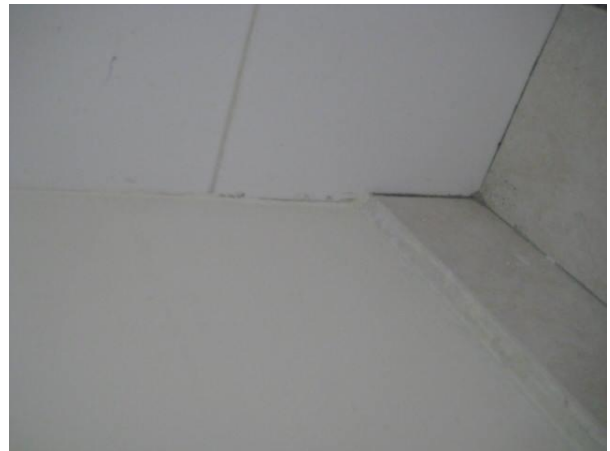
Fine cracks at the joint between the ceiling and plaster wall

54.	Fine cracks at the joint between the ceiling and plaster wall	Page 33, Architectural Works, Part 1: Internal Finishes, 2a (3) states that for Walls: No visible damage/defects.	Page 26, Architectural Works, Internal Finishes, (II) A (2) states that for the walls: No visible damage/defect.

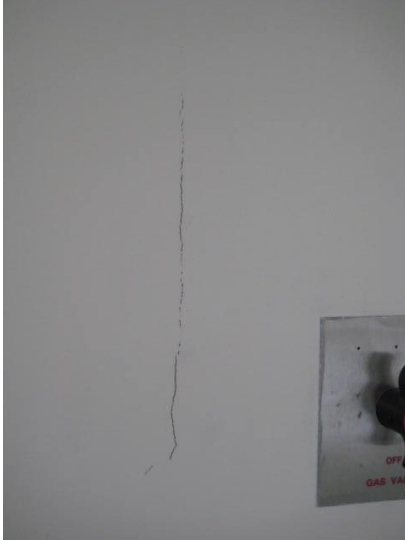
Fine cracks on the plaster wall

55.	Fine cracks on the plaster wall	Page 33, Architectural Works, Part 1: Internal Finishes, 2a (3) states that for Walls: No visible damage/defects.	Page 26, Architectural Works, Internal Finishes, (II) A (2) states that for the walls: No visible damage/defect.

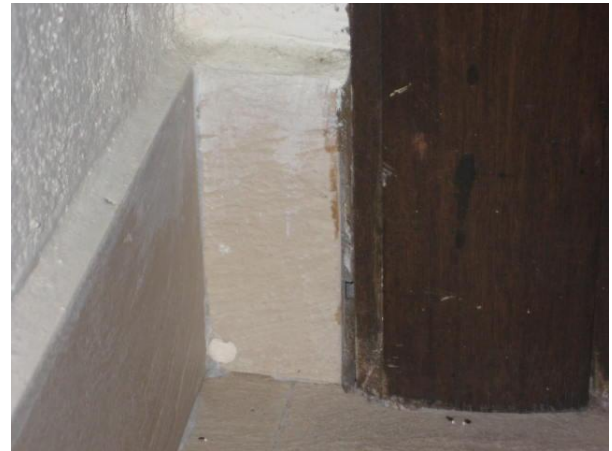
Poor workmanship of sealant works at the joint between the door architrave and skirting

56.	Poor workmanship of sealant works at the joint between the door architrave and skirting.	Page 36, Architectural Works, Part 1: Internal Finishes, 4a (3) states that for Doors: No stain marks and any visible damage.	Page 30, Architectural Works, Internal Finishes, (IV) A (1) states that for the Doors: Neat joints.

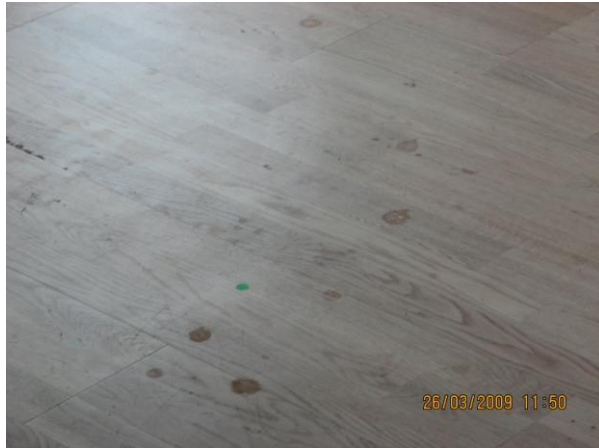
Stains on the timber flooring

No.	Building Defects	Conquas 7 th Edition 2008	Qlassic CIS 7:2006
E	Kiaramas Ayuria		
57.	Stains on the timber flooring	Page 31, Architectural Works, Part 1: Internal Finishes, 1a (1) states that for Floors: No stain marks.	Page 24, Architectural Works, Internal Finishes, (I) A (1) states that for the floors: No stain marks.

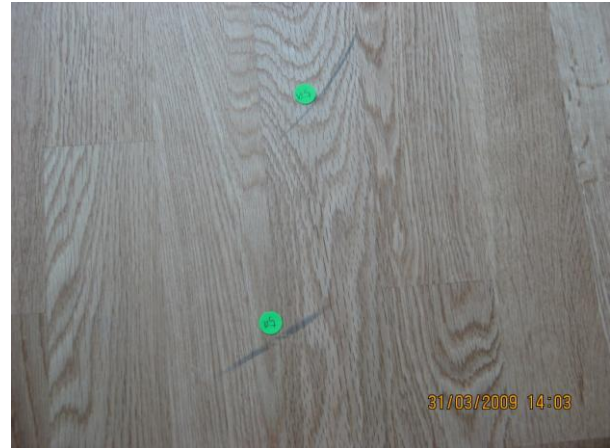
Scratches on the timber flooring

58.	Scratches on the timber flooring	Page 31, Architectural Works, Part 1: Internal Finishes, 1a (3) states that for Floors: No visible damage/defects.	Page 24, Architectural Works, Internal Finishes, (I) A (3) states that for the floors: No visible damage/defects.

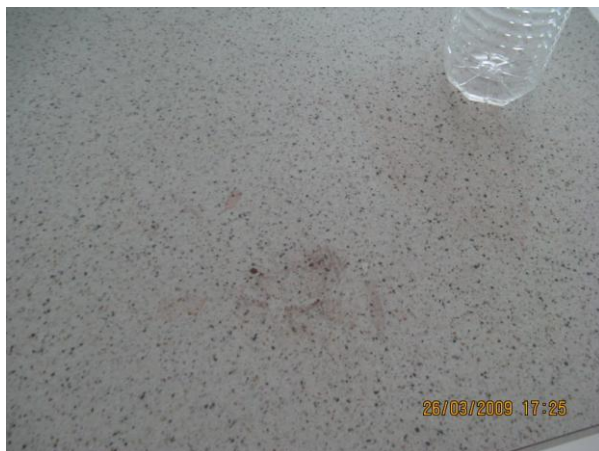
Stains and scratches on the counter top

59.	Stains and scratches on the counter top	Page 60, M&E Works, Part 5: Quality Standards for Basic M&E Fittings, 1 (3) states that for Plumbing & Sanitary Fittings: No visible damage/defects.	Page 32, Architectural Works, Internal Finishes, (IV) C (3) states that for the Fixtures: No stain mark; no damage/defect.

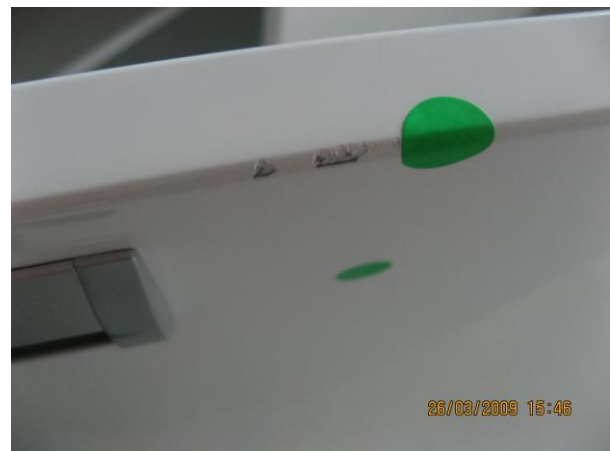
Chipped edges on the cabinet panel.

60.	Chipped edges on the cabinet panel.	Page 38, Architectural Works, Part 1: Internal Finishes, 6a (3) states that for Components: No visible damage/defects.	Page 32, Architectural Works, Internal Finishes, (IV) C (3) states that for the Fixtures: No stain mark; no damage/defect.

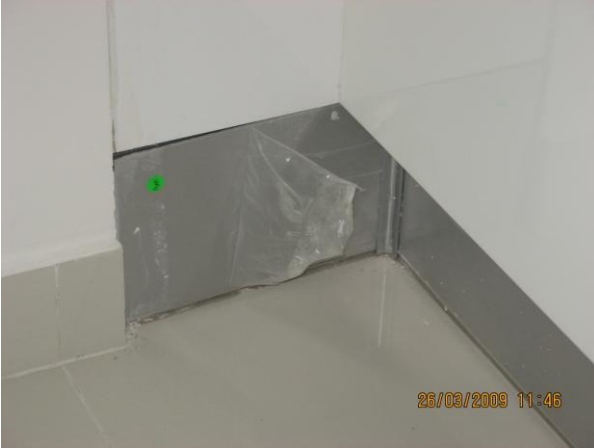
Detached aluminium strip of the cabinet

61.	Detached aluminium strip of the cabinet	Page 38, Architectural Works, Part 1: Internal Finishes, 6a (3) states that for Components: No visible damage/defects.	Page 32, Architectural Works, Internal Finishes, (IV) C (3) states that for the Fixtures: No stain mark; no damage/defect.

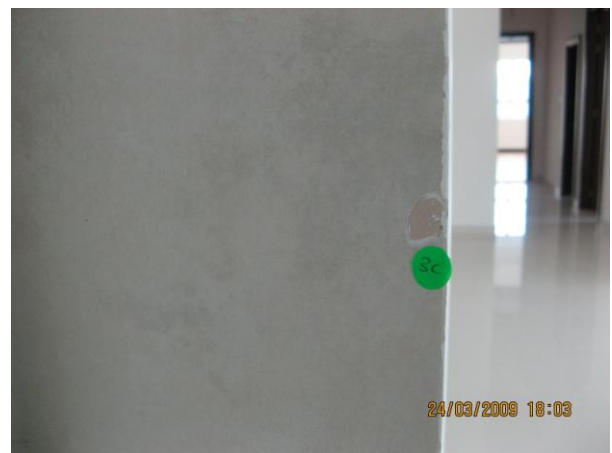
Chipped on the wall tile

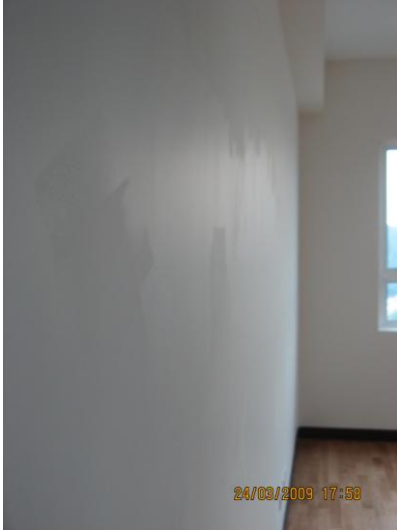
Patches of painting works on the plaster wall
