ROCK MASS SLOPE STABILITY ANALYSIS BASED
ON TERRESTRIAL LIDAR SURVEY ON SELECTED
LIMESTONE HILLS IN KINTA VALLEY, PERAK

**DISSERTATION SUBMITTED IN FULFILMENT OF
THE REQUIREMENTS FOR THE DEGREE OF MASTER
OF SCIENCE**

**DEPARTMENT OF GEOLOGY
FACULTY OF SCIENCE
DEPARTMENT OF GEOLOGY
UNIVERSITY OF MALAYA
KUALA LUMPUR**

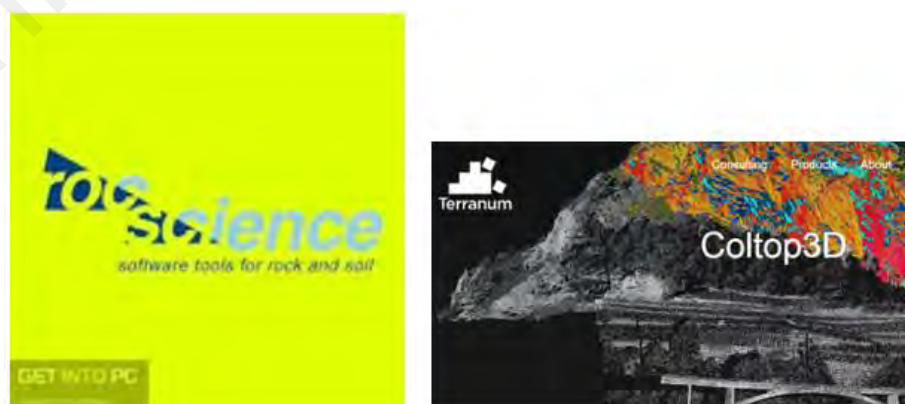
Figure 3.12: Rocscience DIPS software and COLTOP 3D software used for kinematic analysis.

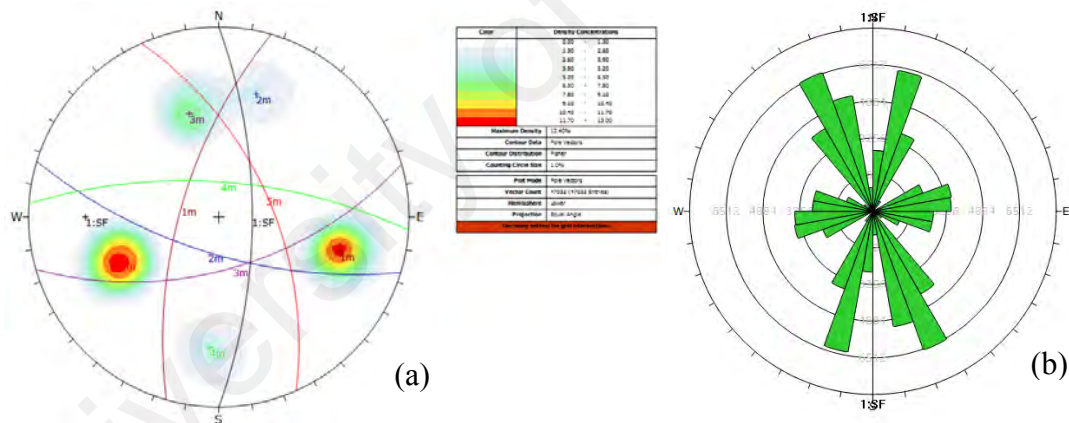
Figure 3.14: Example data from Gunung Lang Area 1 rock slope (a) Stereonet shows the poles plot and major planes plot of all discontinuity sets and (b) Rose diagram showing trend of discontinuity sets.

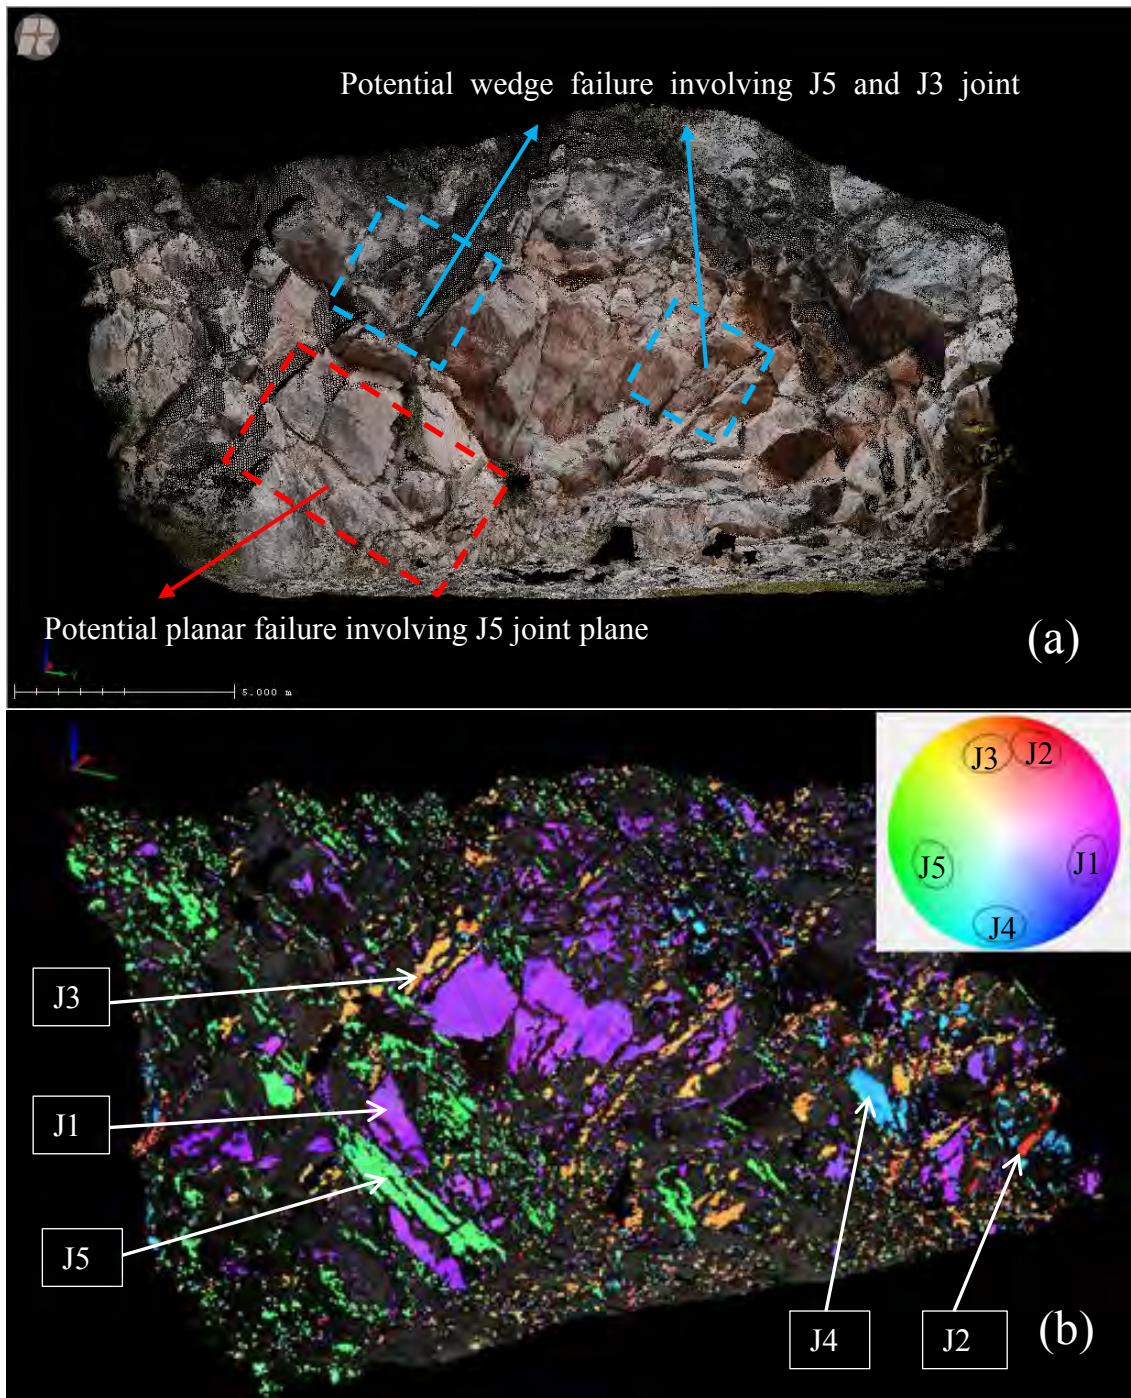
Figure 4.4: (a) True colour 3D Digital Terrain Model (DTM) of the GL1 slope, (b) Multiple joint sets presented in unique colour based on the stereographic projection, each colour represents one joint set (view from Coltop 3D). A total of 5 joint sets were identified which are J1 (67/286), J2 (68/197), J3 (59/164), J4 (69/004), and J5 (59/066). All of the data shown represents the dip angle and dip direction of the joint sets.

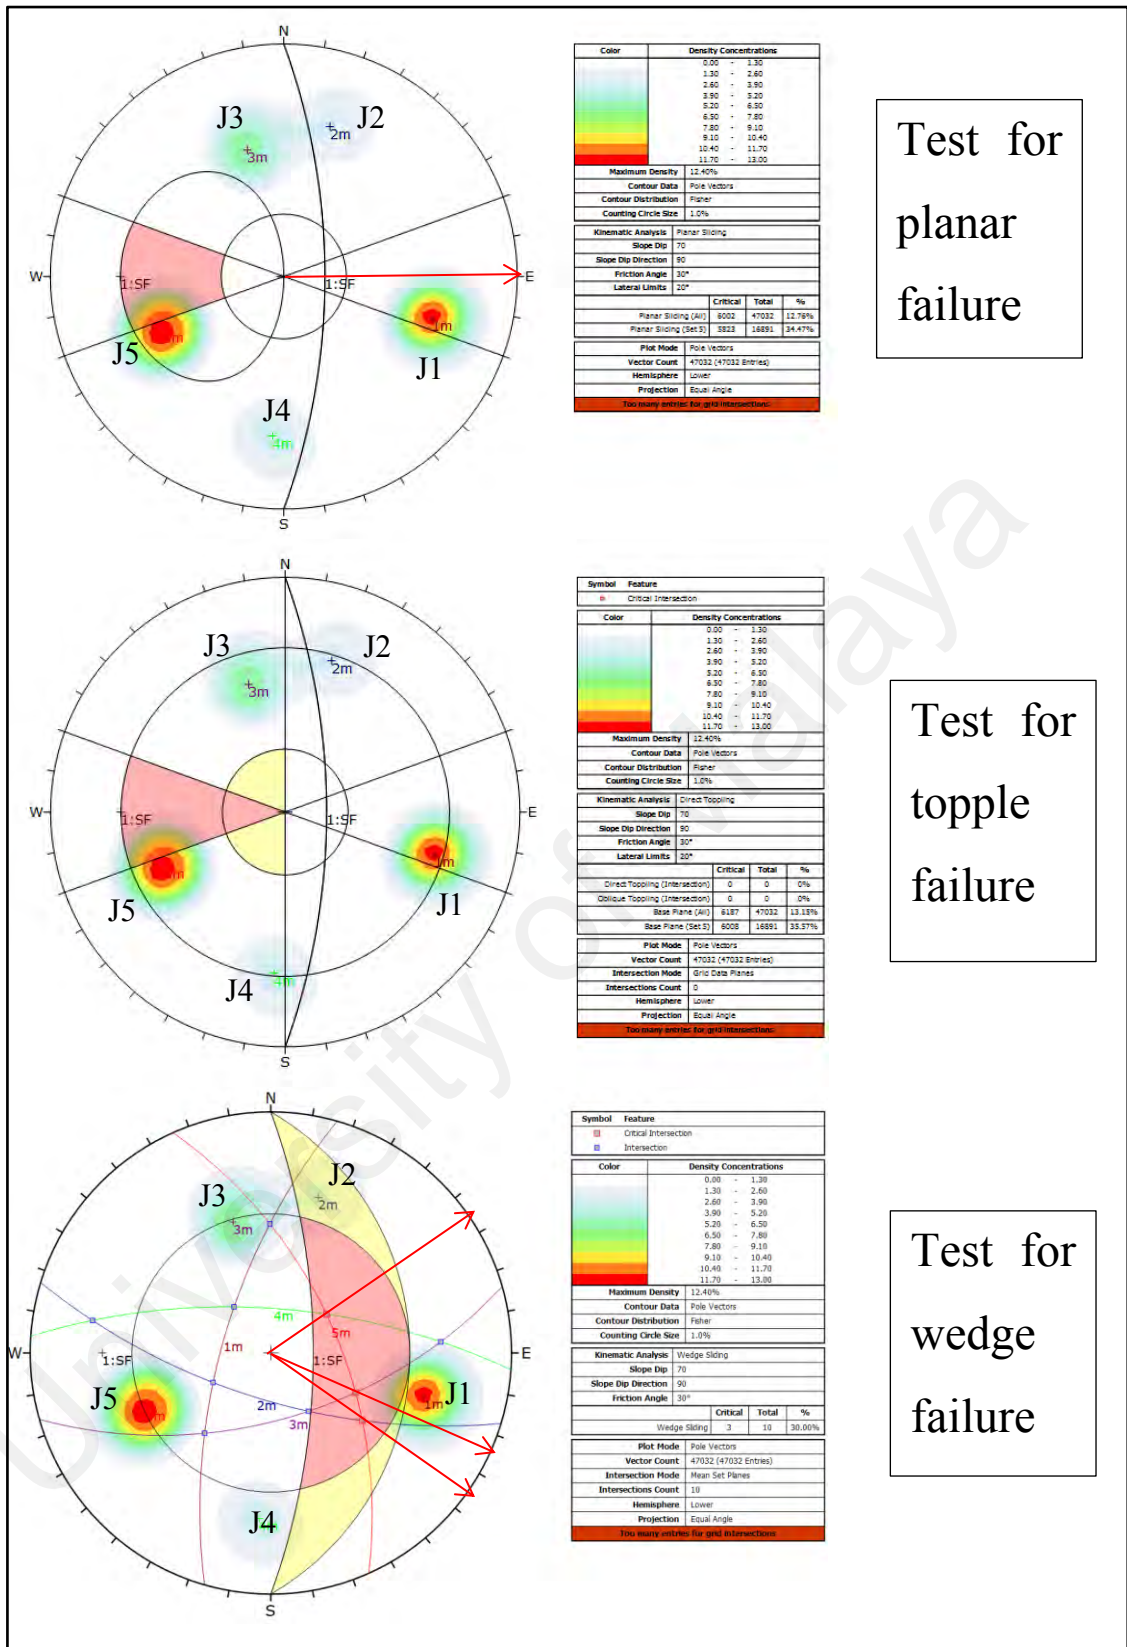
Figure 4.8: Kinematic analysis testing for planar failure, wedge failure, and topple failure in GL1 slope. Red arrows represent the direction of possible failure.

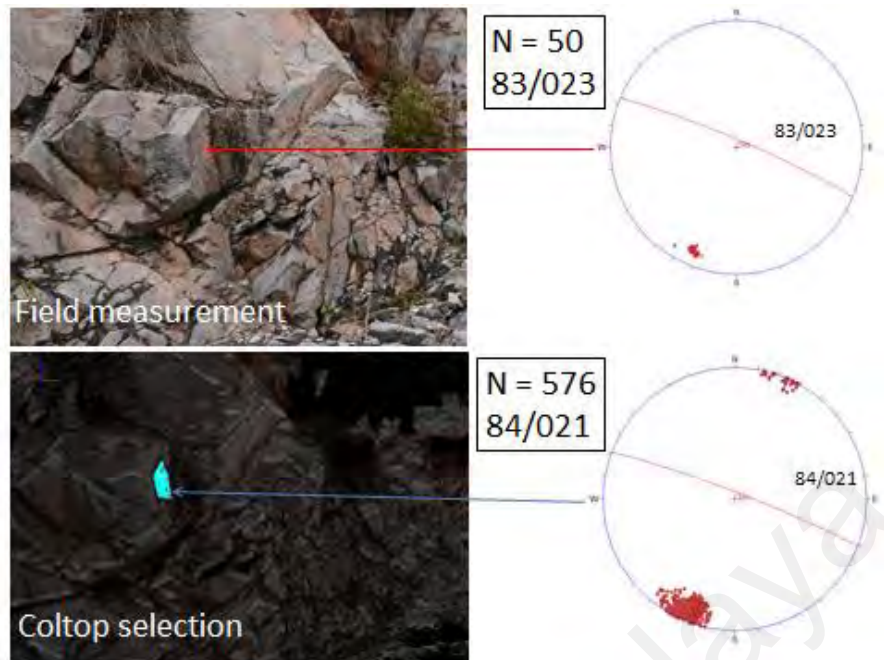
Figure 4.9: Figure shows reading collected on the same joint plane by both field measurement and lidar measurement.

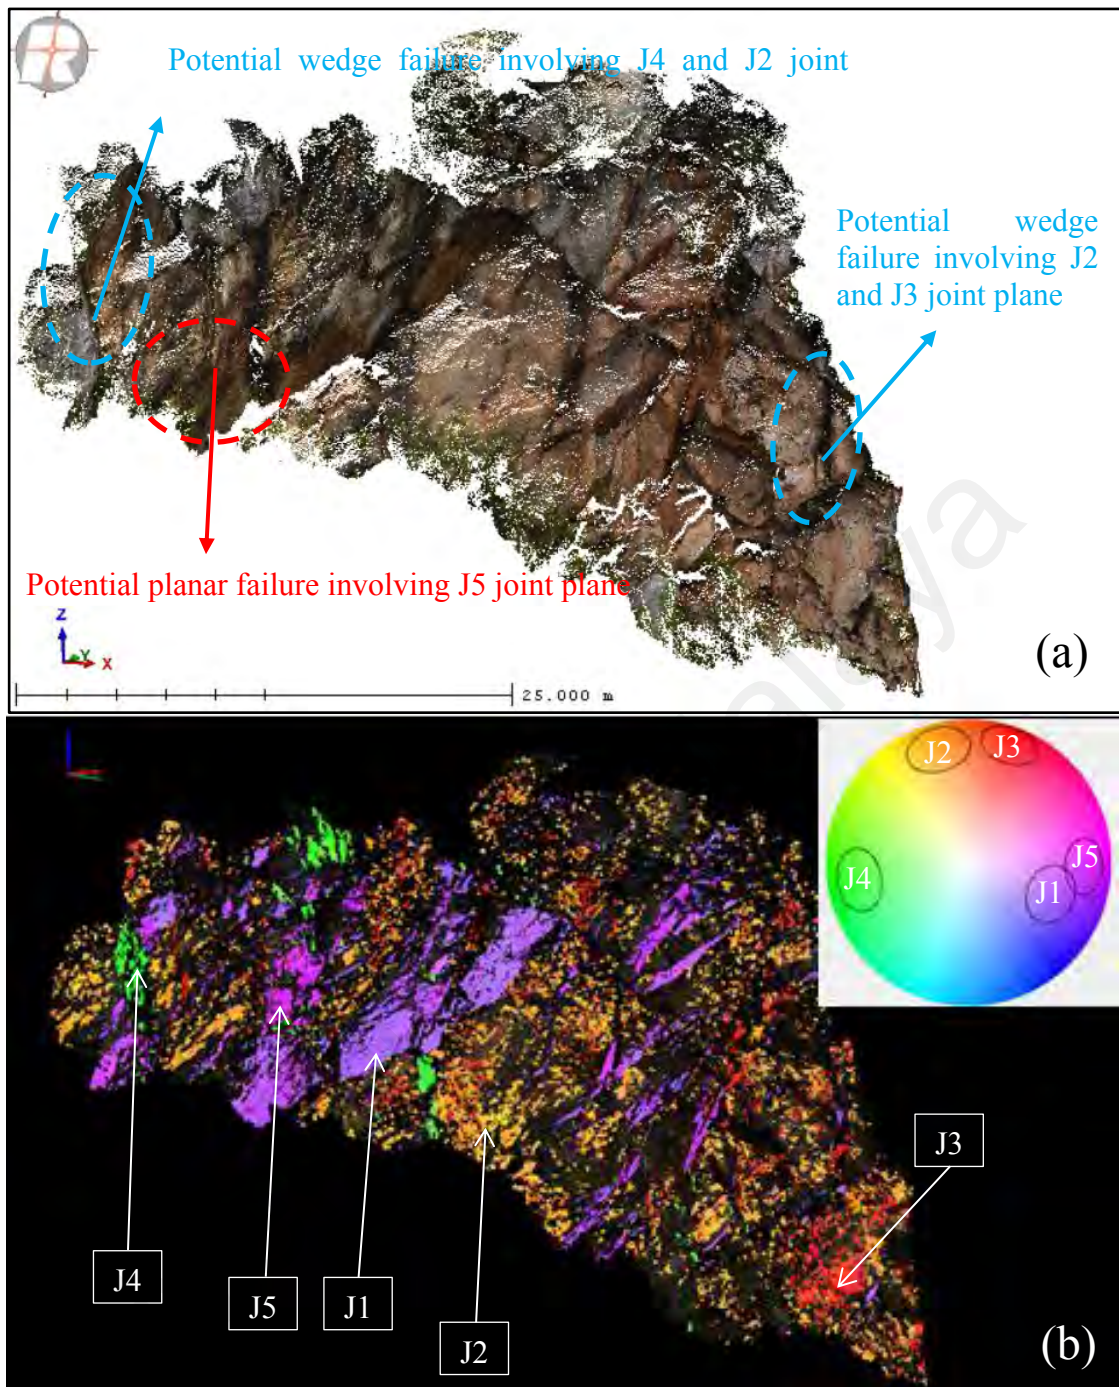
Figure 4.12: (a) True colour Digital Terrain Model (DTM) of GL2 slope (b) Multiple joint sets visualized in unique colour based on stereographic projections (view from Coltop 3D). Five joint sets were identified which are J1 (54/291), J2 (74/164), J3 (79/196), J4 (73/085), and J5 (73/272). Data collected are all in dip angle and dip directions.

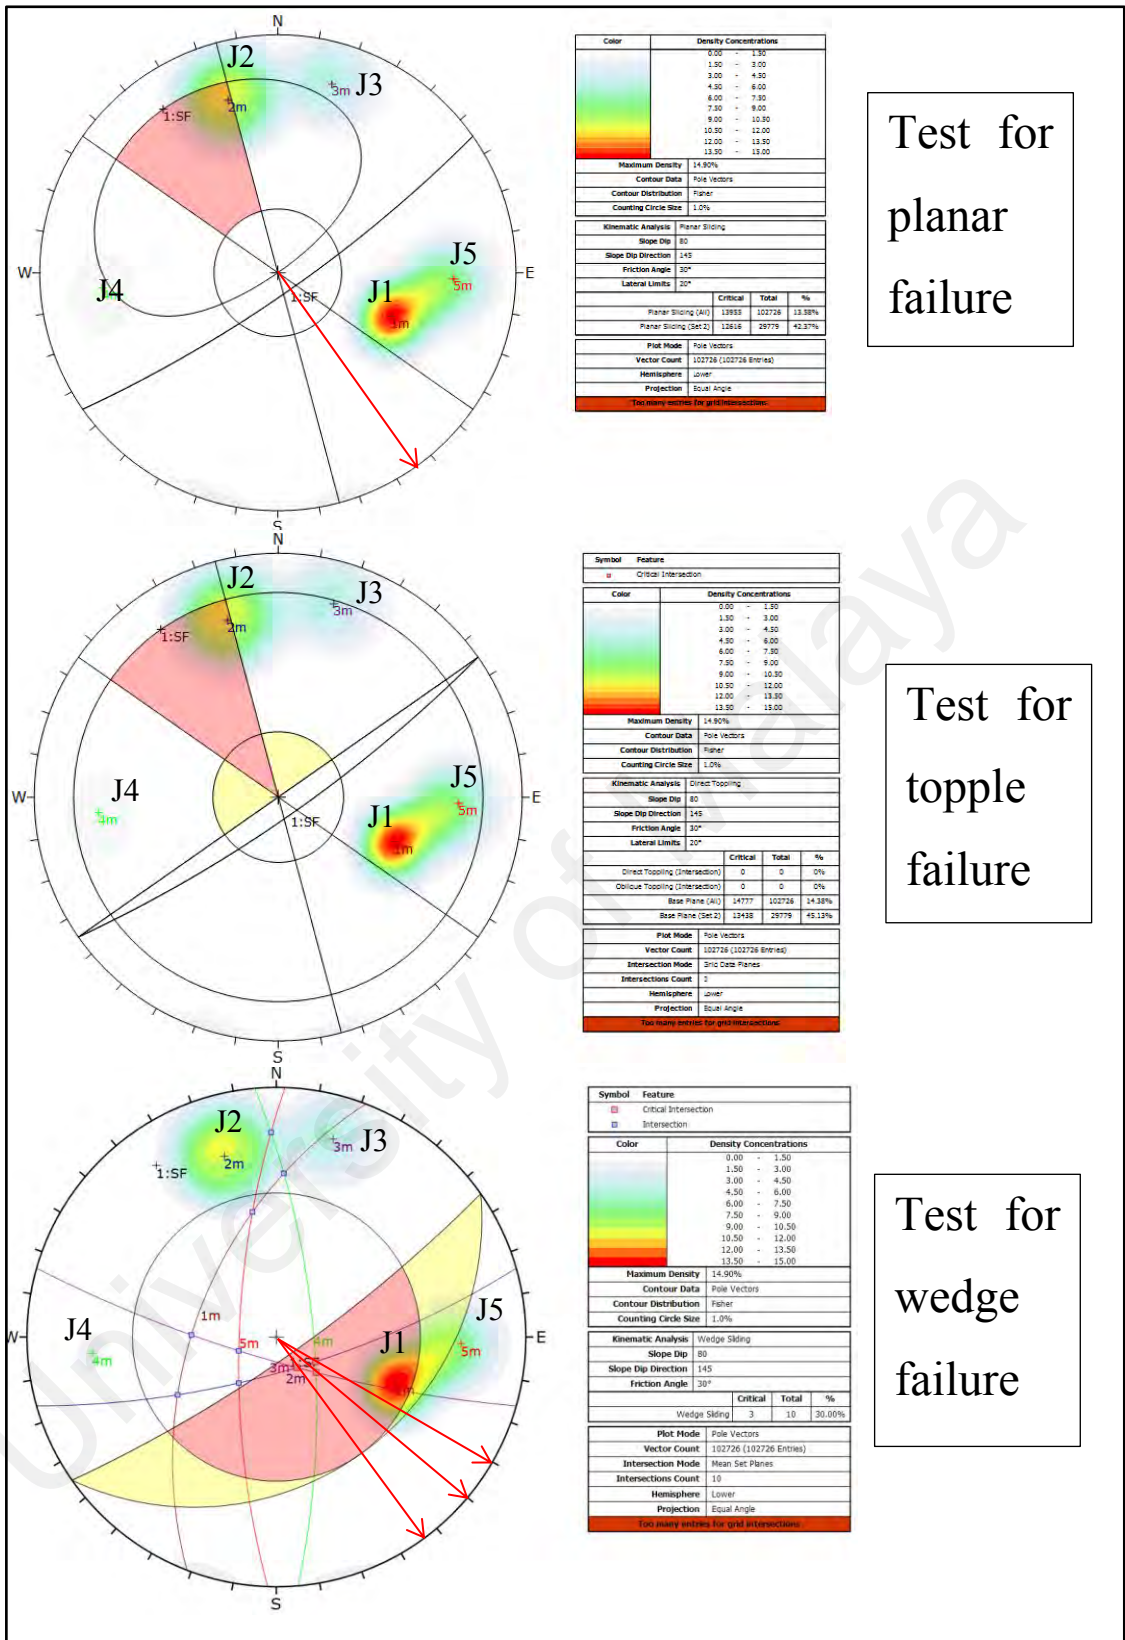
Figure 4.16: Kinematic analysis testing for planar failure, wedge failure, and topple failure in GL2 slope. Red arrows represent the direction of possible failure.

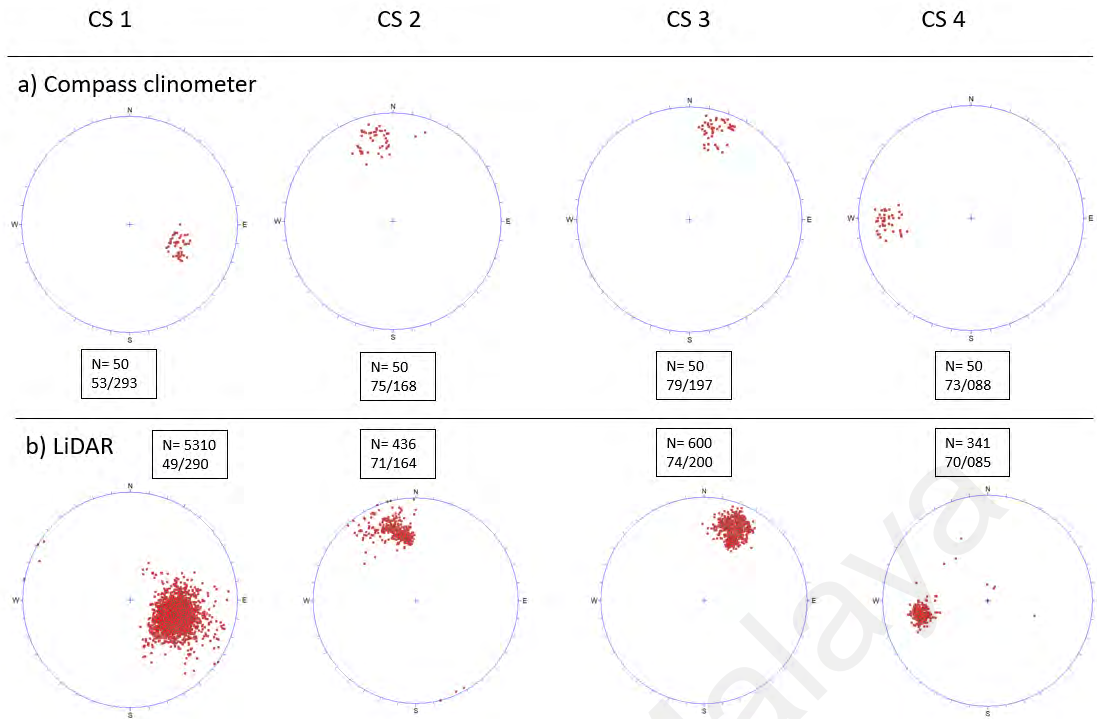
Figure 4.17: Lidar measurement validation with manual measurement at GL2 slope. Four control surfaces CS1, CS2, CS3, and CS4 which represent the joint planes were selected on the slope for validation purposes.

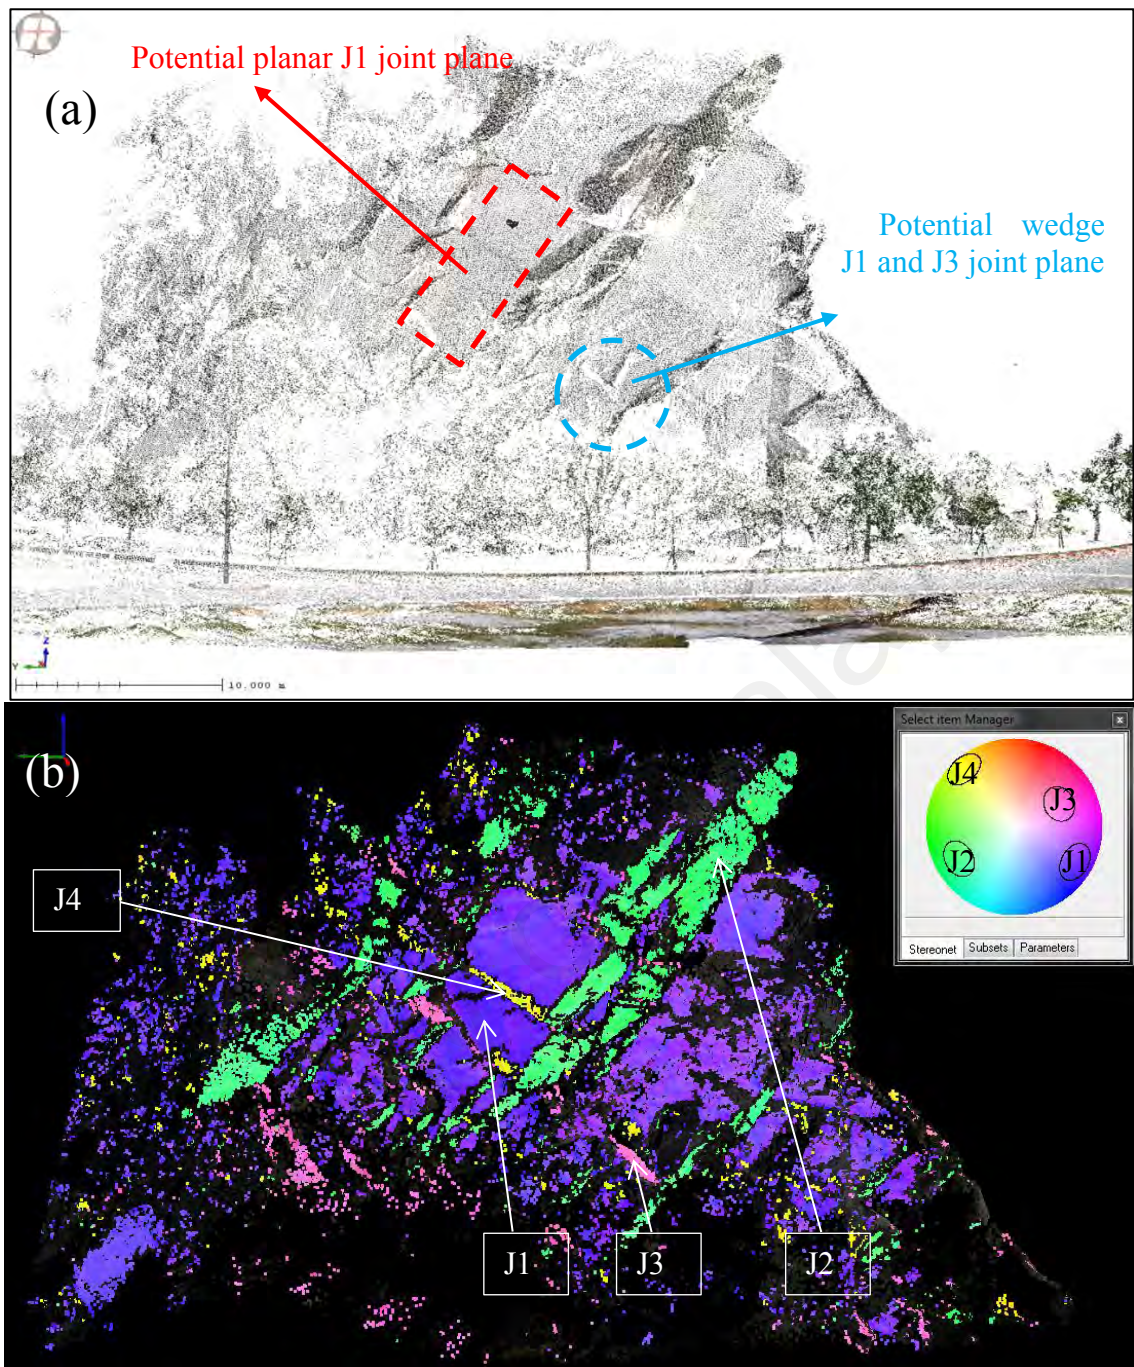
Figure 4.19: (a) Figure shows the true colour Digital Terrain Model (DTM) of the GL3 slope (b) 3D discontinuity plane model with unique colour derived from Coltop 3D. Four joint sets can be identified on the slope which are J1 (69/299), J2 (66/058), J3 (50/245), and J4 (80/137).

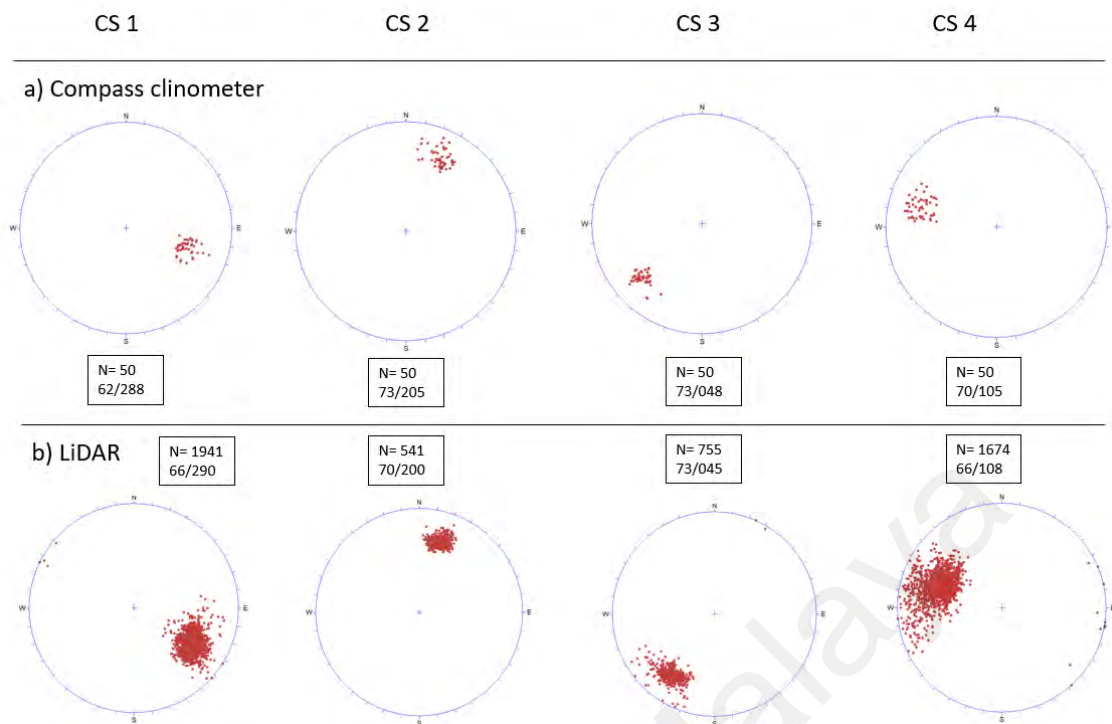
Figure 4.31: Lidar measurement validation with manual measurement at GL4 slope. Four control surfaces CS1, CS2, CS3, and CS4 which represent the joint planes were selected on the slope for validation purposes.

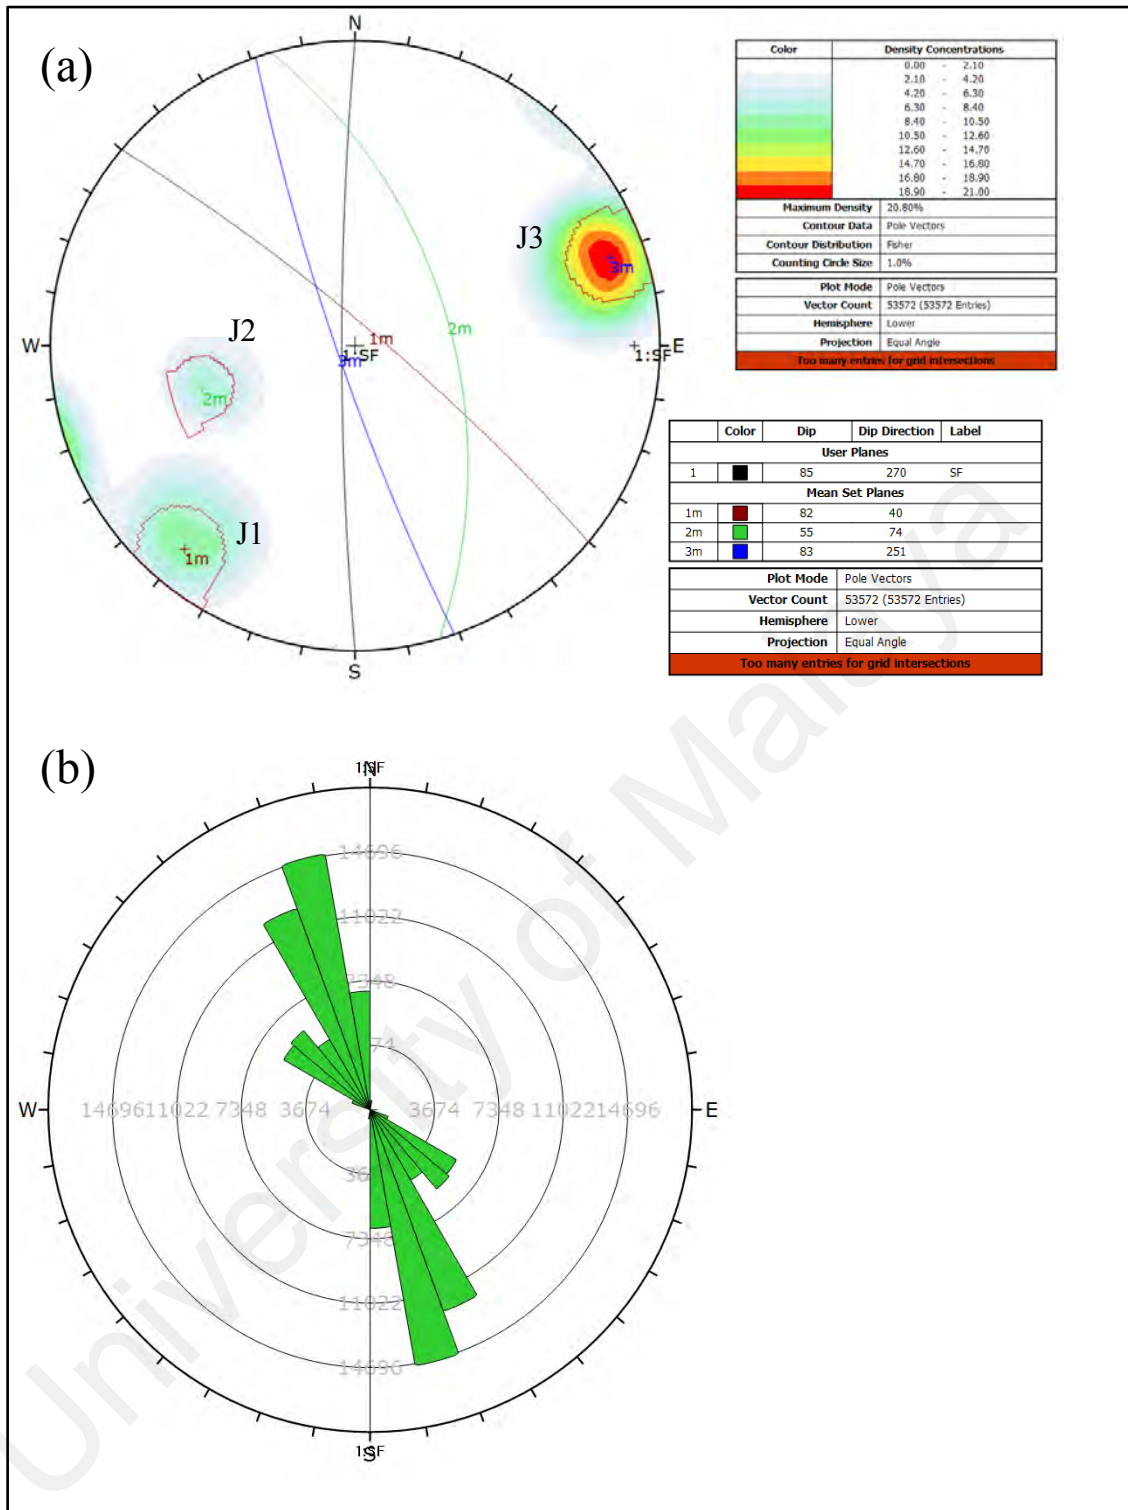
Figure 4.47: (a) Poles plot and major planes plot of all three joint sets in a stereonet (b) Rose plot showing the trend of all major joint sets and the slope face orientation in KLT 1 (a) slope. Based on the rose plot, most dominant joint sets orientation is trending northwest-southeast direction.

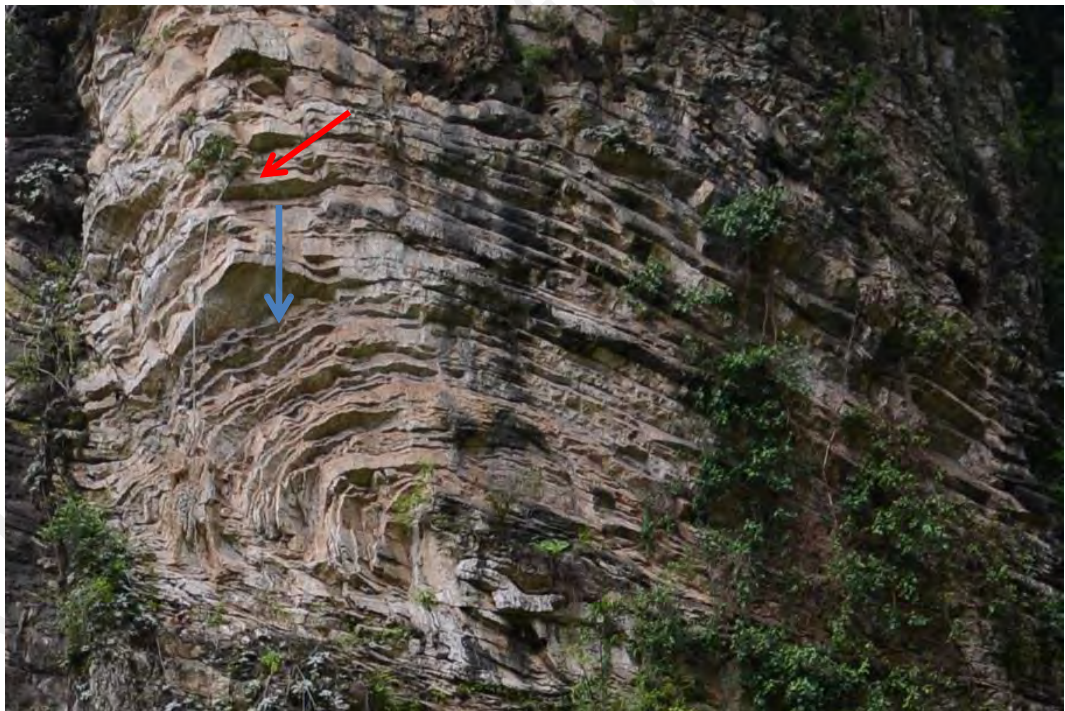
Figure 4.71: Example of possible planar failure involving J2 (80/100) in green point cloud view, Blue arrow represents the dip direction of J2 joints which is daylighting and is a potential for planar failure. Red arrow represents J1 (64/279) dipping direction which is dipping into the slope.

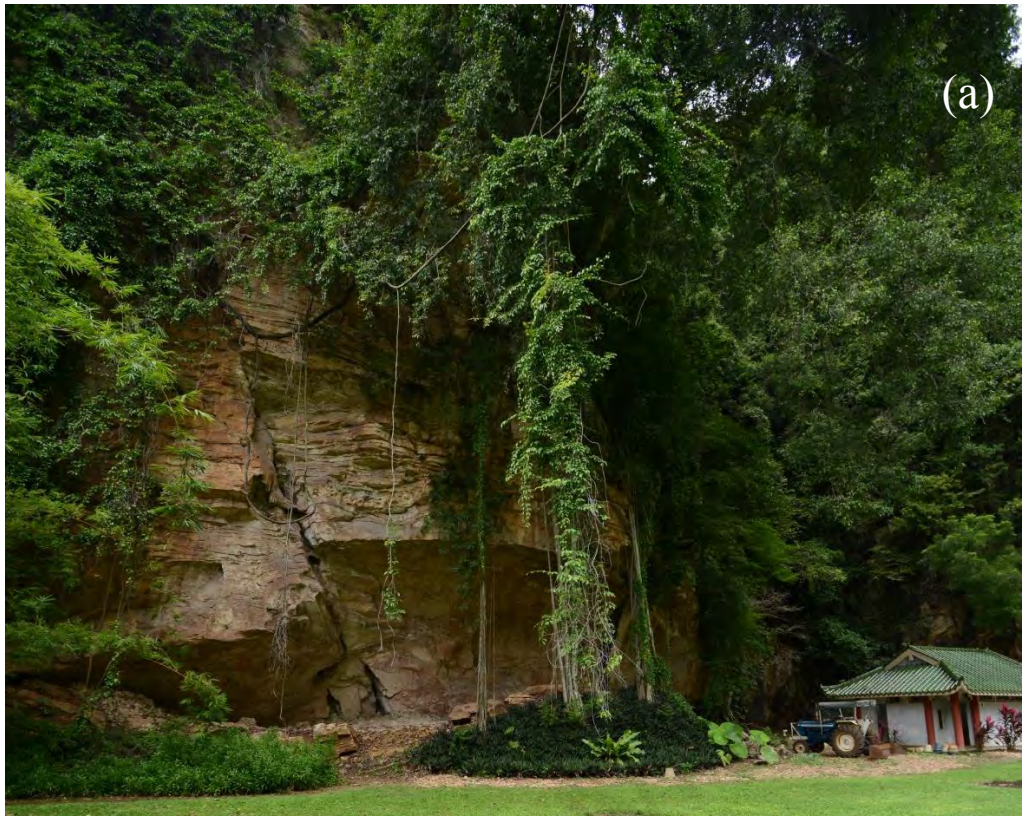
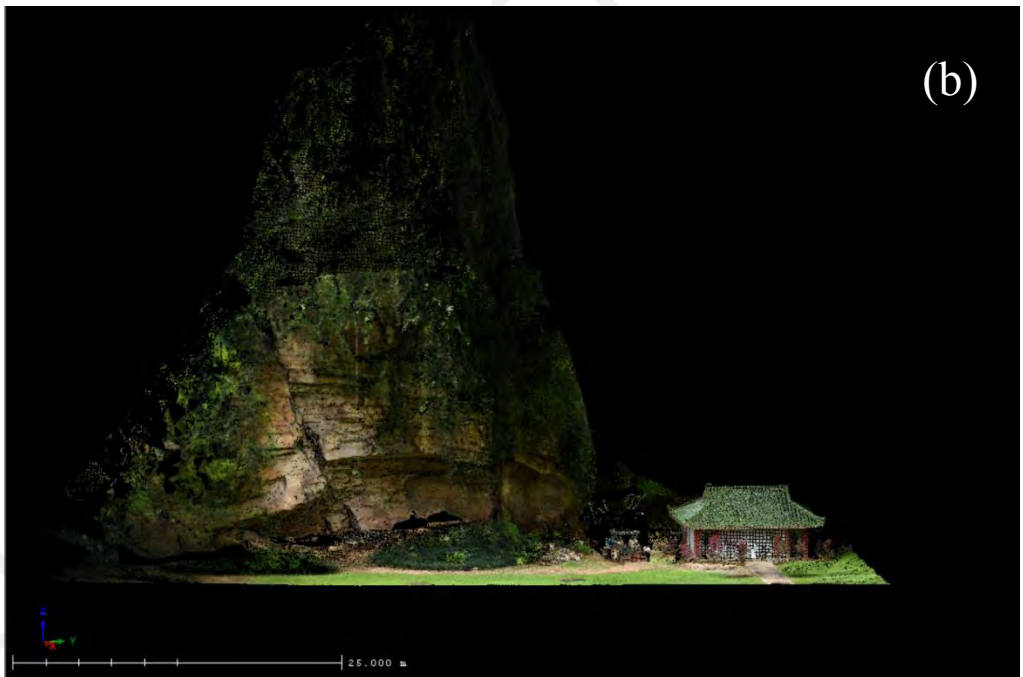
Figure 4.74: (a) Image taken by Nikon D800 camera showing the location of KLT 3 slope (b) Digital Terrain Model (DTM) of the slope with true color display.

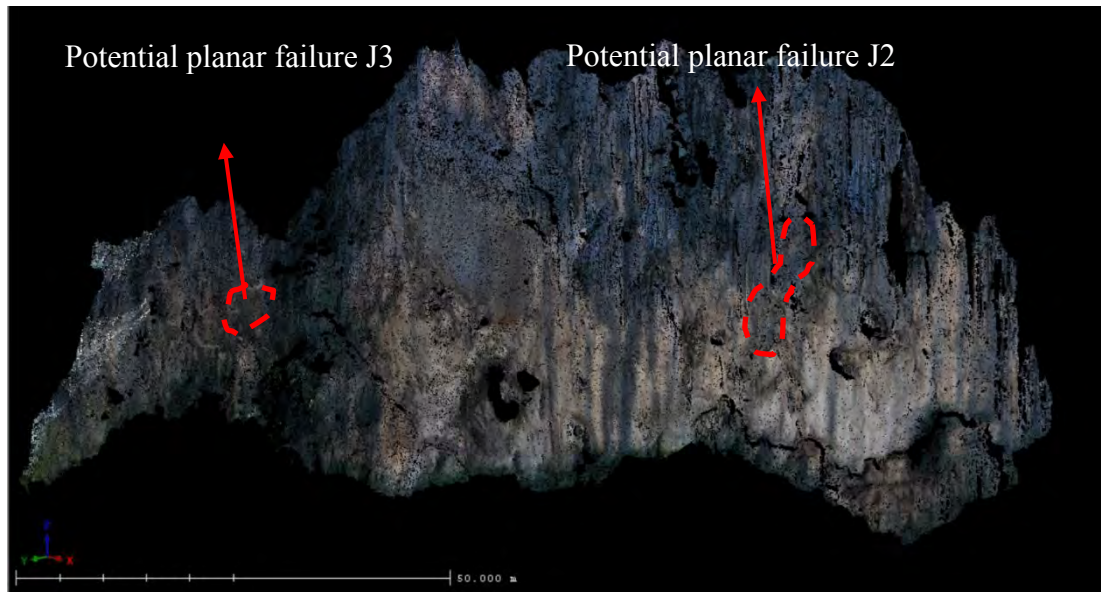
Figure 4.86: Overall view of Digital Terrain Model (DTM) of slope KYT (a) in true color display.

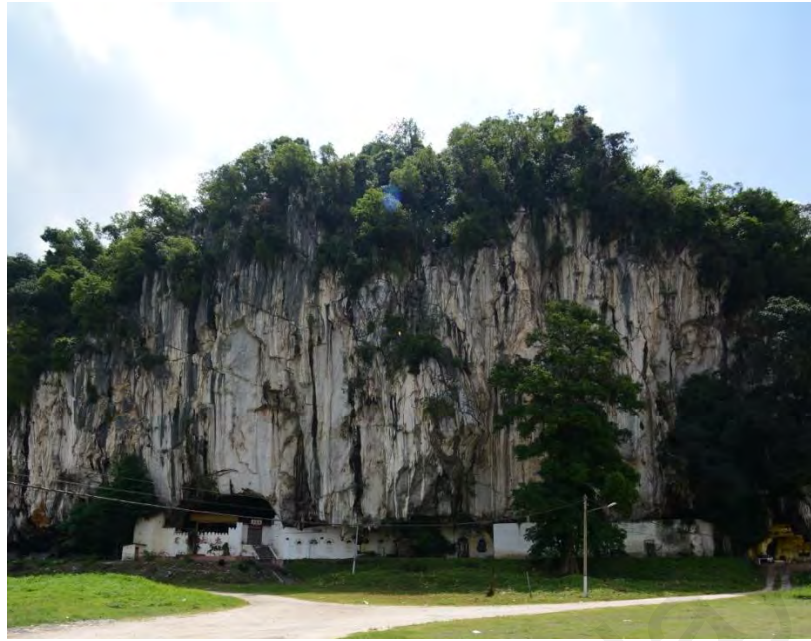
Figure 4.95: Gunung Cheroh limestone hills, the presence of a shelter cave at the base of the limestone hills restricts the manual scanline survey measurement.
