SURFACE MODIFICATION OF BIOMATERIALS TO
REDUCE POLYETHYLENE WEAR IN METAL-POLYMER
CONTACT

DEPARTMENT OF MECHANICAL ENGINEERING
FACULTY OF ENGINEERING
UNIVERSITY OF MALAYA
KUALA LUMPUR

**DISSERTATION SUBMITTED IN FULFILMENT OF
THE REQUIREMENTS FOR THE DEGREE OF MASTER
OF ENGINEERING SCIENCE**

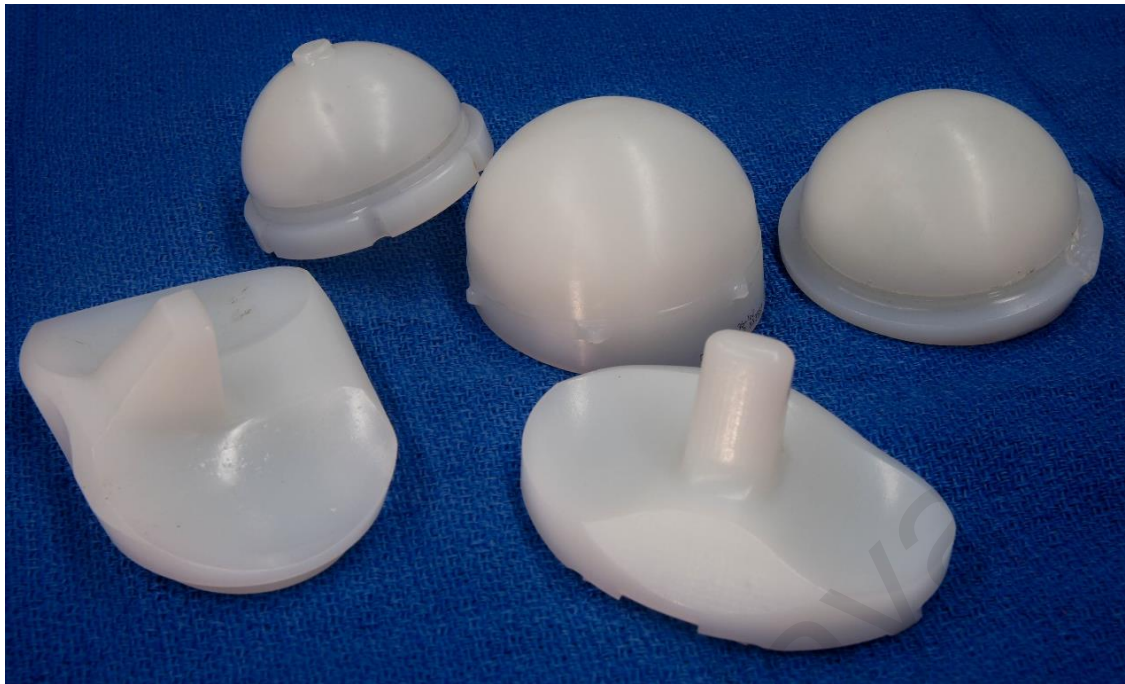
Figure 2.2 Orthopedics UHMWPE Liner (Ansari, F. et al., 2013)

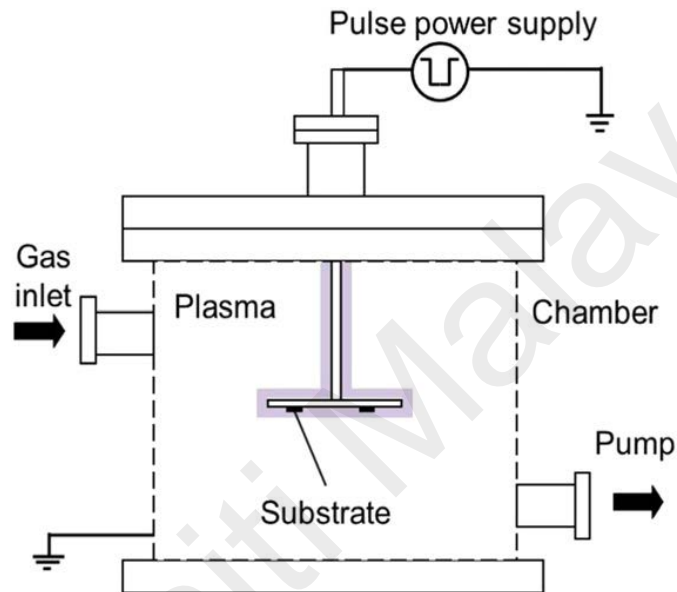
Figure 2.8 Schematic Diagram of Chemical Vapor Deposition machine (Liza et al., 2016)

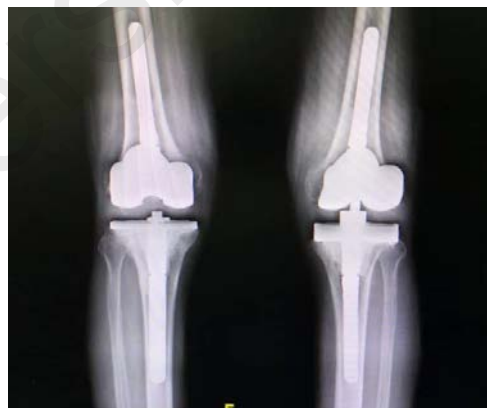
Figure 3.2 Radiographs of (a) the left knee of the patient at presentation 6 months after primary total knee replacement (arrow pointing at osteolysis of bone near the implant), (b) the right knee of the patient at presentation 8 months after primary total knee replacement and (c) postoperative view after the left and right knee post revision knee replacement

Right knee implant is from SIGMA® Knee System and was retrieved 8 months after the previous total knee arthroplasty. The femoral component and the tibial tray were made of cobalt-chromium-molybdenum (CoCrMo); while the tibial insert was made from XLK UHMWPE. Periprosthetic joint infection has been diagnosed after the aspiration diagnosis have been done on the right knee. The x-rays view of the knee is as shown in Figure 3.2.

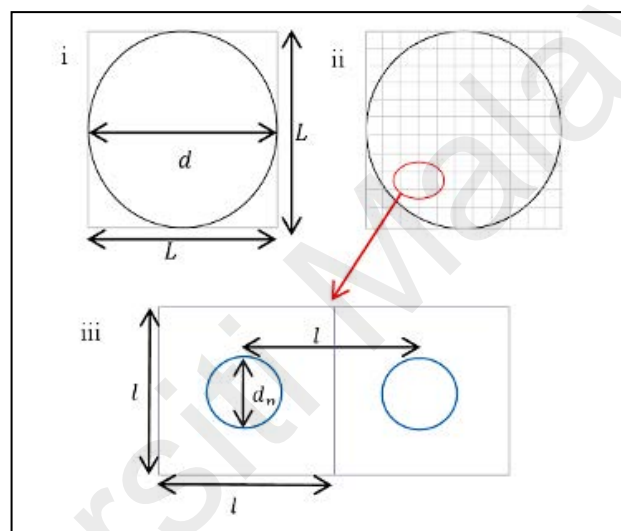
Figure 3.5 Schematic for (i) dimple surface; (ii) imaginary grid and (iii) dimple cell.

Laser Surface Texturing (LST) Machine were used to introduce the dimple pattern on the metal surface. The plate substrates (15mm x 15mm) have been texturized using laser surface texturing (LST) machine. The choice of circular dimples pattern was used as a geometrical pattern due to easy fabrication and low costs. There are three major parameters involved with surface texturing, such as dimple shape, dimple depth and dimple density. For this study, density of the surface texture used is 10%. The schematic diagram of the texture is as shown in Figure 3.5.

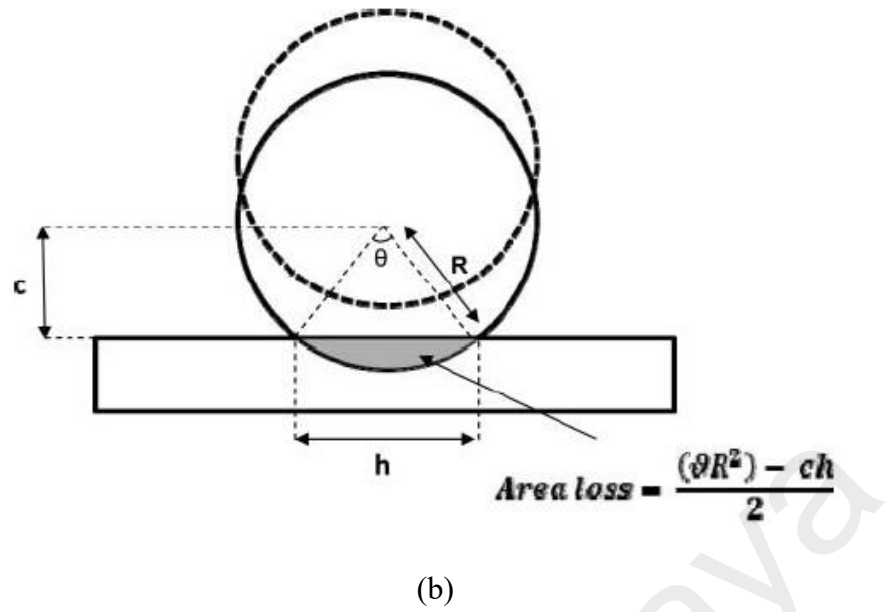
Figure 3.7 Method to Calculate the (a) Volume Loss of the metal substrate (coated, uncoated) and (b) Volume Loss of the UHMWPE Pin

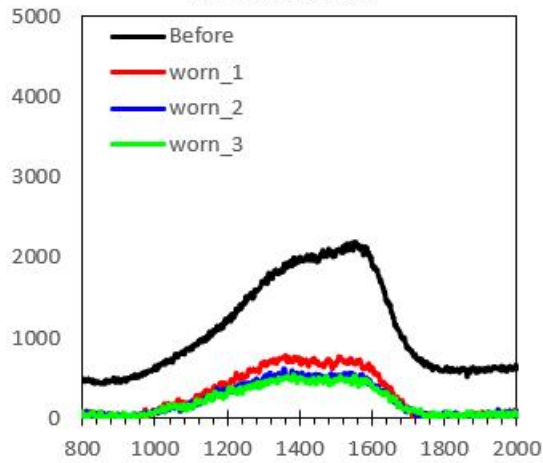
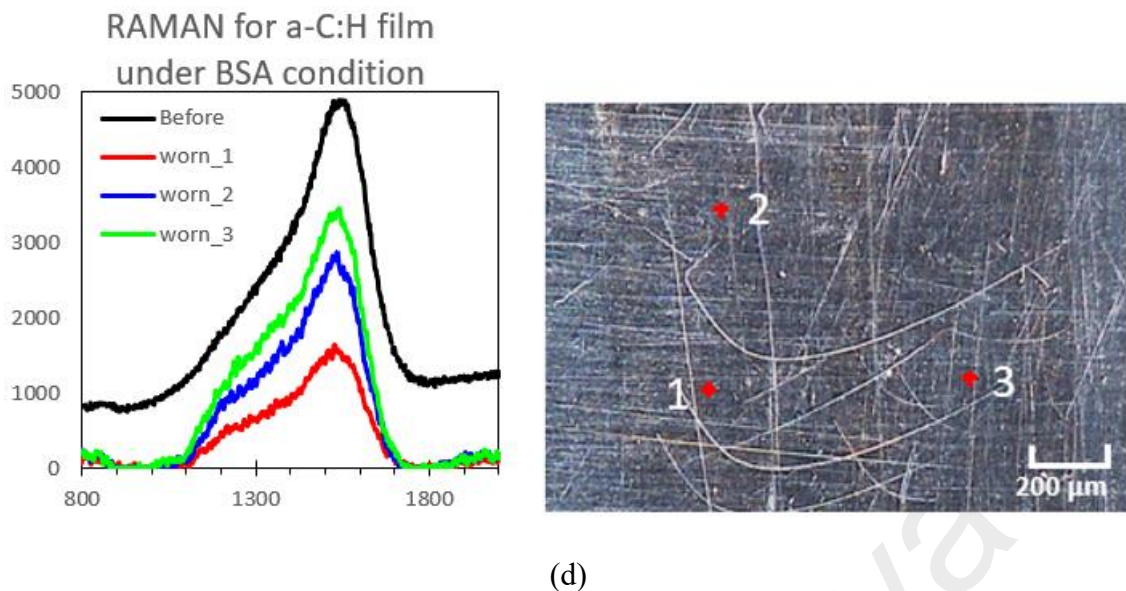
Figure 4.14 RAMAN spectrometer of (a) ta-C and (b) a-C:H film under BS condition; (c) ta-C and (d) a-C:H film under BSA condition.

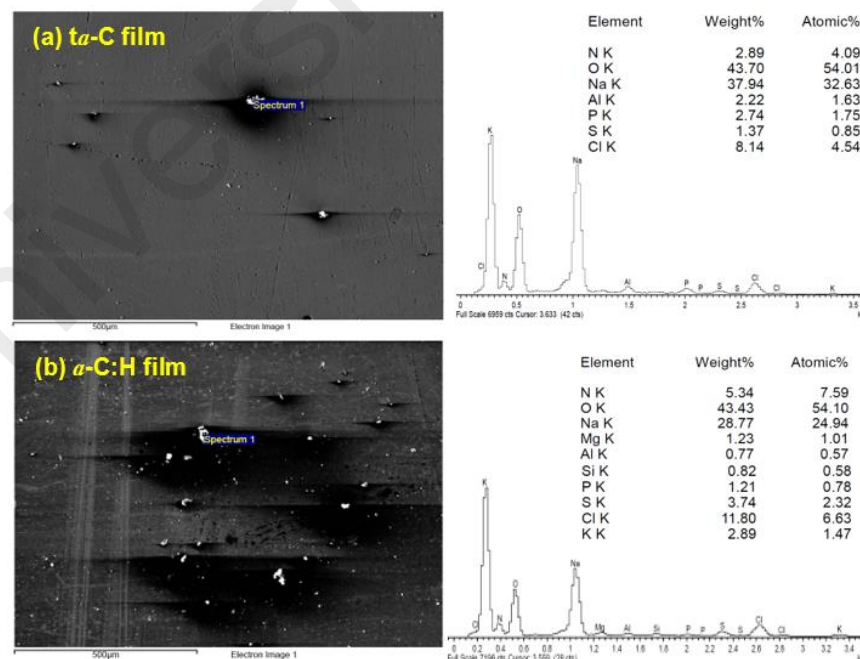
Figure 4.16 SEM-EDS of all films after wear test under BS condition

SEM images of wear traces (Figure 4.16 and 4.17) were obtained for different type of DLC films after wear test. The EDS detection of the white particles on all film surfaces denotes that it contains distinguished elements from DLC film which is N, Cl, Ca and Na elements. These elements were precipitated from diluted BS and BSA solution. In this case, we are able to reveal the adsorption of protein occurs onto those surfaces, which confirm the result from Figure 4.14 and 4.15. There is element of nitrogen (N) which attributed to the amino acid residue or peptide bond in the protein are observed to confirm the occurrence of protein adsorption (Ishihara and Choi, 2010). Figure 4.16(b) and 4.17(b) shows clearly that the adsorbed protein was dominant on a-C:H film surface. The adsorption of protein has a significant effect on the wear behavior. As the mechanism, it was a possibility that there are protective layers through protein adsorption between the contact surfaces. As a result, less wear was observed on worn surfaces of UHMWPE which slides against a-C:H film (Figure 4.13).
