DETERMINING THE DELAY FACTORS FOR
RECONSTRUCTED MEGA-**PROJECT'S PHASES AND**
THE ASSOCIATED CHALLENGES

**THESIS SUBMITTED IN FULFILMENT OF THE
REQUIREMENTS FOR THE DEGREE OF DOCTOR OF
PHILOSOPHY**

**FACULTY OF CIVIL ENGINEERING
UNIVERSITY OF MALAYA
KUALA LUMPUR**

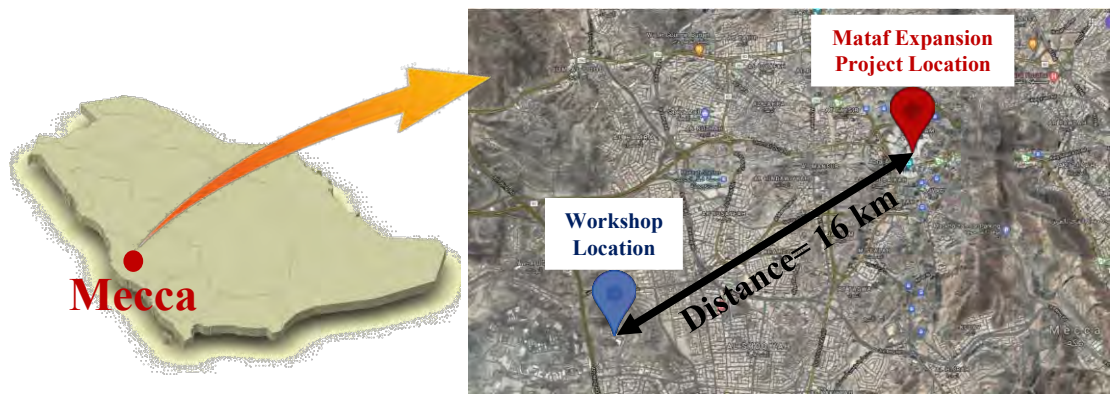
Figure 3.5: Map shows the location and the distance between Mataf Expansion Project and the workshop area

During the mobilization and preparation stage and before starting the actual works at Mataf Expansion project, workshop and storage locations were selected. These locations were around 16 kilo meters away from Mataf Expansion project location as shown in Figure 3.4. In fact, many preparation works had been done in the workshop area to serve the project. Two demolition mockups were built for this project in the workshop area, one for the historical part and the other for the nonhistorical one, as shown in Figure 3.5. In addition, there were two construction mockups, one for the historical part and the other for the nonhistorical one, as shown in Figure 3.6. The aim of these four mockups was to determine the best demolition and construction methods that could be used in the project before starting the actual work on the site.

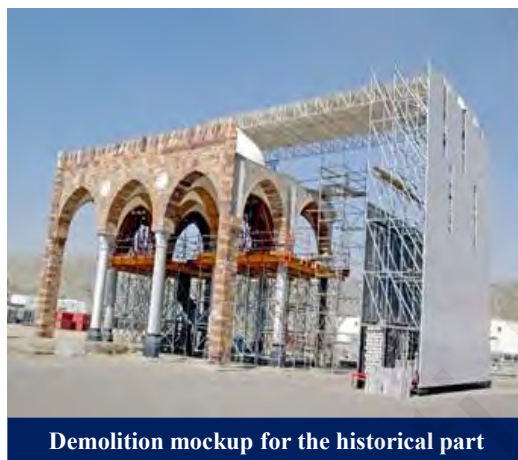
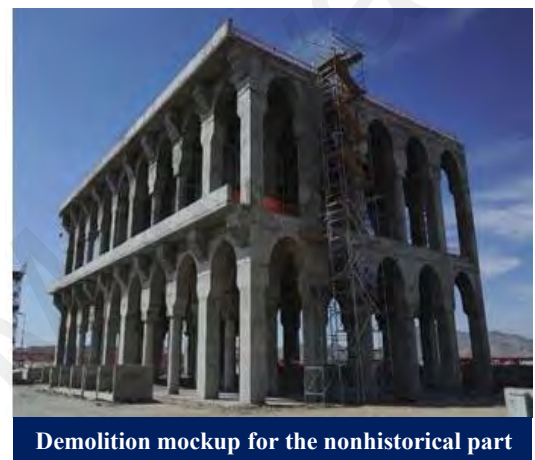
Demolition mockup for the historical part

Demolition mockup for the nonhistorical part

Figure 3.6: Demolition mockup for the historical and nonhistorical parts in the workshop area

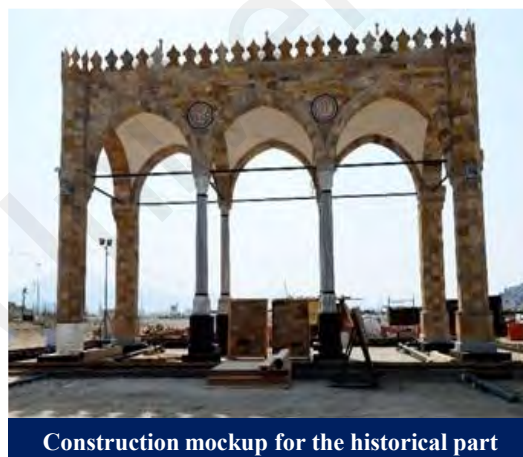
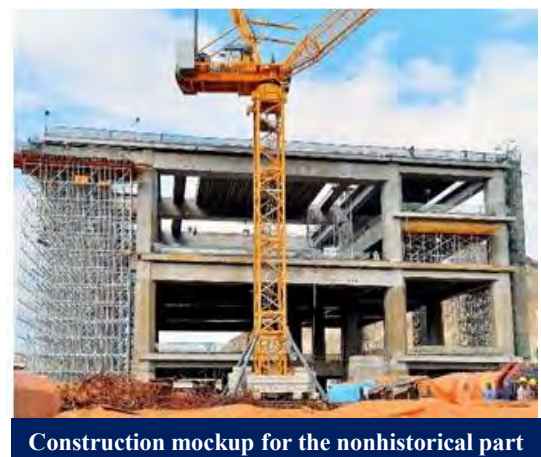
Construction mockup for the historical part

Construction mockup for the nonhistorical part

Figure 3.7: Construction mockup for the historical and nonhistorical parts in the workshop area

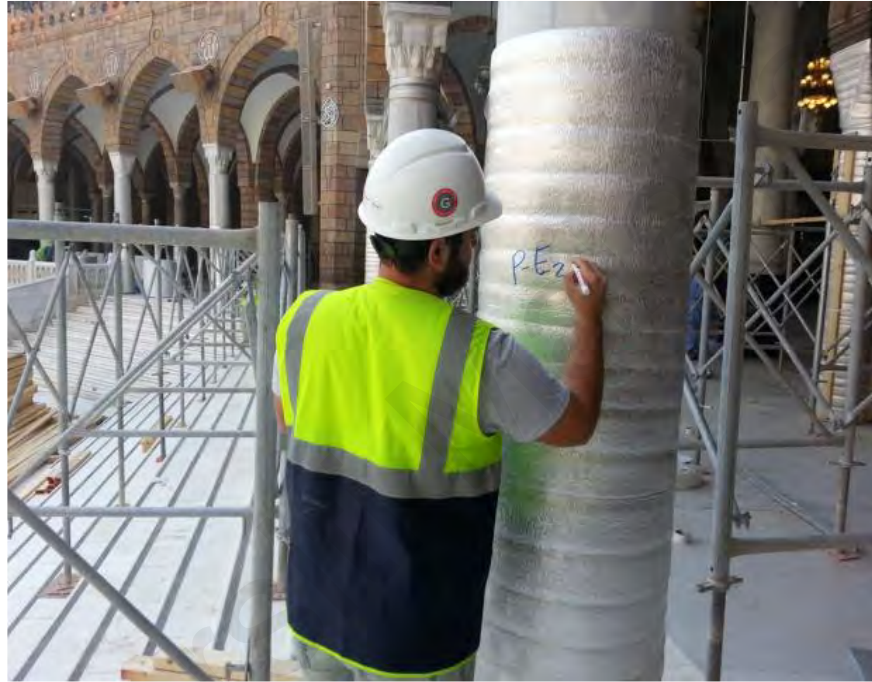
Figure 3.13: Numbering the column body

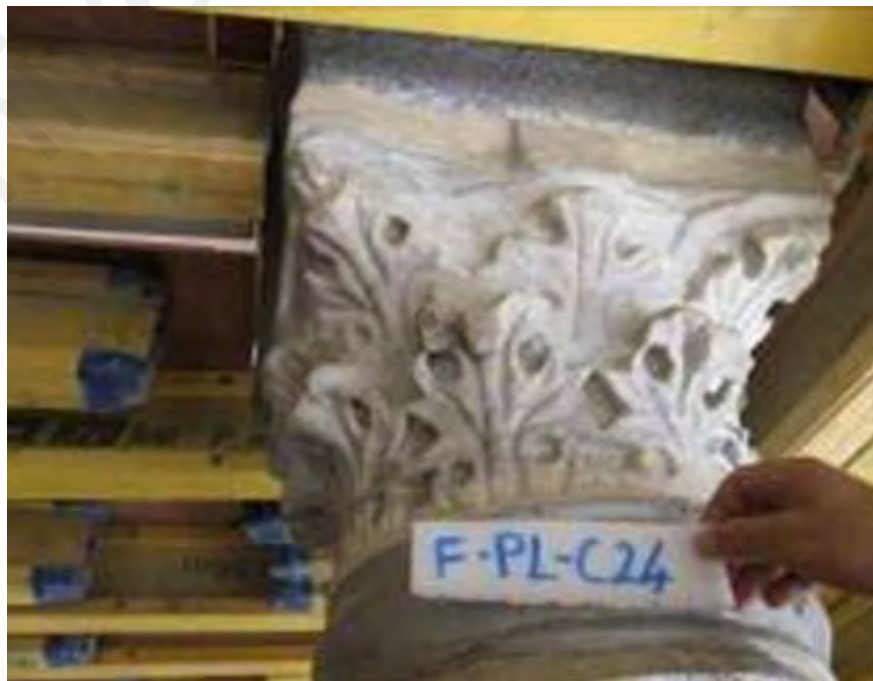
Figure 3.14: Numbering the column capital

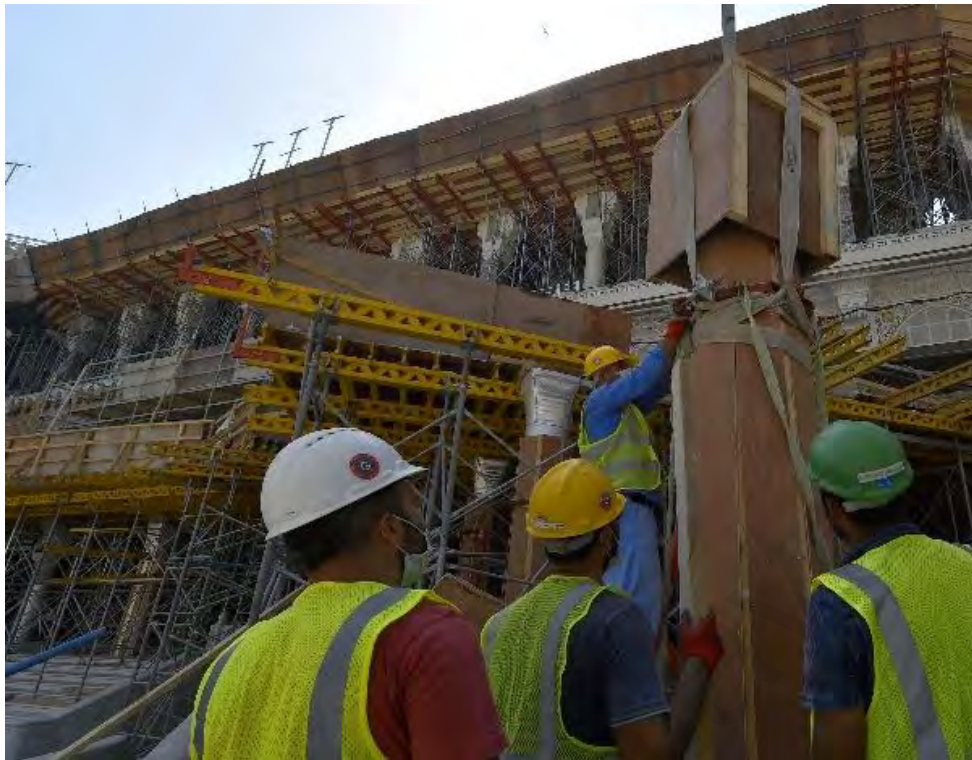
Figure 3.15: Protecting and packing the column

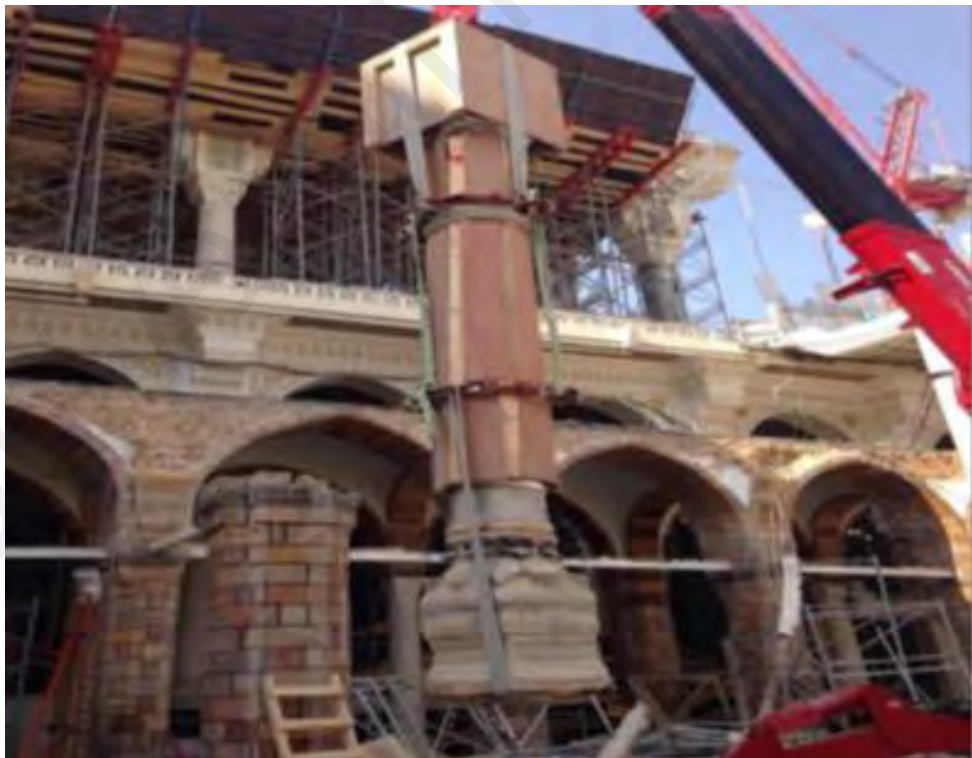
Figure 3.16: Column dismantling

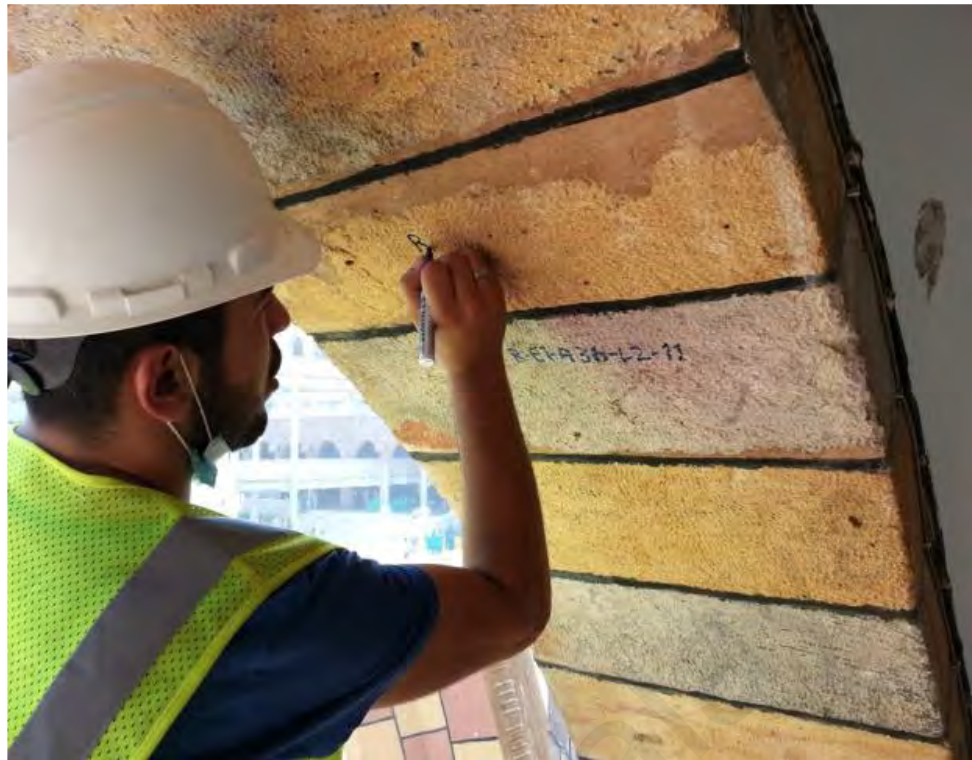
Figure 3.17: Numbering the historical stones

Figures (3.16- 3.19) show the numbering works for the historical stones, the dismantling works for the domes, the facade stones, and the dismantling works for the arches. All the historical stones were protected, packed and transported to the workshop area. The experts mentioned that the previous works required special and manual dismantling tools. In spite of the availability of skilled laborers, however these works required a long period that negatively affected the project duration.

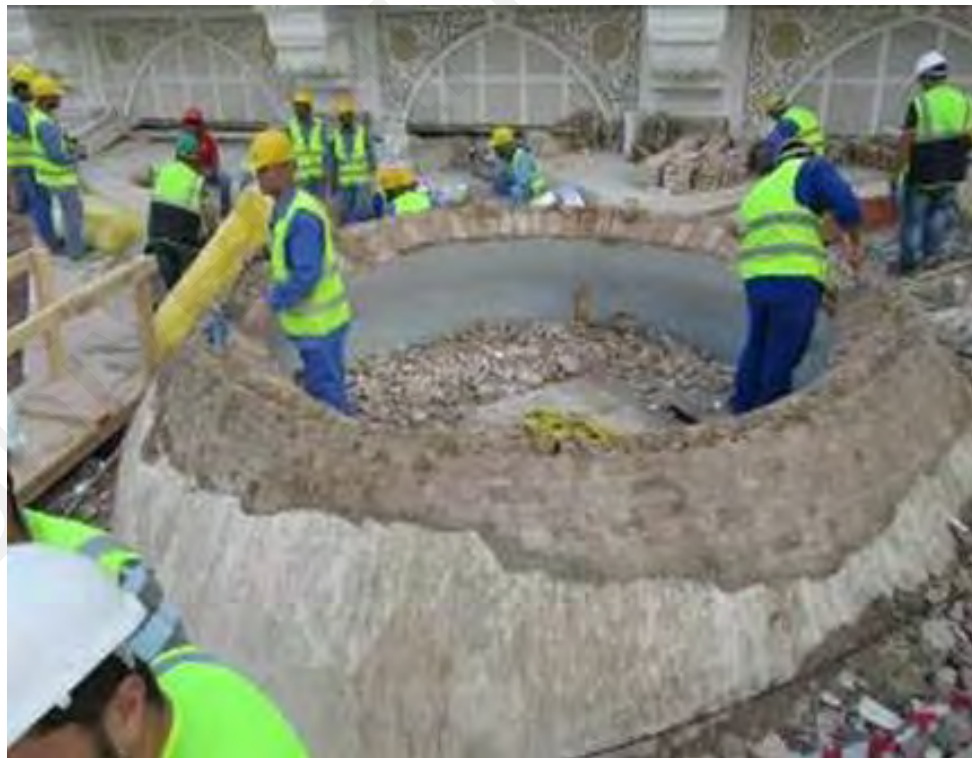
Figure 3.18: Domes dismantling

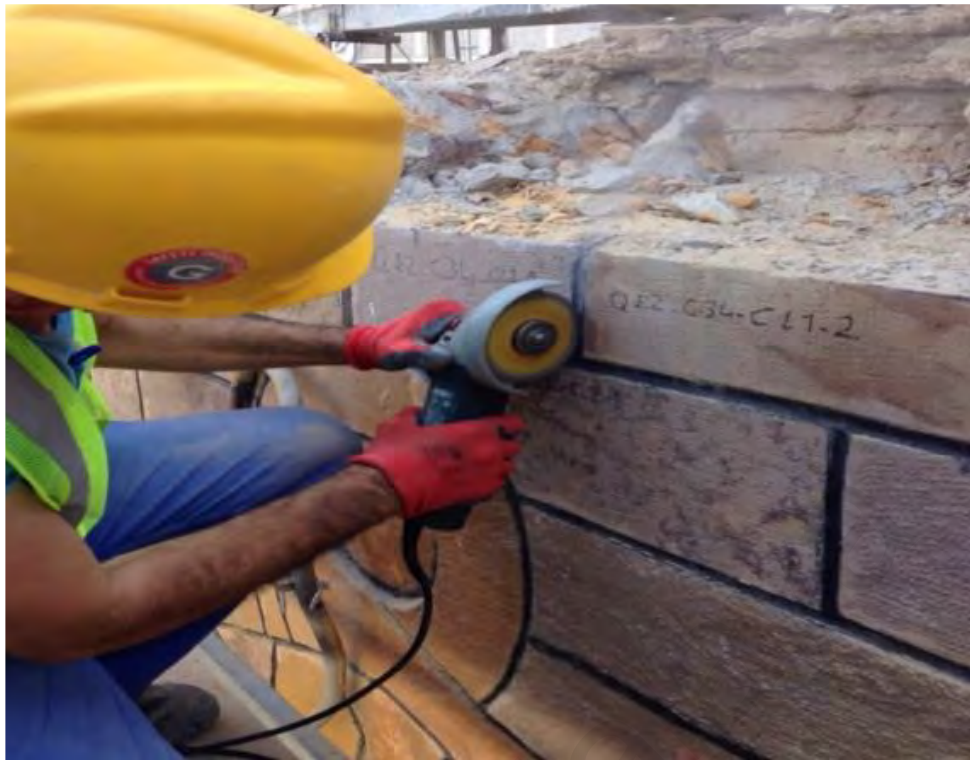
Figure 3.19: Facade stones dismantling

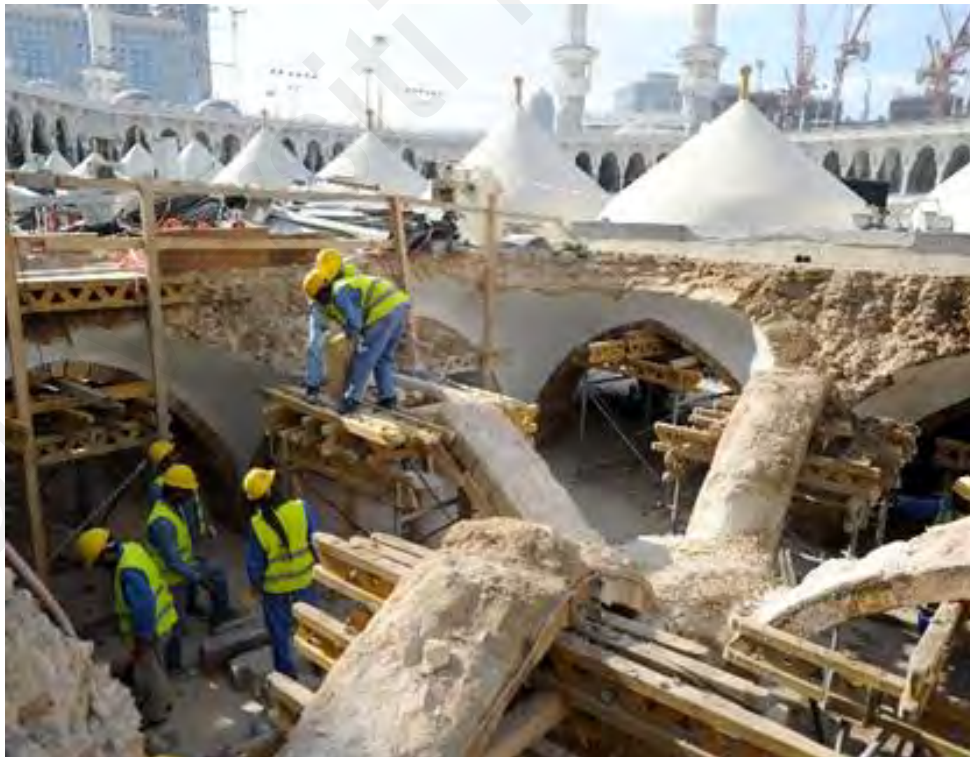
Figure 3.20: Arches stones dismantling

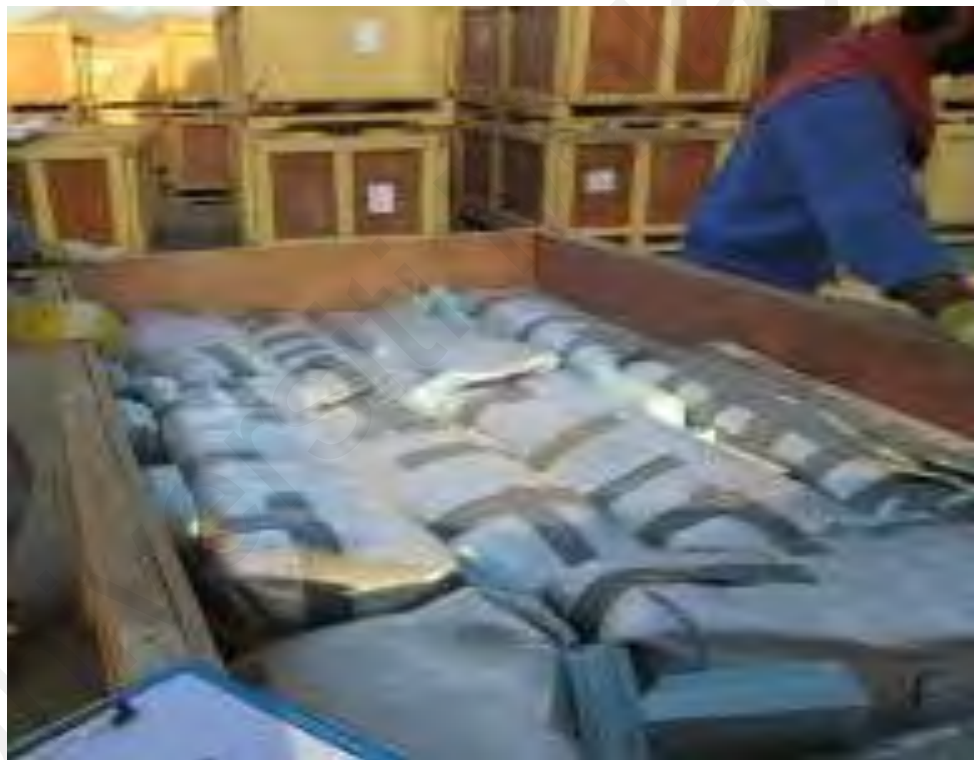
Figure 3.21: Unpacking works

After transferring the historical elements to the workshop area, the next stage works started by unpacking, sorting and arranging the different elements as Figures (3.20-3.23) show the unpacking and sorting works for the stones and the columns.

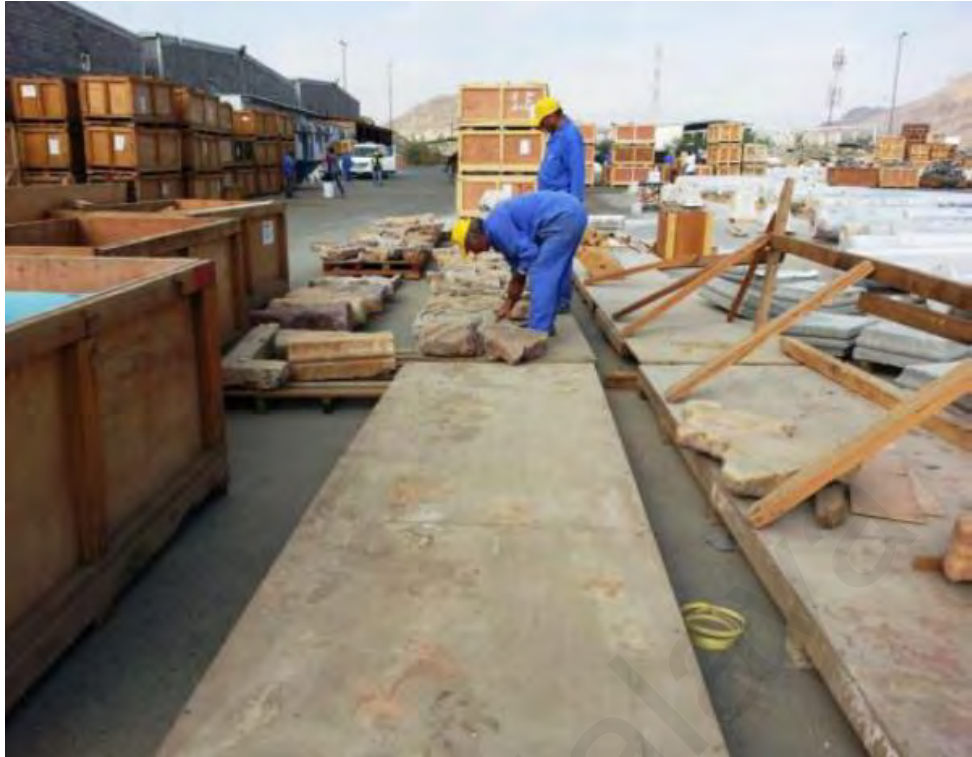
Figure 3.22: Unpacking and sorting works

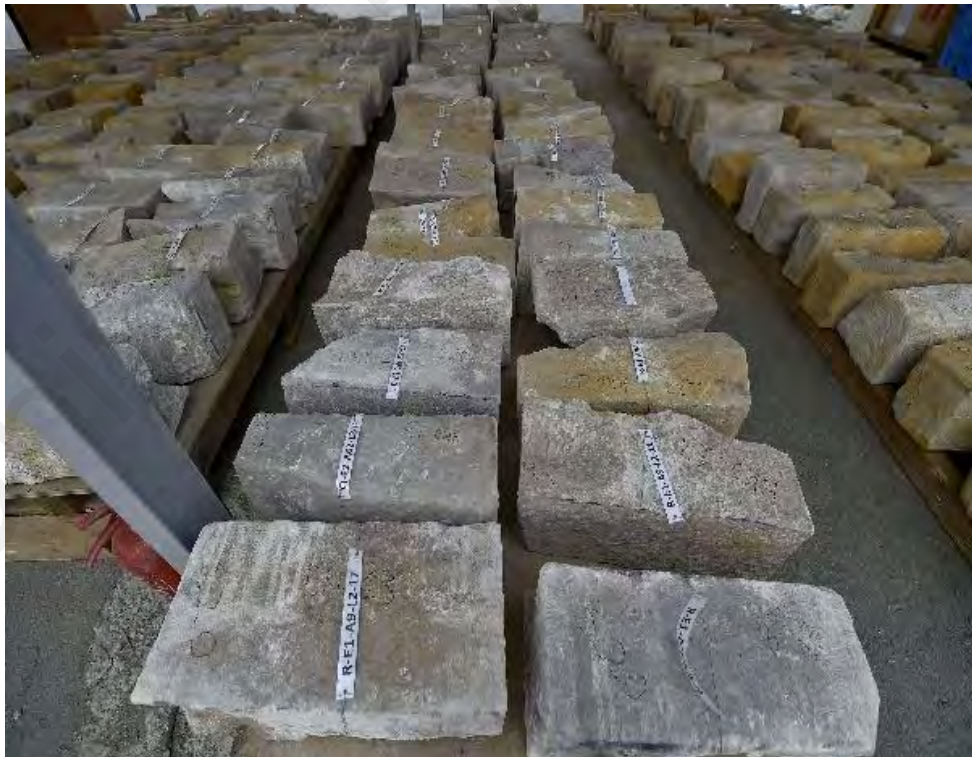
Figure 3.23: Sorting works of the stones

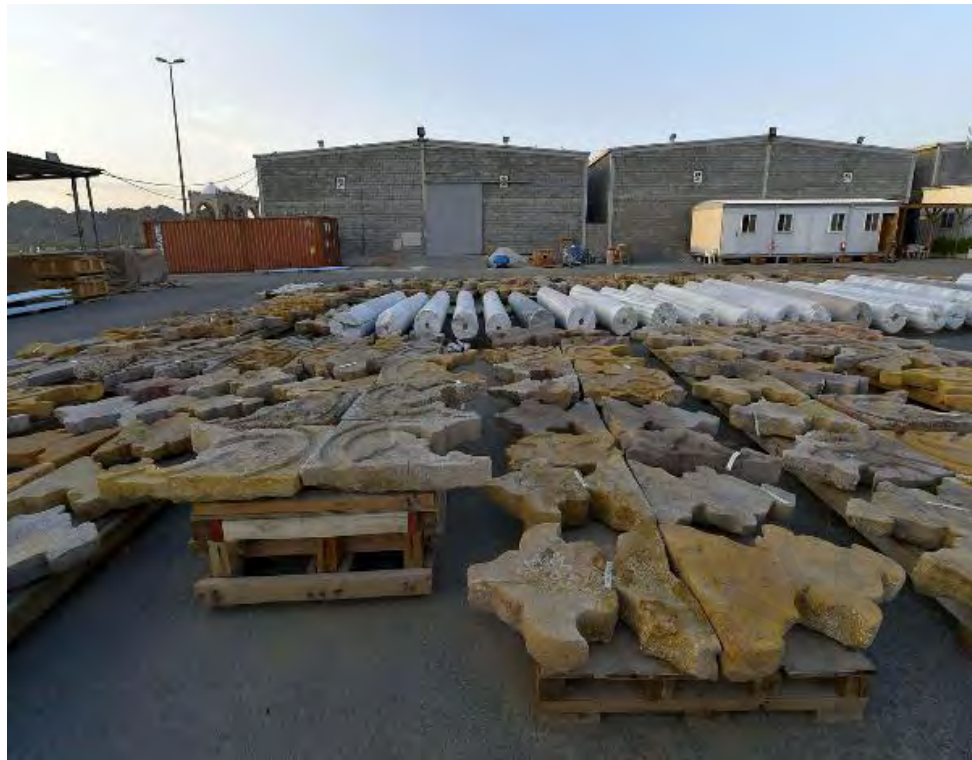
Figure 3.24: Sorting of the stones and Columns

The experts mentioned that the selected items were treated through a series of activities according to the item condition. The first activity was the cleaning works which divided into two steps. The first step was the surface cleaning by using soft brushes and small spatulas, while the second one was the deep cleaning by using the chemical materials in order to remove the grease and oil stains, as well as cleaning the joints and spaces as shown in Figures 3.24 and 3.25.

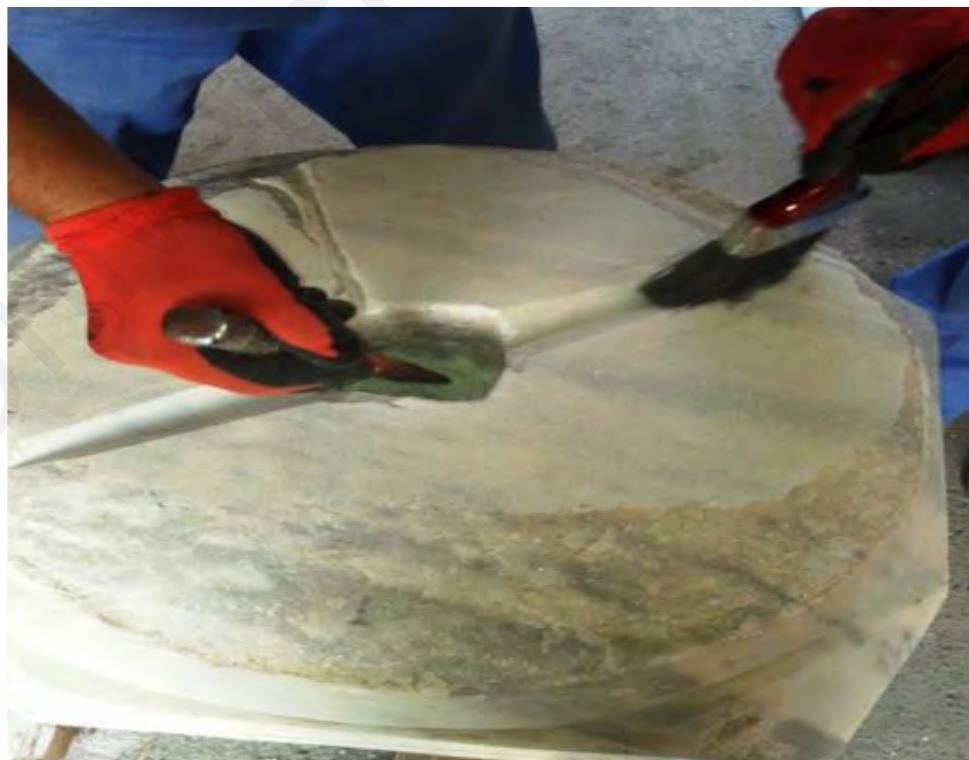
Figure 3.25: Surface cleaning of a column base

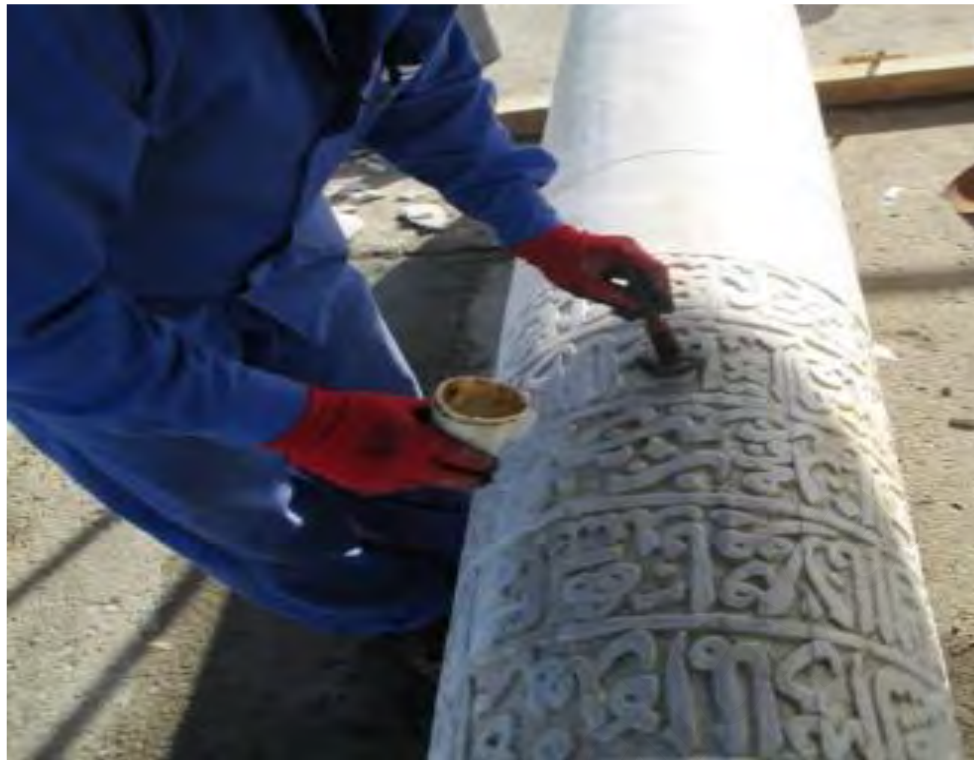
Figure 3.26: Deep cleaning of a column body

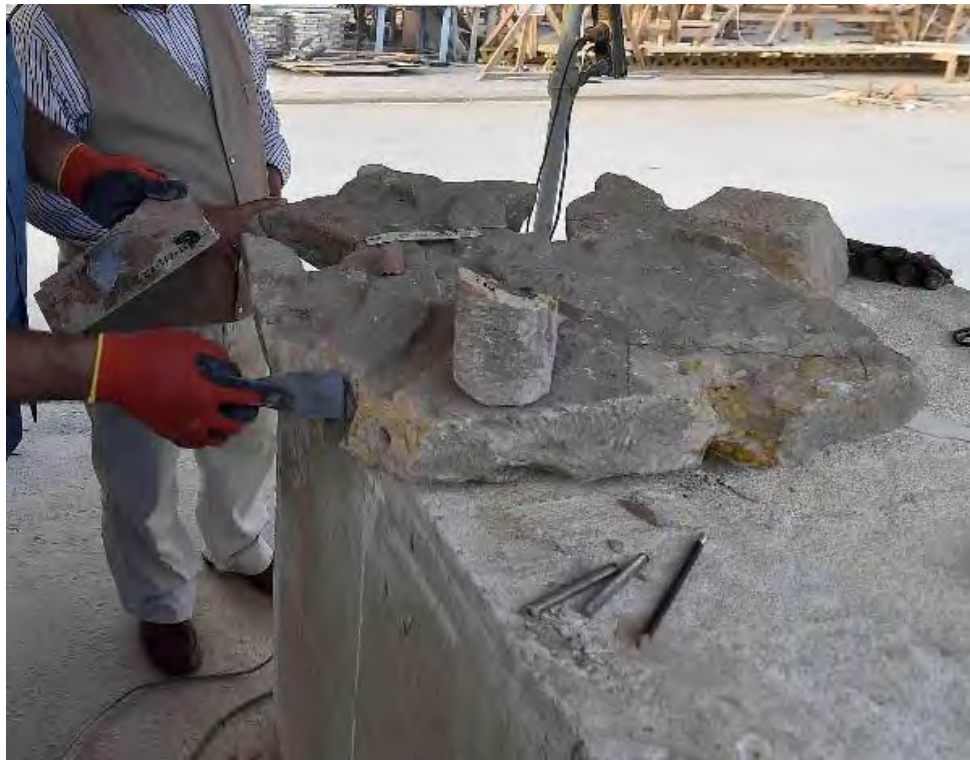
Figure 3.27: Chemical substances applied

Actually, sometimes the joining pieces could be from the same historical item, as shown in Figures (3.26- 3.29).

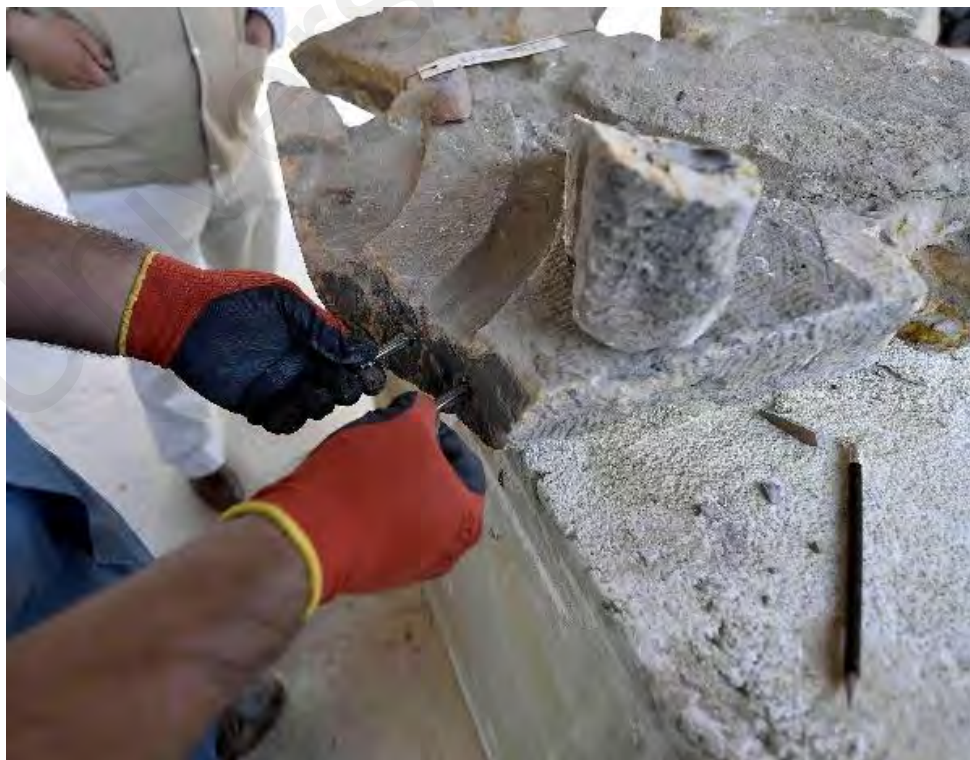
Figure 3.28: Steel anchors utilized

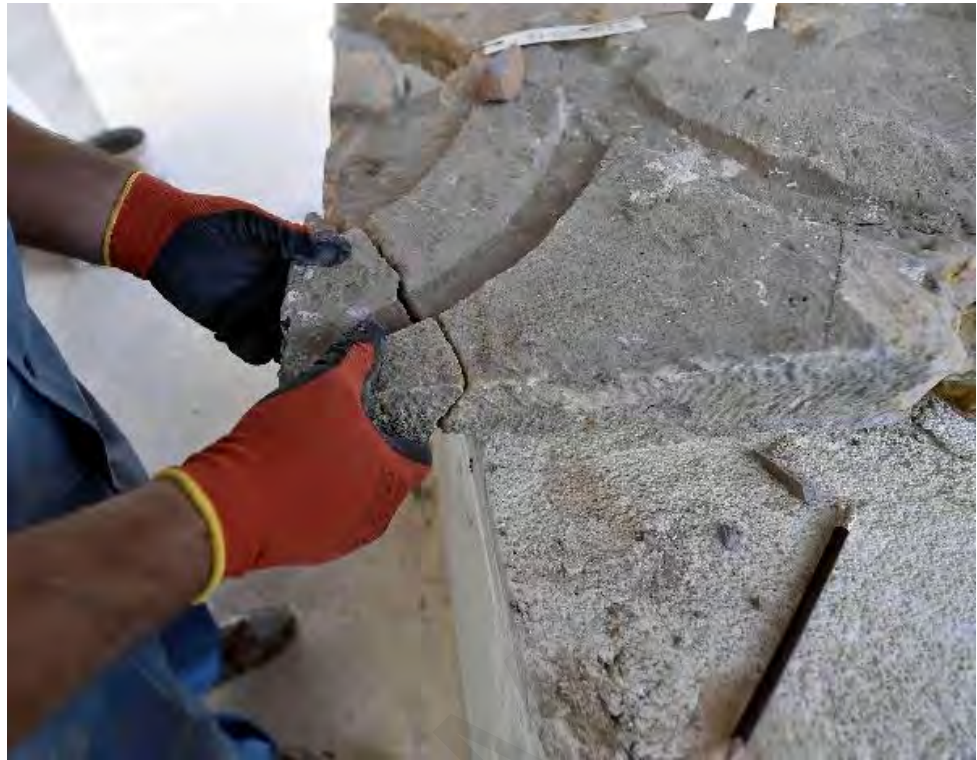
Figure 3.29: Stone pieces joined

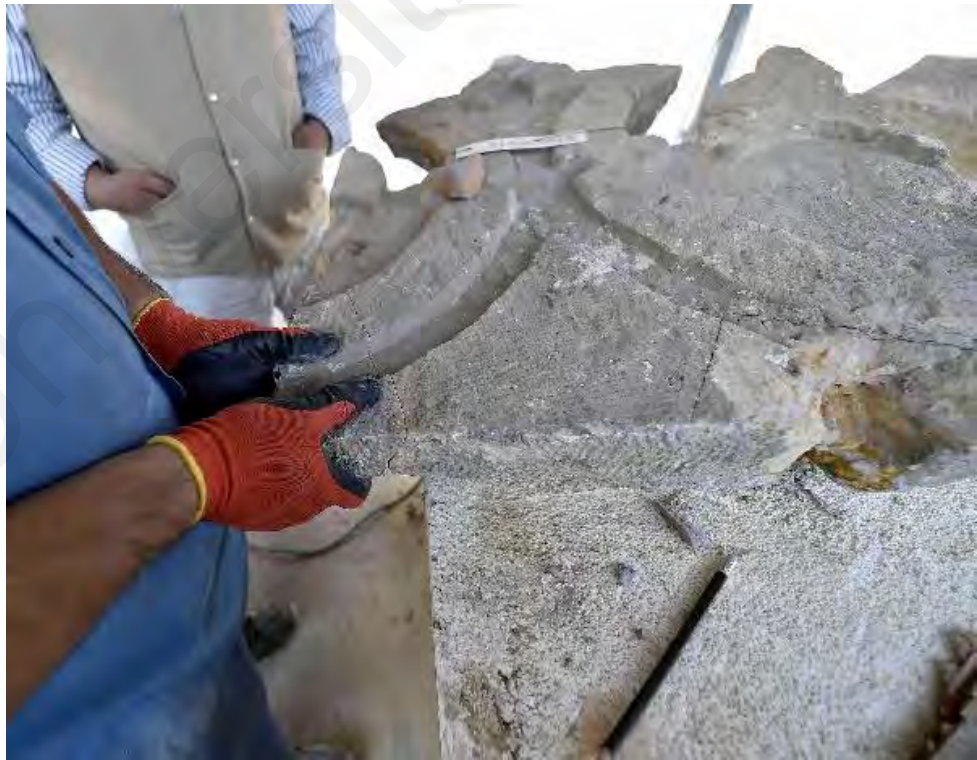
Figure 3.30: Stone shape after restoration

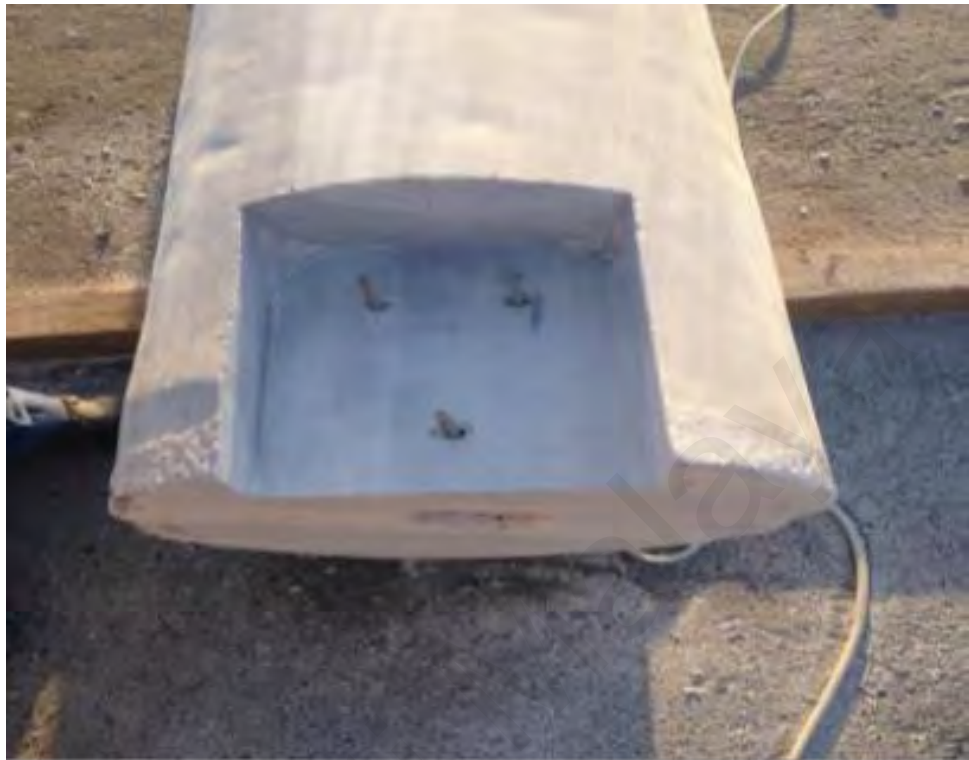
Figure 3.31: Chemical substances and anchors applied

However, sometimes for restoration works a new piece of the same nature of the historical item could be joined as shown in Figures (3.30- 3.31).

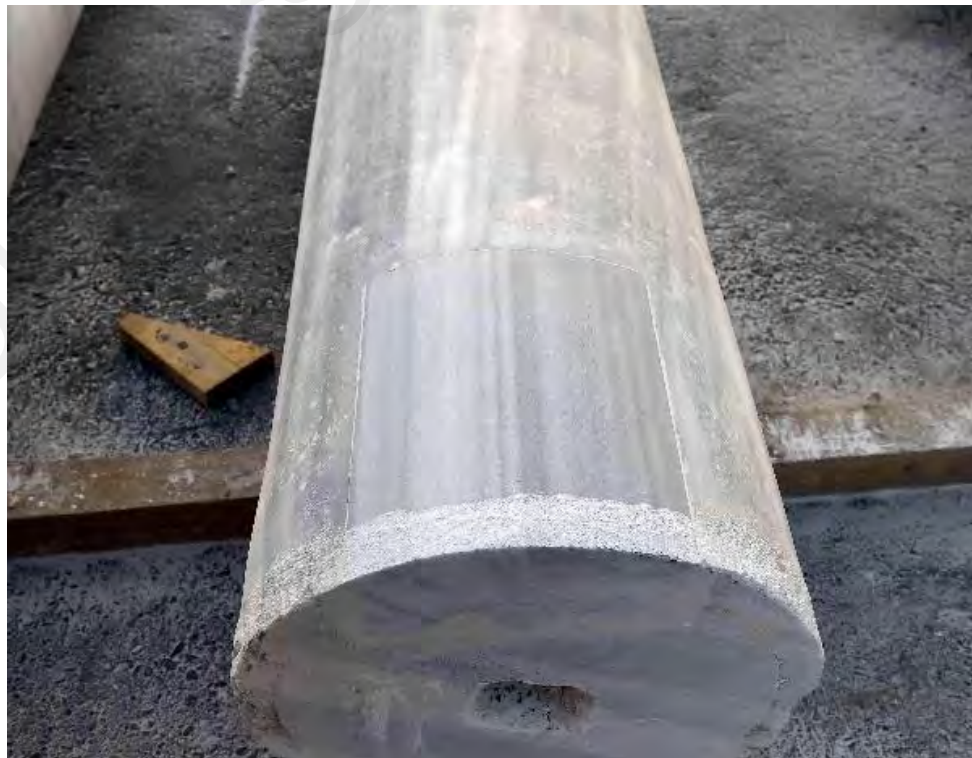
Figure 3.32: Marble column after restoration

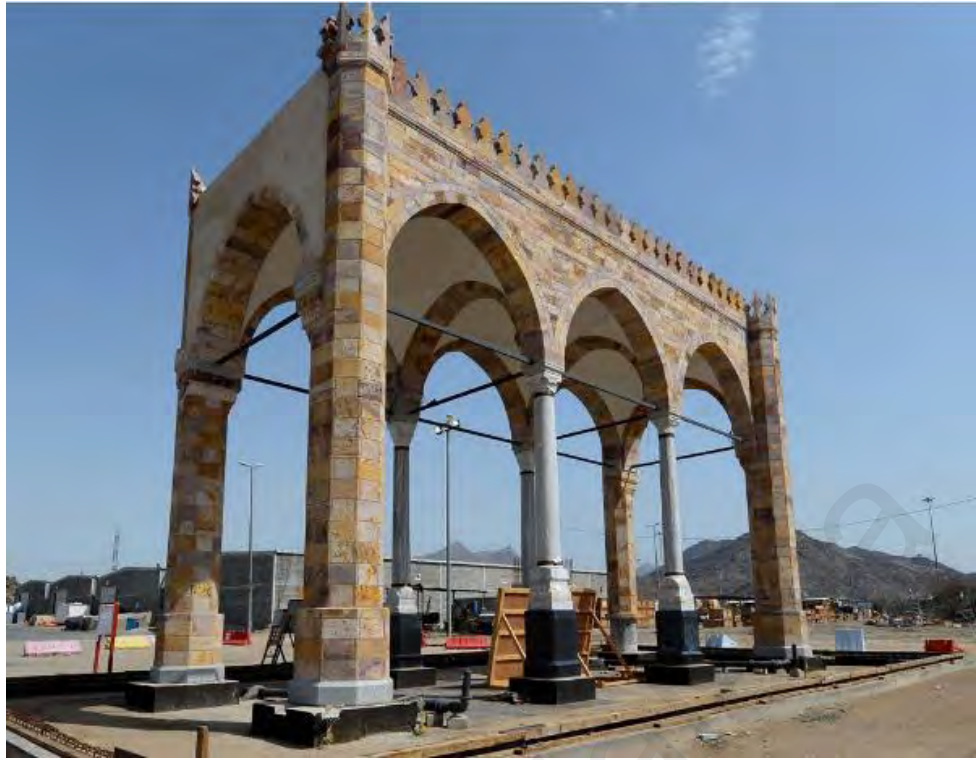
Figure 3.34: New historical building mockup

Moreover, the new design approval from all the related parties before proceeding with the reconstruction works at site, was subject to the building of a mockup showing all the details related to the structure, mechanical, plumbing and electrical design. In fact, the execution of the mockup was the final outcome of all the above mentioned stages and challenges, as mentioned by the experts in the project. It was also the penultimate step preceding the reconstruction of Old Riwaq at the project site. In addition, during the interviews many purposes for the mockup were mentioned such as: testing the best and fastest methods for the reconstruction works, especially the formwork systems and the required equipment, testing the design constructability and conflicts, showing the shape of the restoration elements after the installation works and the final integration form of the project, testing the sustainability and the safety requirement for the new reconstruction building and obtaining approvals from the consultant and other entities in order to start the actual reconstruction works at site. Figures (3.32-3.34) show the three-dimensional model for the new design and the new historical building mockup.

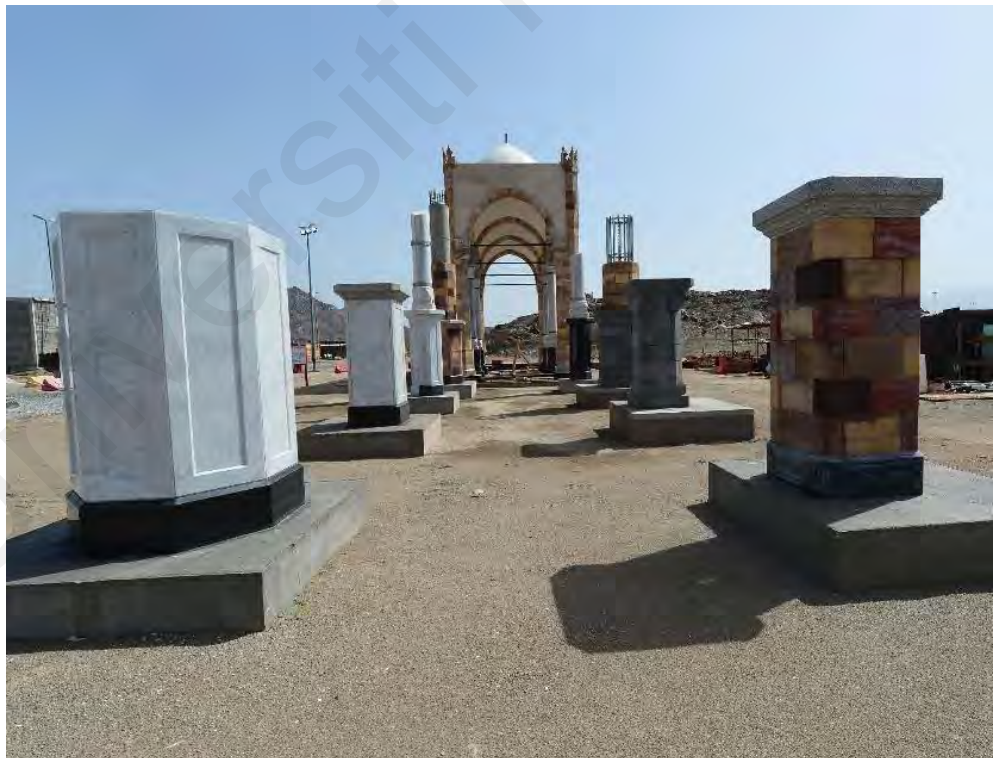
Figure 3.35: Mockups for column pedestals stone cladding

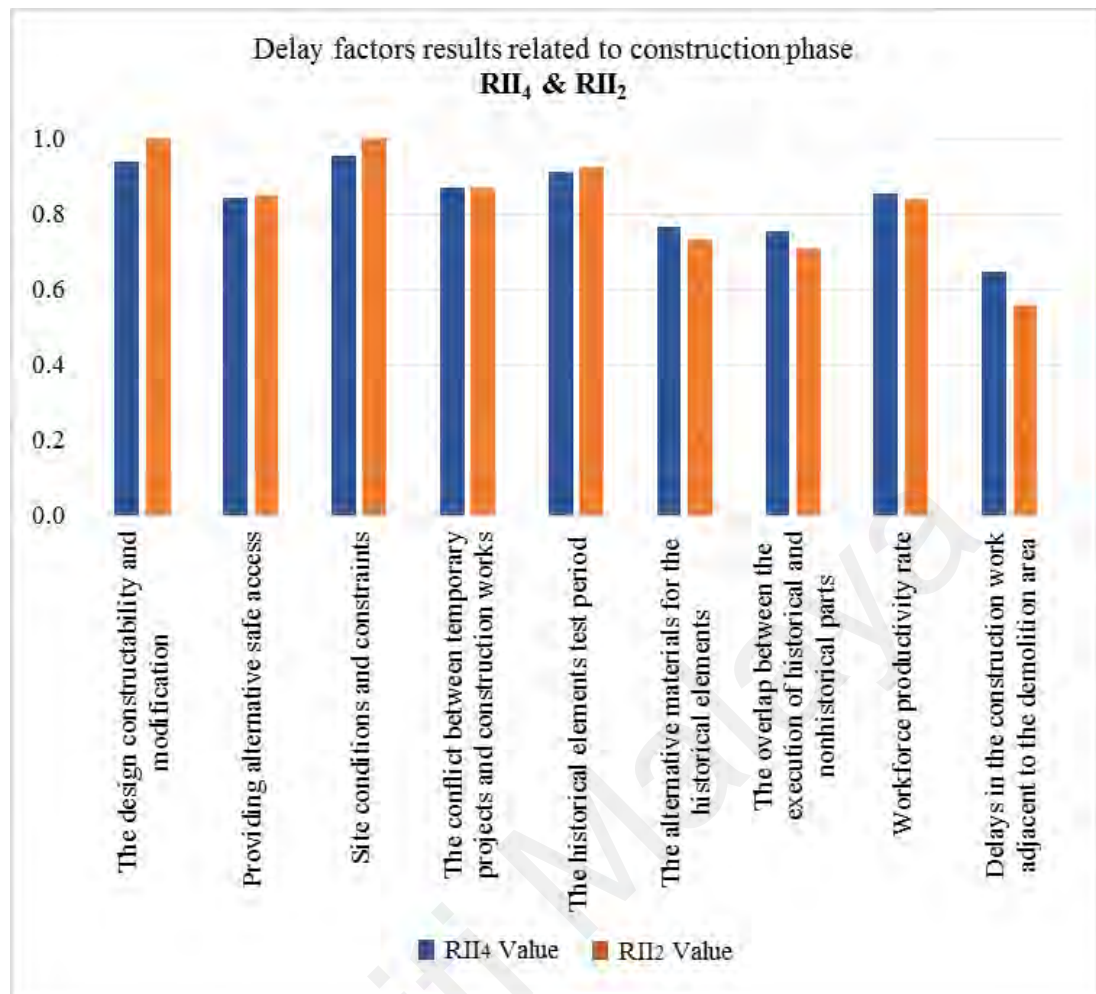
No.	Delay Factor	RII ₄ Analysis Results		RII ₂ Analysis Results	
		Value	Rank	Value	Rank
1	The design constructability and modification	0.941	2	1.000	1
2	Providing alternative safe access	0.841	6	0.849	4
3	Site conditions and constraints	0.954	1	1.000	1
4	Overlap between temporary projects and construction works	0.871	4	0.871	3
5	Historical elements test period	0.911	3	0.925	2
6	Alternative materials for the historical elements	0.766	7	0.731	6
7	Overlap between the historical and nonhistorical parts	0.753	8	0.710	7
8	Workforce productivity rate	0.855	5	0.839	5
9	Delays in the building works next to the demolition area	0.648	9	0.559	8

Figure 4.2: Graphical representation of RII₄ and RII₂ that affect the construction phase

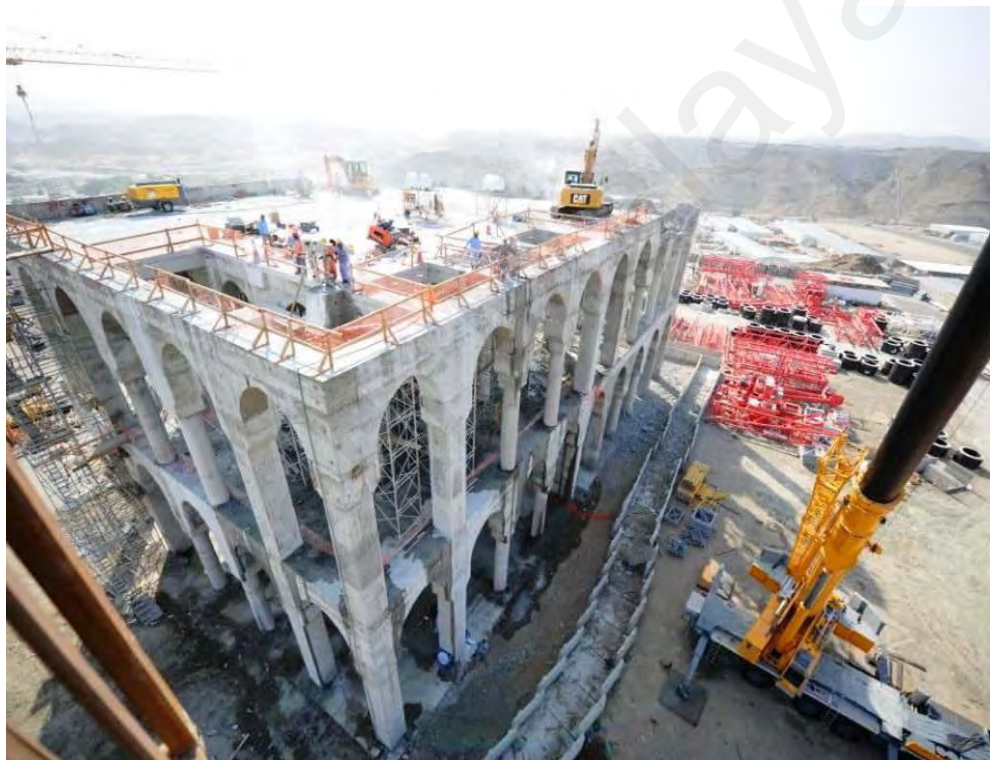
($RII_2 = 1$, Rank = 1) and with respect to the impact on the construction phase duration according to Table 4.11 ($RII_4 = 0.954$, Rank = 1) and ($RII_2 = 1$, Rank = 1). There was a big difference between the site conditions during demolition and construction mockups, which were built in special workshop, and site conditions during work on the project. This difference resulted from a set of points. Firstly, the mockups could be easily accessed and worked on from all sides, whereas the project site is not easily accessible, so work is restricted to specific aspects, as shown in Figures (4.4 - 4.5).

Figure 4.4: Demolition mockup for accessibility

Figure 4.5: The project site itself, showing it is not easily accessible

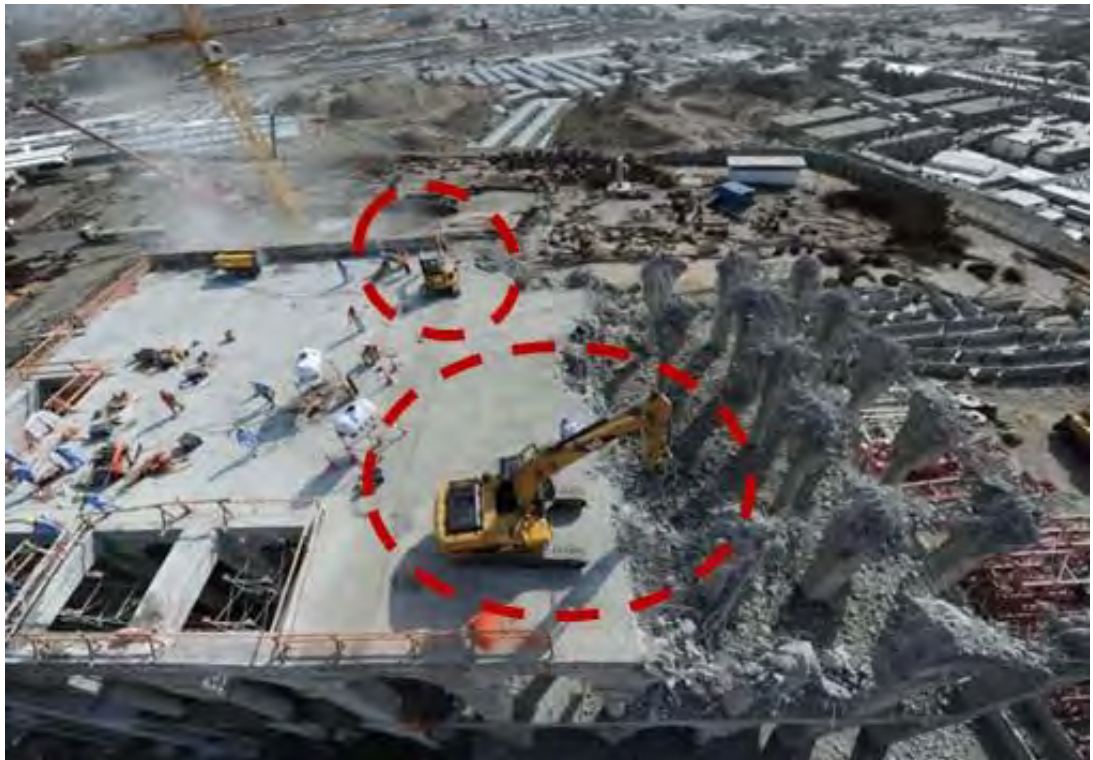
Secondly, there are no restrictions on the equipment size used for demolition and construction within the workshop area, where demolition and construction mockups were built due to the availability of wide tracks and entrances. However, this is not the case on the actual project site, where there are restrictions on large equipment due to the narrow tracks. This means that equipment, demolition debris, and building materials are often transported using tower cranes, as shown in Figures (4.6-4.7).

Figure 4.6: Large (in the bottom red circle) and small (in the top red circle) machinery at the demolition mockup

Figure 4.7: Small machinery (shown in the red circles) at the project site
