DETERMINING THE DELAY FACTORS FOR
RECONSTRUCTED MEGA-**PROJECT'S PHASES AND**
THE ASSOCIATED CHALLENGES

**THESIS SUBMITTED IN FULFILMENT OF THE
REQUIREMENTS FOR THE DEGREE OF DOCTOR OF
PHILOSOPHY**

**FACULTY OF CIVIL ENGINEERING
UNIVERSITY OF MALAYA
KUALA LUMPUR**

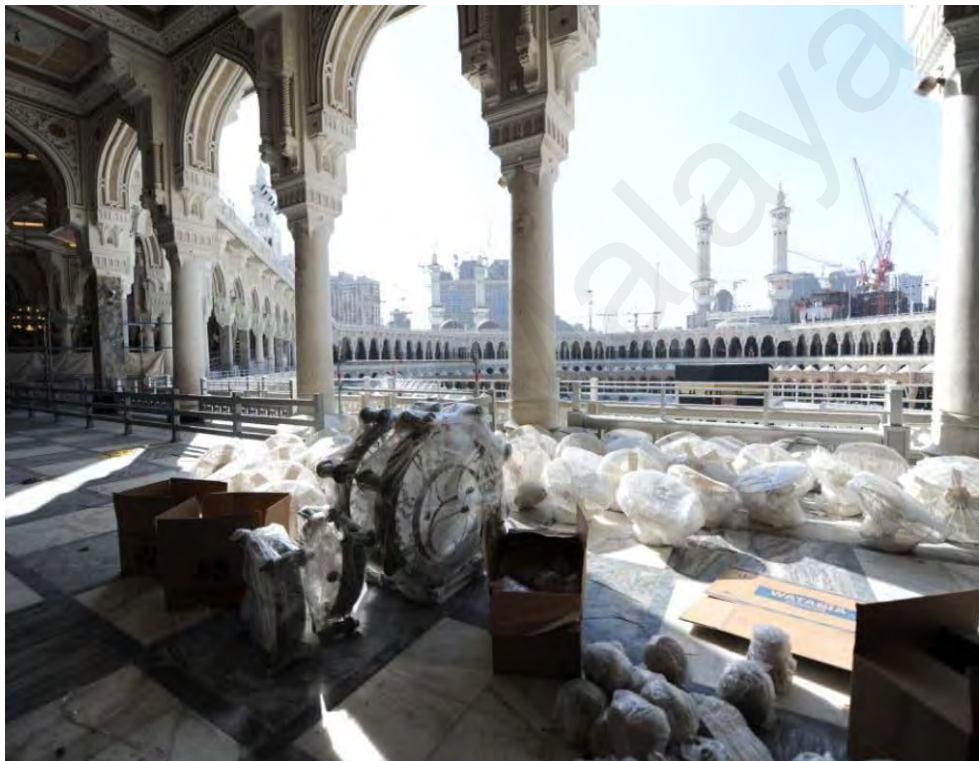
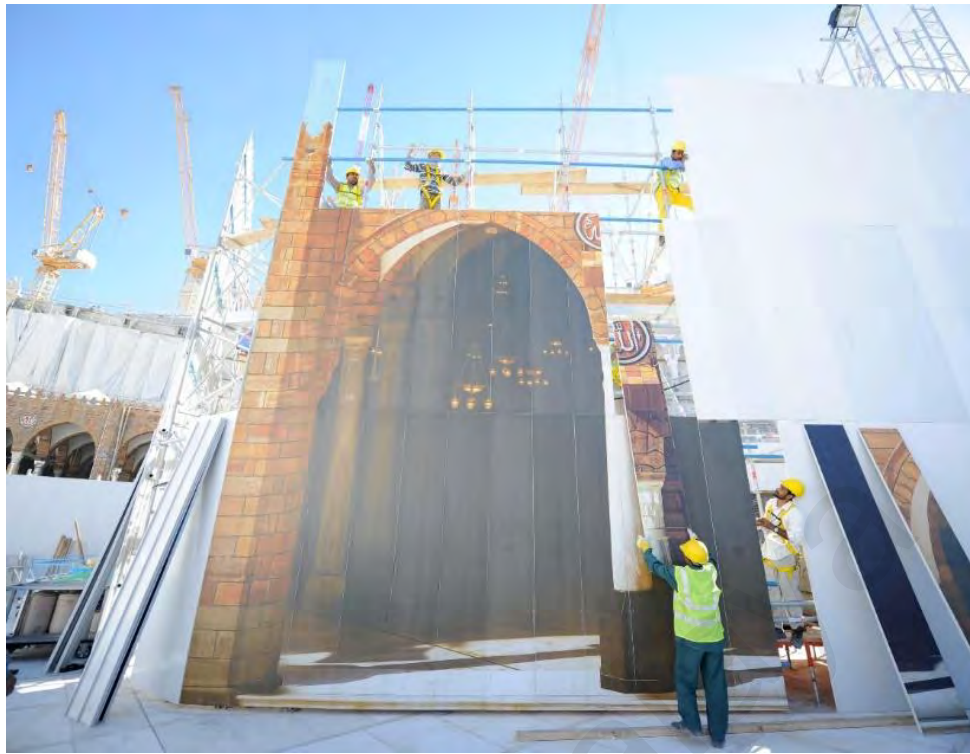
Thirdly, the mockup area is completely closed off to visitors, which allows work to continue without interruptions or special safety requirements. Fourthly, demolition work started immediately on the mockup without the need for any mobilization or preliminary work. Unlike the project site, where demolition work did not start until the following works, which are historical documentation, dismantling and packaging holdings, and building fences that mimic the project shape are done as it is shown in Figures (4.8-4.9)

Figure 4.8: Dismantling and packaging holdings

Figure 4.9: Temporary fences mimic the project shape

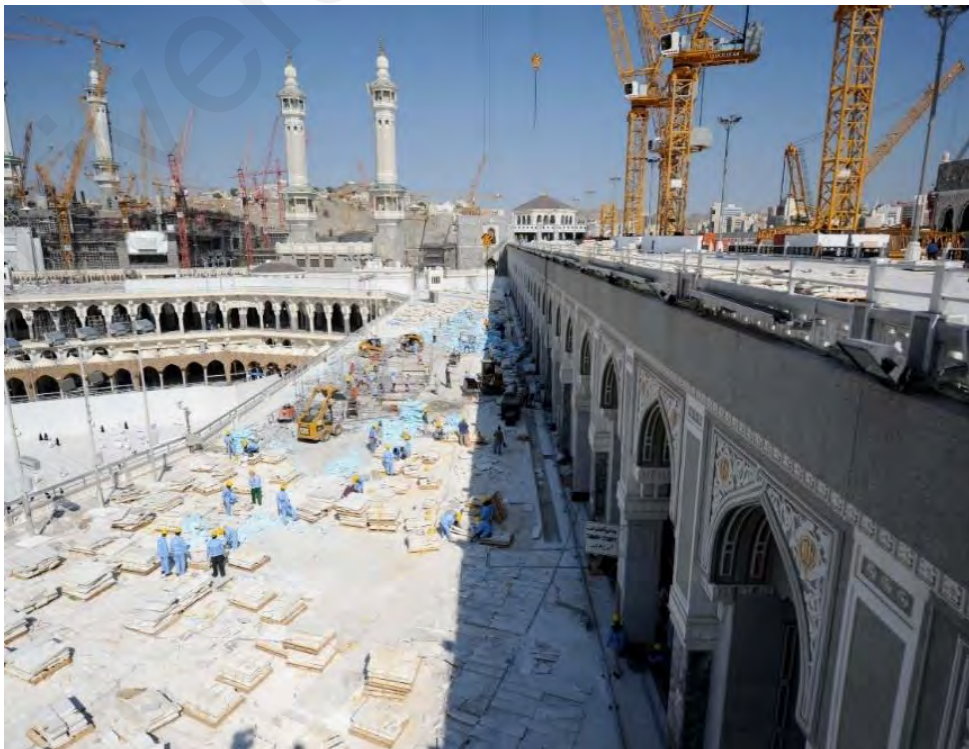
Fifthly, cutting the roof slabs for the mockup roof began directly. However, in the project site the slabs demolition and cutting could not start until the marble and roofing system materials were removed from the roof, as shown in Figure 4.10.

Figure 4.10: Marble and roofing system material removal

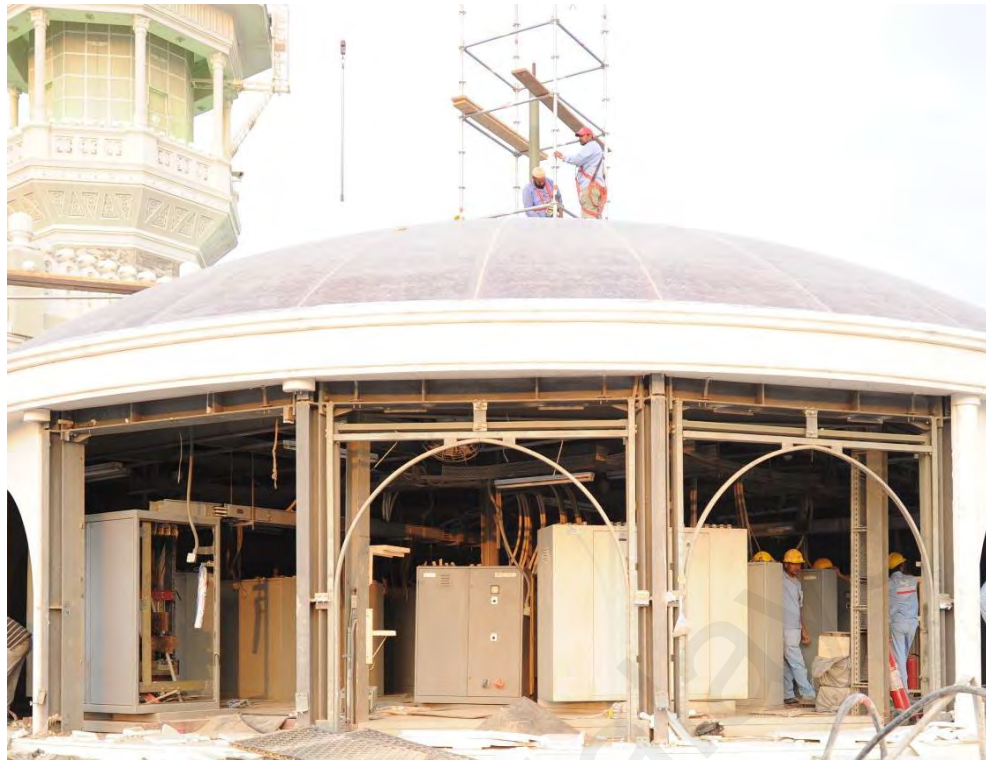
Rerouting works for all electrical and mechanical utilities factor ranked second in terms of influence on the overall project duration, according to Table 4.12 ($R_{II4} = 0.941$, Rank = 2) and ($R_{II2} = 1$, Rank = 1), and it came second in relation to its impact on the demolition and dismantling phase duration, according to Table 4.10 ($R_{II4} = 0.957$, Rank = 2) and ($R_{II2} = 1$, Rank = 1). There was a consensus on this factor, because all the electrical and mechanical services and systems were operating in integrated systems and continuous loops. For these systems to continue working properly and safely in the rest of the project phases without any disruption, these services had to be transformed and alternative routes found. This ensures that the services work properly and with the required efficiency. In fact, the transfer of electromechanical services is not limited to diverting the routes of these utilities, but also includes rebuilding new service rooms outside the demolition areas and equipping them with all the required equipment and control systems. These rooms are tested and operated temporarily in order to ensure their effectiveness and performance, before handing them over to the authorized entities to obtain permission for removing the old rooms, as shown in Figure 4.11. Service transfer takes time and delays the demolition work and, as a result, the project as a whole.

Figure 4.11: Rerouting work for an electrical service room

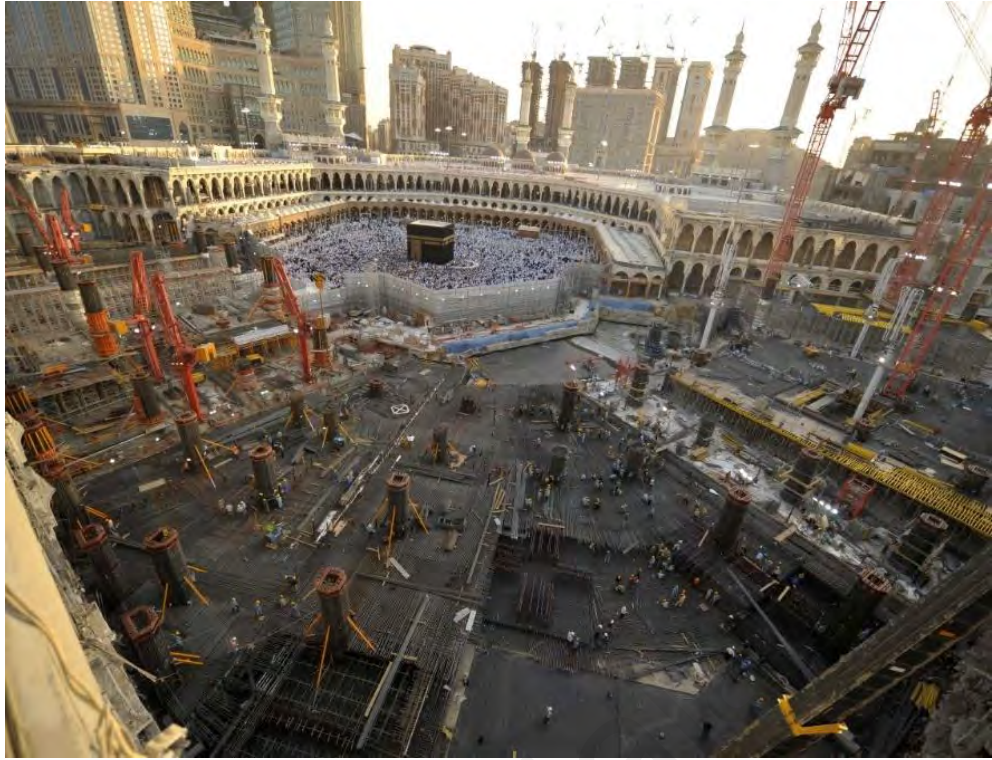
The design constructability and modification factor came third in terms of the impact on the overall project duration, according to Table 4.12 ($R_{II4} = 0.935$, Rank = 3 and ($R_{II2} = 1$, Rank = 1), and second in terms of the impact on the construction phase duration, according to Table 4.11 ($R_{II4} = 0.941$, Rank = 2) and ($R_{II2} = 1$, Rank = 1). The most important criterion was large spaces between the columns in order to permit people to move easily among the project zones, and the possibility of expanding the project vertically without the need for any demolition work. These were major reasons behind the project design difficulty. For example, the steel reinforcement of the raft foundation made it particularly hard to execute the necessary work as shown in Figure 4.12. In fact, design difficulties and modifications during the building work delayed the construction phase, and this delay negatively affected the overall project duration.

Figure 4.12: Steel reinforcement density in the raft foundation

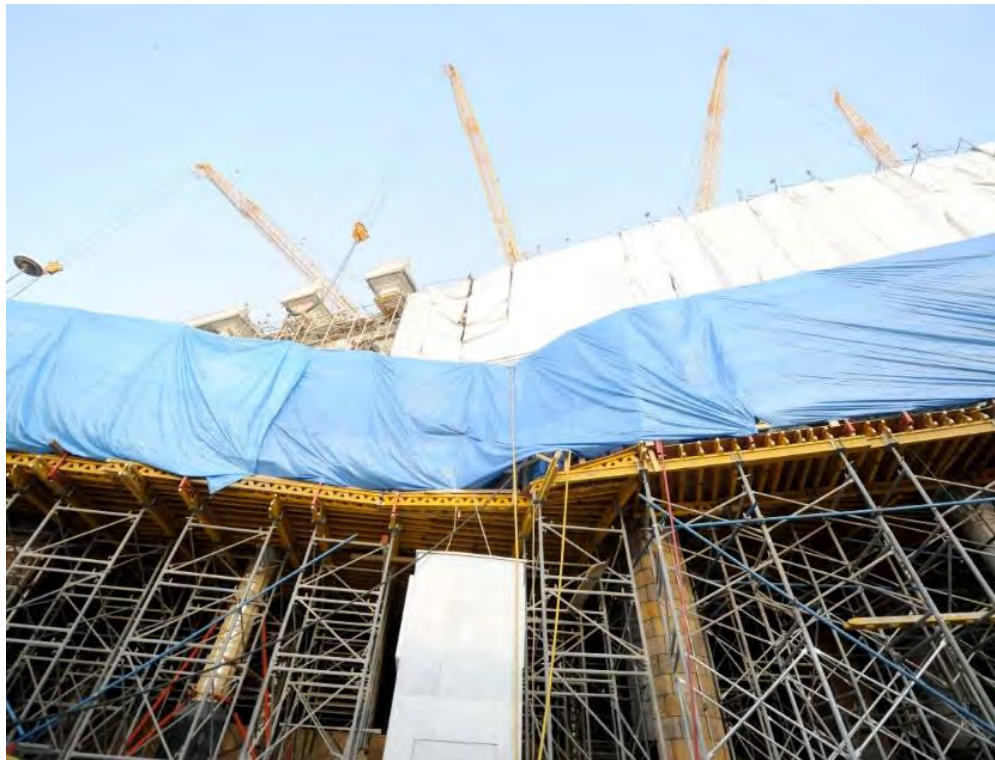
The back propping and supporting works factor came in eleventh place in terms of its impact on the overall time project duration, which is the penultimate stage, according to Table 4.12 ($RII_4 = 0.699$, Rank = 11) and ($RII_2 = 0.645$, Rank = 8), while it came in fifth place in terms of its impact on the demolition phase duration according to Table 4.10 ($RII_4 = 0.707$, Rank = 5) and ($RII_2 = 0.656$, Rank = 3). Before starting demolition work in any area of the project, necessary supporting work had to be completed based on the approved demolition plan. In fact, the project required additional propping-up, due to the fact that construction was in operation and visitors' safe access had to be ensured, in addition to the large floor height, as shown in Figure 4.18. The propping-up required additional time, which affected the demolition phase duration. As a result, it affected the overall project duration.

Figure 4.18: Back propping and supporting works
