## **APPENDIX A**

### **CHINESE TECHNICAL REPORTS**

# **WIRE BONDING PROCESS**

## **FINE PITCH WIRE BONDING ON 56L SDIP PRODUCTS**

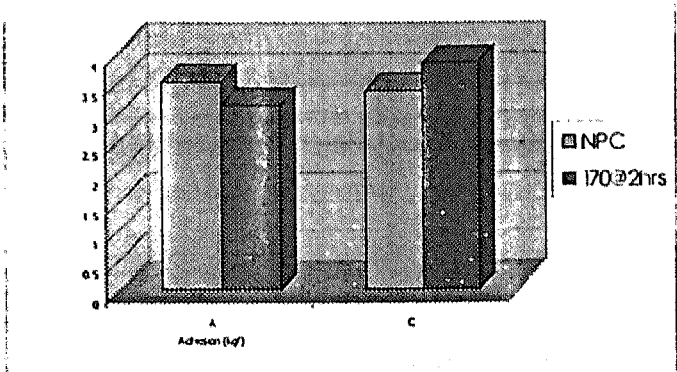
cure condition	adhesion(kgf)	
	A	C
NPMC	129	111
170@2hrs	167	155

Fig. 2 Adhesion to cu lead frame

how in table 2 and Fig. 2, the effect of postcure on adhesion to metal lead frames is  
 evident on the compound type. The adhesion of Molding compound A with postcure to  
 ver leadframe was found lower than that of no-postcure, while Molding compound C  
 ved higher adhesion to copper leadframe after postcure.

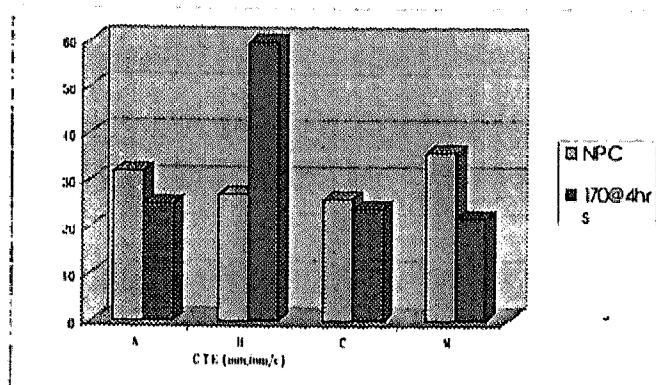
cure condition	CTE (mm/mm/degree)			
	A	B	C	M
NPMC	32	27	26	36
170@4hrs	25	60	24	22

### g) Coefficient of thermal expansion of no-postcure versus postcure

efficient of expansion (CTE) are generally governed by filler type and level, not by postcure or postcure conditions. As displayed in Table 3 and Fig. 3, however lower CTE after postcure have been noticed except B.

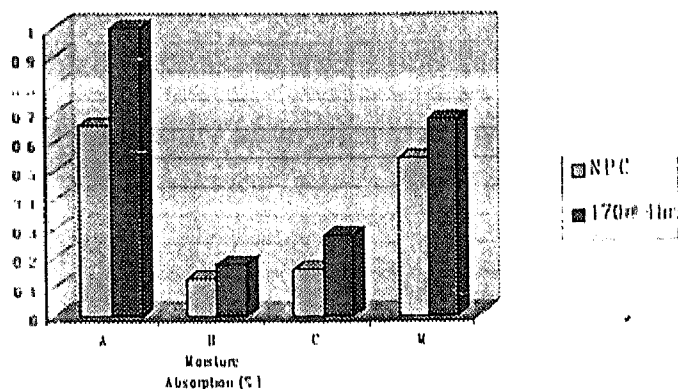
cure condition	Moisture Absorption(%)			
	A	B	C	M
NPMC	0.66	0.13	0.16	0.55
170@4hrs	1	0.18	0.28	0.68

#### 4Moisture absorption of no-postcure versus poscure

effect of postcure on moisture absorption depends on it's moisture condition. Moisture rption in Fig. 4 and table 4 showed that postcure increase moisture absorption. The omenon has been explained an increase in free volume with postcure.

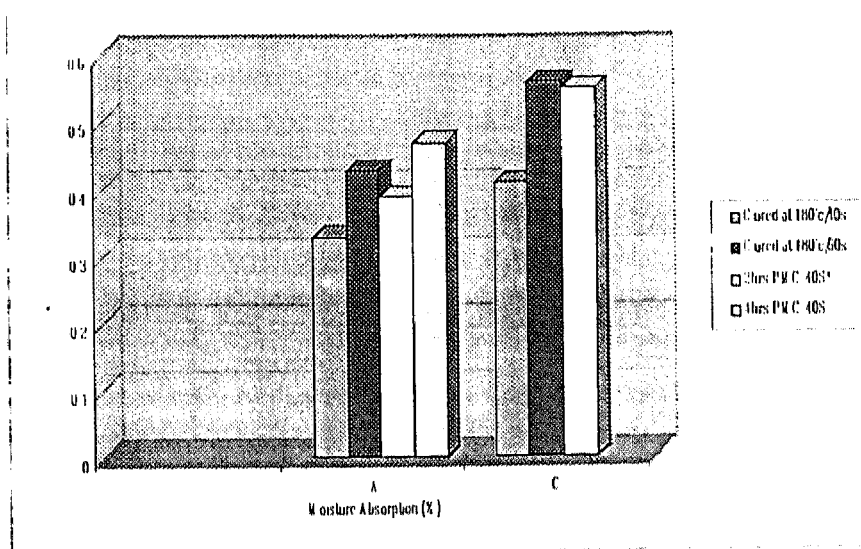
cure condition		
	A	C
Cured at 180°C /40s	0.33	0.41
Cured at 180°C /60s	0.43	0.56
2hrs PMC 40s	0.39	0.55
4hrs PMC 40s	0.47	N/A

Fig.5 Moisture absorption of no-postcure versus postcure

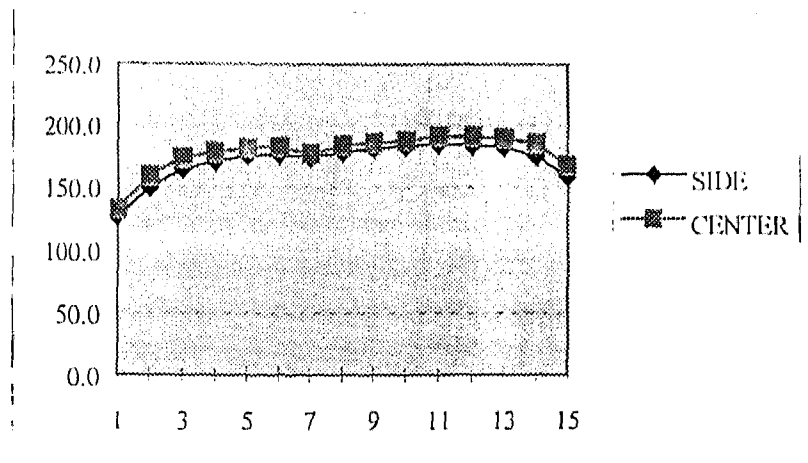
Figure3 Temperature profile of snap cure

Snap cure has big difference from oven cure. Its temperature profile was measured as Figure1. It can't provide the same stable temperature profile as oven cure: the temperature readings at different positions in tunnel are different from each other and for one L/F, the temperature at side strands is lower than that at center strand. This is a potential root cause of unstable die shear strength.

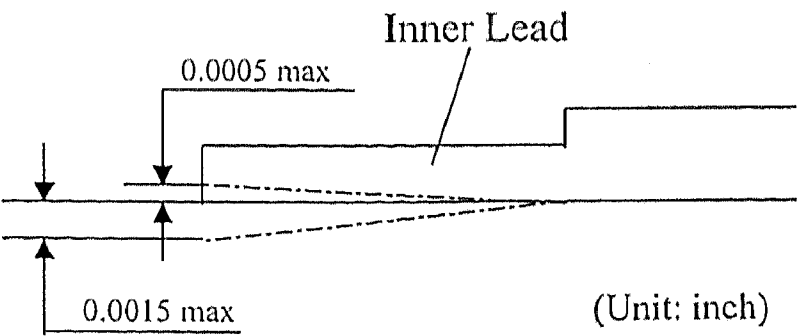
Figure 1. Before Modification

Although PPF has same physical dimensions with the copper leadframe, flatness of inner leads turns to be a important property for PPF. Wire peel strength was found to be very low for PPF during evaluation. After much effort to optimize wire bonding quality of stamped, we find that L/F manufactured with current  $\beta$  specification can not meet the flatness requirement needed for normal PPF production.

Through experiment and analysis, the “angled coining” inner lead design was proved to be the root cause of the bad peel strength. The modified inner lead drawing is as figure2. A downward “angled coining” for the lead tip of inner lead before modification is changed to a “flat coining” ( no downward angle).

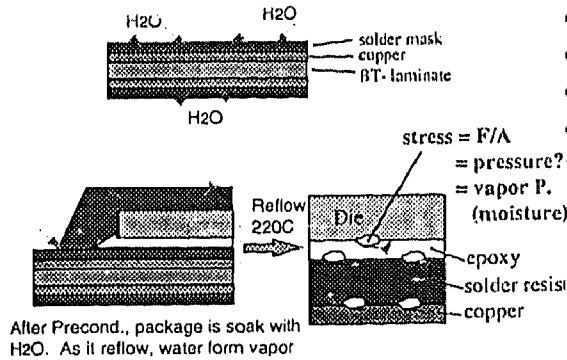
H<sub>2</sub>O from Ambient (60% RH) will be absorbed by the solder mask and BT-laminate (organic)

Fig. 5. Organic substrate with moisture reaction during reflow

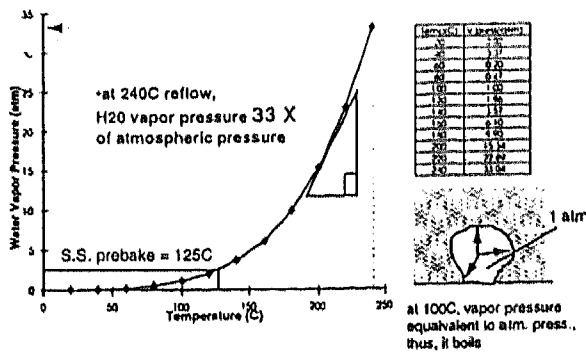
Fig. 6. The effect of temperature on the water vapor pressure.

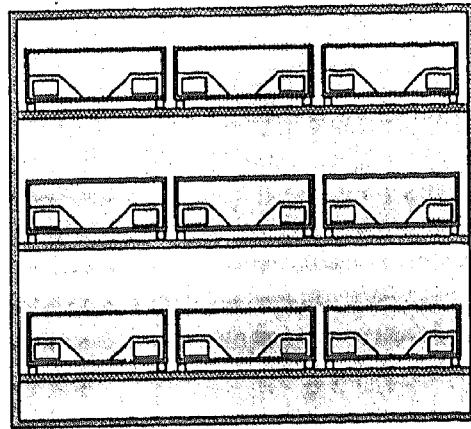
1. Stacking prebake for higher output.  
Condition : 50 strips/stack and 54 stacks per load. See illustrations below :

Fig. 10. Front view of oven with trays for stacking prebake.

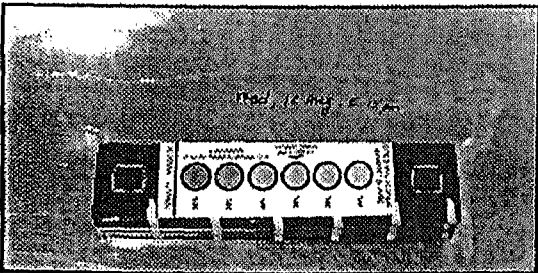
Fig. 13. Substrates after vacuum sealed (50 strips/packet) with moisture indicator.

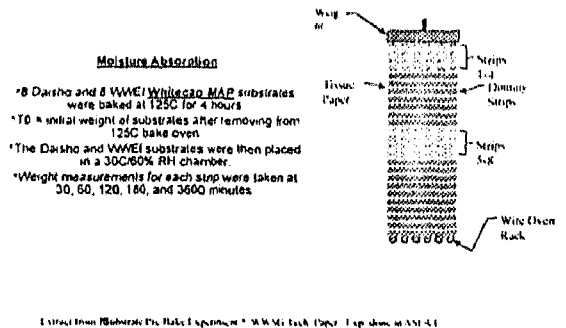
Fig. 26 Stacking prebake method by ASE-CL

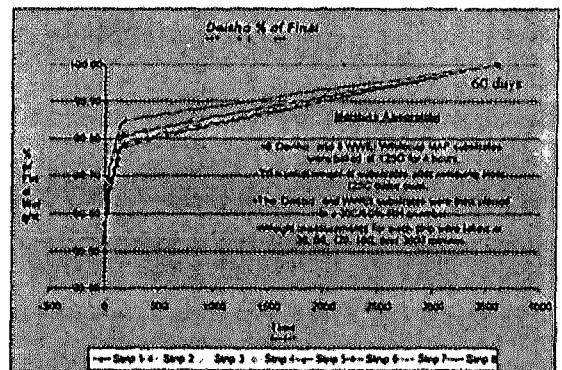
Fig. 27 shows the final weight % of the Daisho moisture gain after a given time. The slope from 30 to 180 hours is steep which translate a greater moisture absorption. This is a typical trend moisture absorption curve for substrate. In the case of current production environment which is 25°C/45%RH, the slope gradient is expected to be lower. Thus, there is a significant difference between 10 and 12 hours of staging time as they fall within the slope region.

Fig. 27 Daisho %moisture weight gain

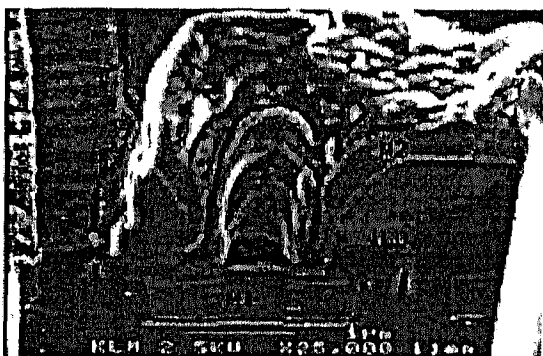
Figure 8: SEM imaging on s/n1 shows that an interlevel oxide layer was above the metal 1 layer blocking the via forming a connection.

Note: Passivation layer removed.

Figure 7 shows a correlation voltage contrast imaging on a good via. Wright etch was used to stain the sample for better imaging. Scanning Electron Microscopy (SEM) showed what was believed to be an interlevel oxide layer above the metal 1 layer blocking the via connection to it (Figure 8 and 9). Figure 10 shows a correlation good via. Both s/n1 and 2 were found with similar failure mechanism.

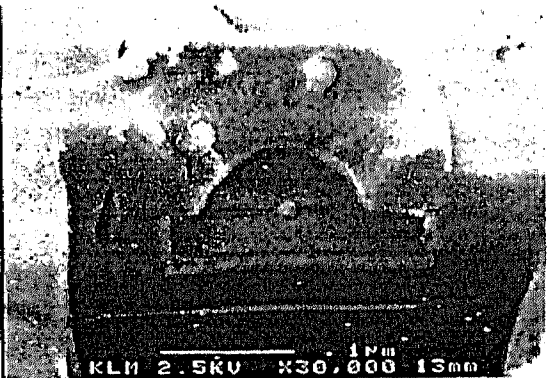
Figure 13: After metal etch, SEM image on a good via.

clearly indicates that there has a layer separating metal 1 and 2 via (Figures 12 and 13).

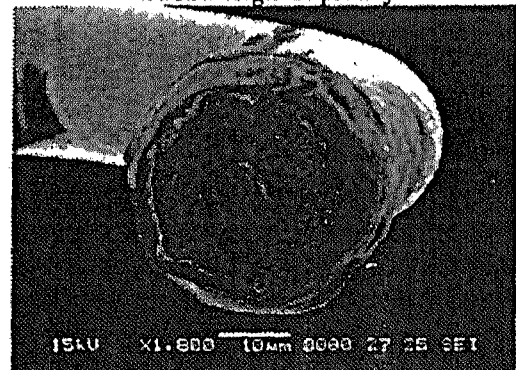
Figure 5: Intermetallic analysis for standard and DFX design capillary

from the bonding response and inter-metallic analysis, it can be seen that the DFX design capillary is capable of producing a smaller ball size as compared to the standard design with a minimum ball shear stress of 90 N/mm<sup>2</sup> (6g/mil<sup>2</sup>). Hole and CD dimensions remain the same for both capillary designs.

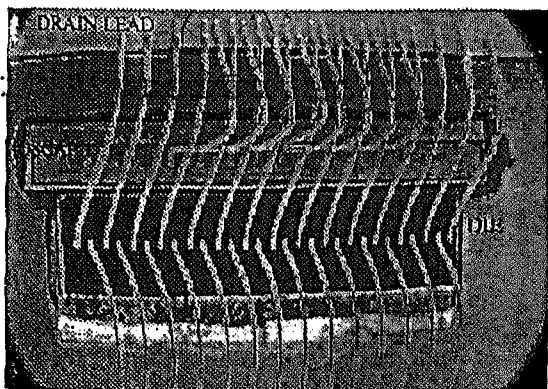
Figure 10 : SEM micrograph showing the MOSCAP1 wire connection to DRAIN LEAD( have 8 high loop wires) and DRAIN LEAD to DIE( have 15 wires). Fourteen(14) wirebonding connection from DIE to MOSCAP2 to GATE LEAD(not visible here in this micrograph)

Figure 10-18 shows the SEM wirebonding micrograph between Drain post, on the die and on the MOSCAP for *A* device. No comparison were made to MRF19030 due to the package differences.

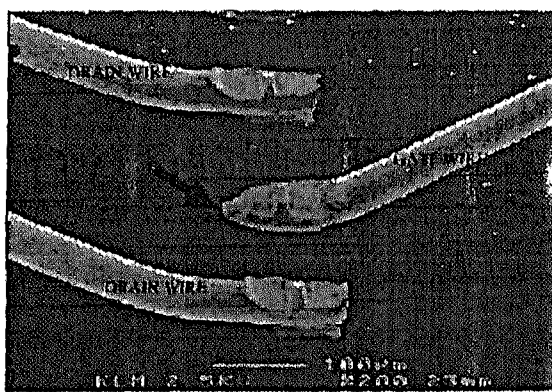
Figure 13: SEM die wirebonding micrograph for *A* 10035 tilted at 10 degree. It is observed that the wire connection from DRAIN LEAD post to die( DRAIN wire) has a blunt edge, indicated by the red arrow. Wirebonding from DIE to MOSCAP2 to GATE LEAD(GATE wire) post has a narrow look edge, pointed by the blue arrow

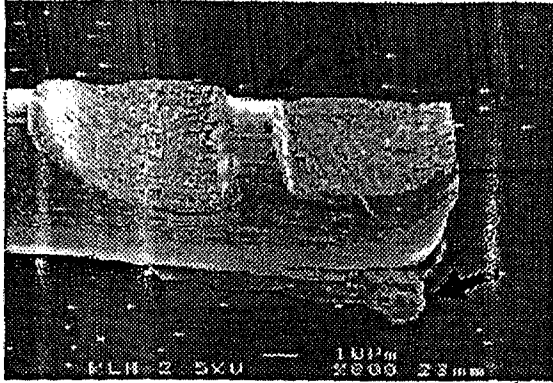
Figure 14 : SEM micrograph showing the details of *A* 10035 device single DRAIN wire tilted at 10 degree. The quality of wirebonding is not good. There seems to be an access wire impression on the bond pad as shown by the arrow. Side view also shows that the wire bond tool does not pressed the wire evenly as visible by the middle bump, pointed by the blue arrow.

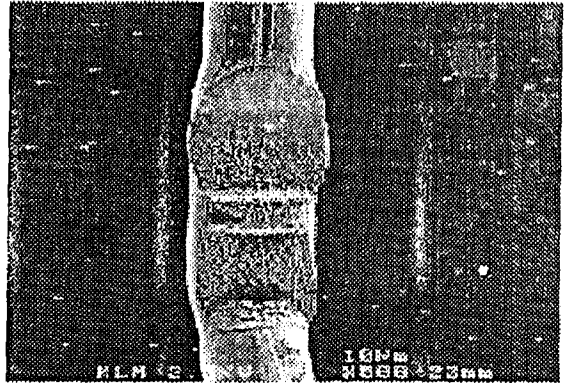
Figure 17 : SEM micrograph showing the details of *A* 10035 device single GATE wire connection on MOSCAP2. Similar unpressed middle bump feature is observed for this wedge wirebonding.

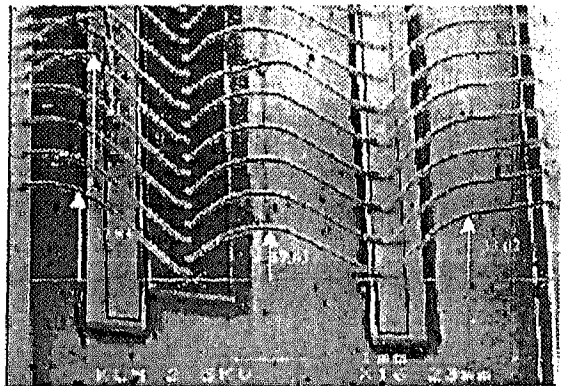
Figure 18 : SEM micrograph of *A* - 10035 device tilted at 40 degree showing the wire loop. The wire length and wire loop dimension was also included in this micrograph All the dimensions are in mils.

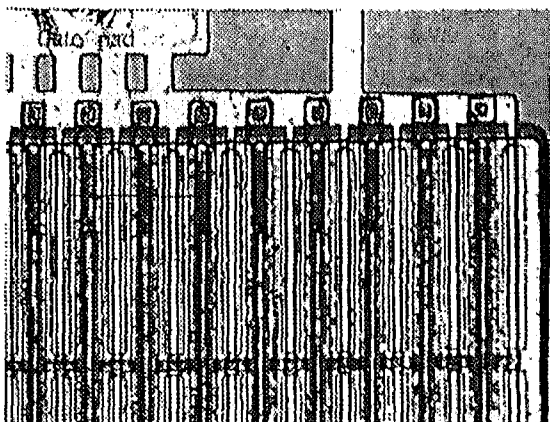
Figure 20 : Optical view of *B* MRF19030 die finger where the cross-sectioning was conducted utilizing FIB to understand the die cross-section structure. The cross-sectioned finger is conducted between the GATE wire and DRAIN wire as indicated by the red box

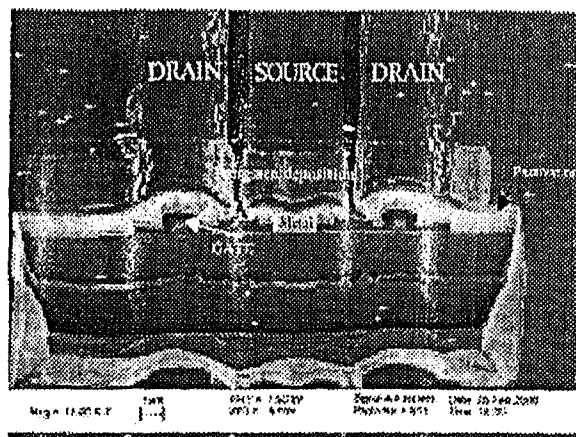
Figure 21 : SEM micrograph of *A* 10035 cross-sectioned die magnified at 12000X showing the junction details. Take note that tungsten was deposited on top of the passivation layer for edge protection during FIB cross-sectioning. This die uses only 1 metal scheme.

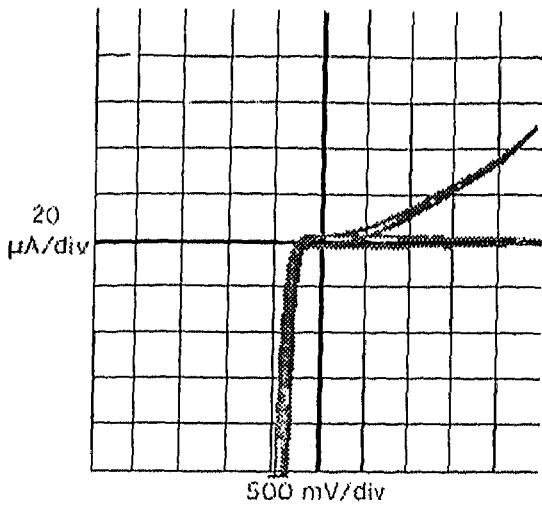
Figure 1. A typical IV curve revealed leakage on pin 139 (TDO). Similar leakage was observed on the respective failing pins. Green Curve: good unit. Red Curve: bad unit.

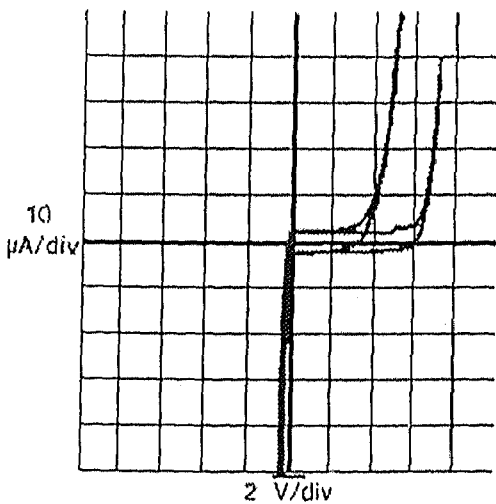
Figure 2. A typical IV curve revealed an early breakdown on pin 143 (SC12) when powered up to 3.3V. Green curve: good unit. Red curve: bad unit.

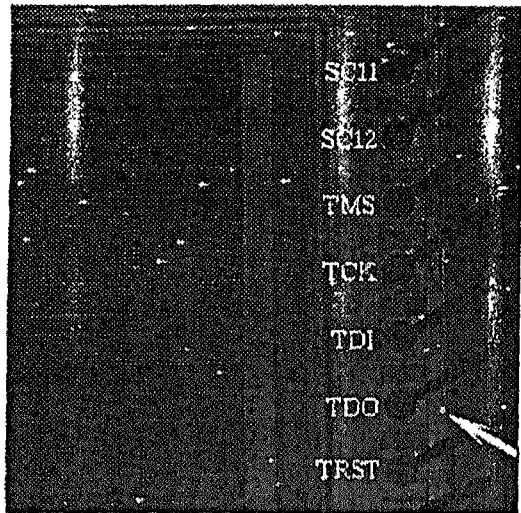
Figure 3. Light emission analysis revealed a typical light spot on leakage pin (139 - TDO) as indicated by a white arrow. Similar light emission was observed on the respective failing pins.

Light emission analysis revealed a light spot on the respective leakage pins (Figures 3 and 4).

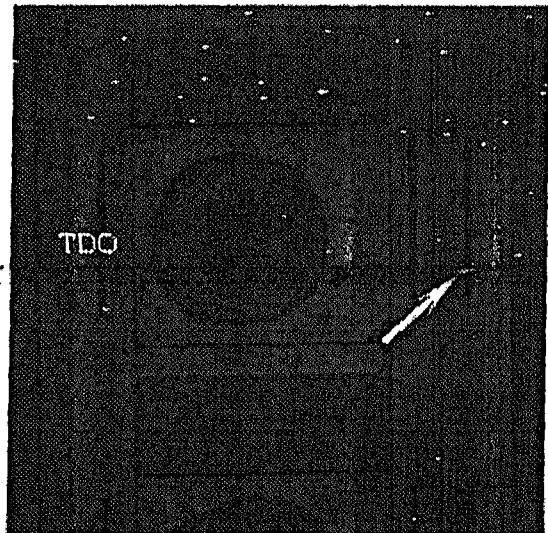
Figure 4. A close up view of the light spot on the leakage pin (pin 139 - TDO) as indicated by a white arrow. Similar light emission was observed on the respective failing pins.

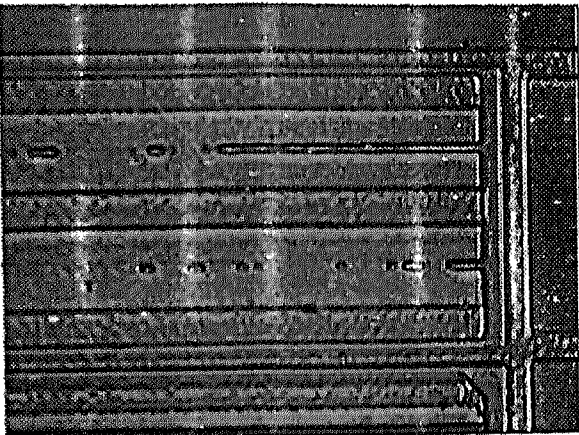
Figure 5. Optical micrograph revealed a typical anomaly on ESD protection diode where the light emitted (pin 139 - TDO). This anomaly was observed on all pins, from pins 134 to 144.

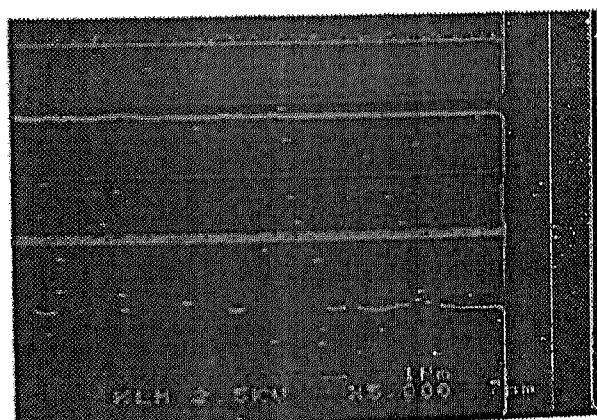
Figure 6. SEM micrograph revealed a typical anomaly on ESD protection diode where the light emitted (pin 139 - TDO). This anomaly was observed on all the pins from pins 134 to 144.

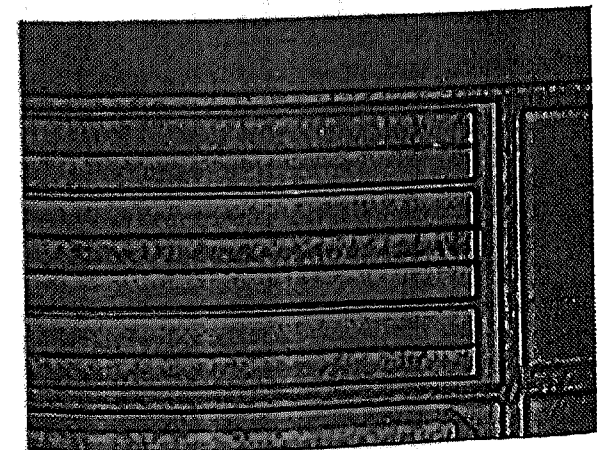
Figure 7. Optical micrograph revealed no anomaly on ESD protection diode of a correlation unit (Trace Code - XQAB9945).

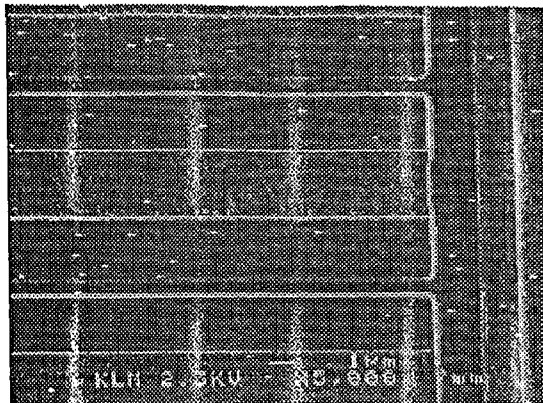
Figure 8. SEM micrograph revealed no anomaly on ESD protection diode of a correlation unit (Trace Code - XQAB9945).

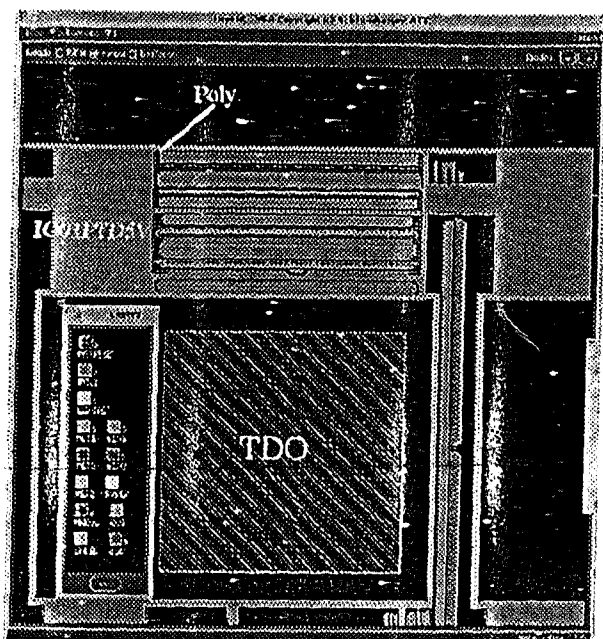
Figure 15. Die layout showed a typical pin (pin 139 - TDO) from J22\_MG\_IUP1 module where an anomaly was found on ESD thick field transistor (IO01PTD5V).

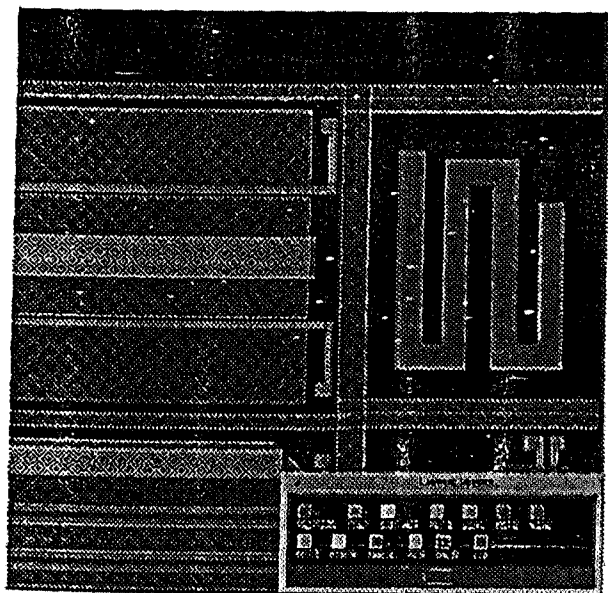
Figure 16. A close up die layout showed a typical pin (pin 139 - TDO) from J22\_MG\_IUP1 module where an anomaly was found on ESD thick field transistor (IO01PTD5V).

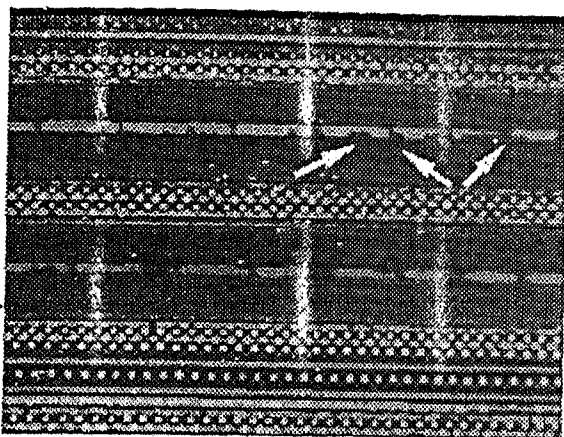
Figure 17. Optical micrograph shows the defect found on ESD thick field transistor appeared to be appeared to be poly patterning defect (pin 144 - SC11).

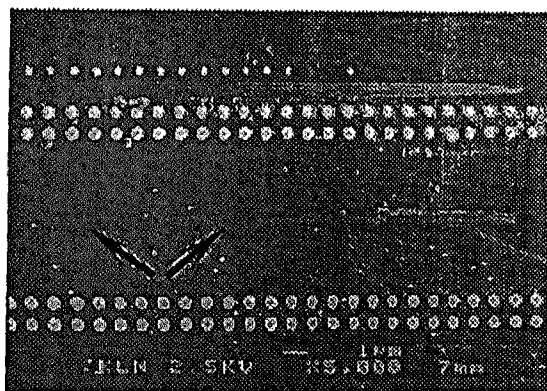
Figure 18. SEM micrograph revealed a poly patterning defect on ESD protection circuit (pin 144 - SC11).

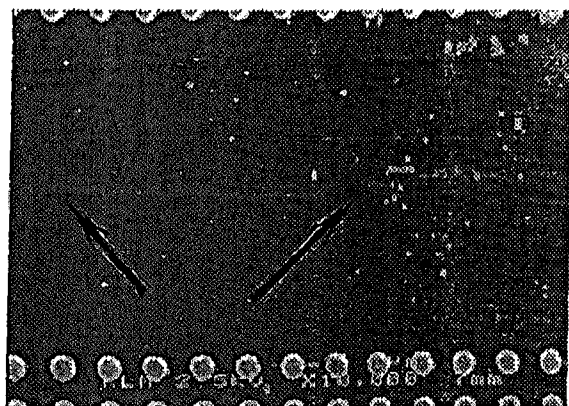
Figure 19. A close up view of the poly patterning defect on ESD protection circuit (pin 144 - SC11).

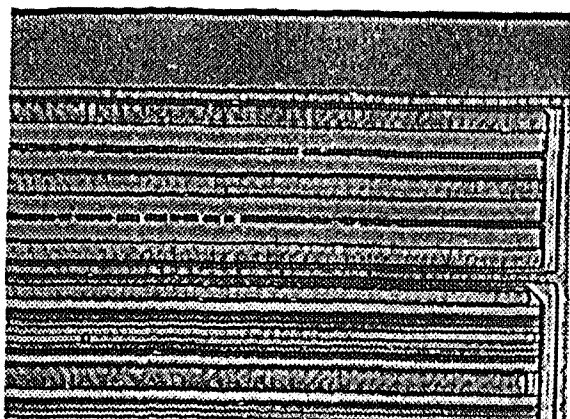
Figure 20. Optical micrograph revealed an anomaly in a lesser extent on ESD protection diode on a good unit from the same wafer lot, E115070. This anomaly was observed on most of the pins from 134 through 144.

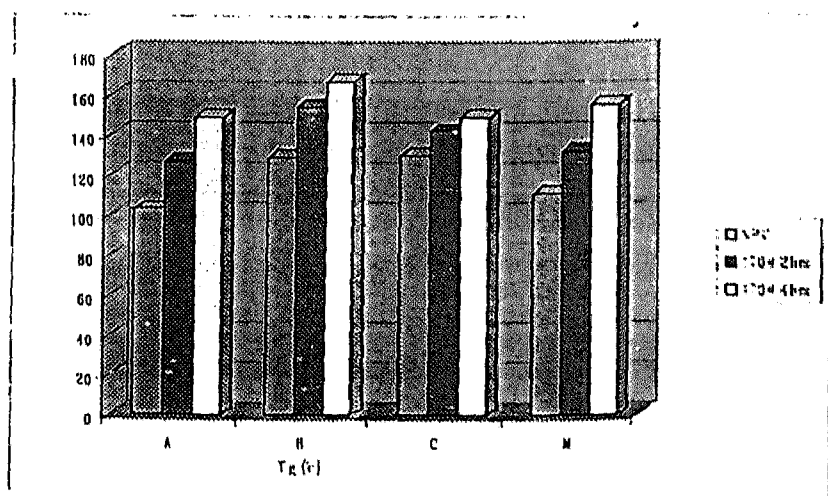
Fig. 1 The postcure effect on Tg

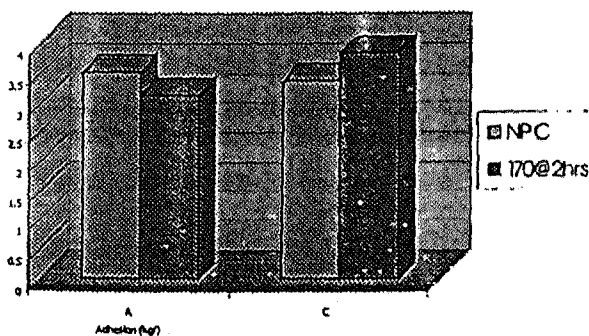
Fig. 2 Adhesion to cu lead frame

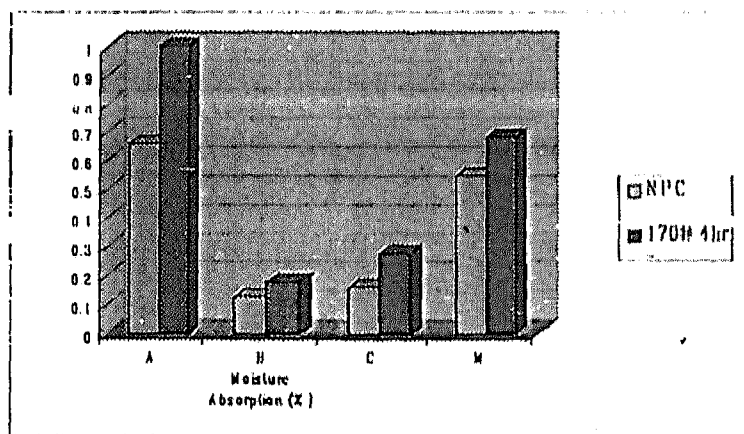
Fig. 4 Moisture absorption of no-postcure versus postcure

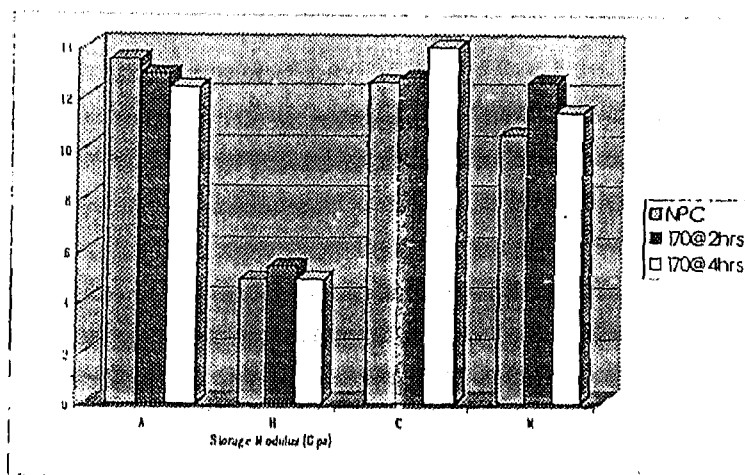
Fig.6 The effect of postcure on storage modulus

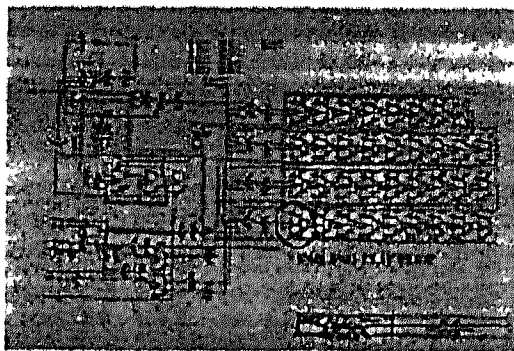
Figure 1: Key Off Timer (KOT) circuitry schematic identifying failing flip flop.

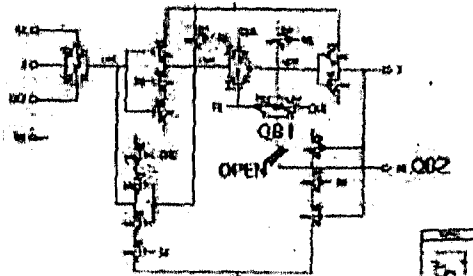
Figure 2: Detailed of the failing flip flop schematic.

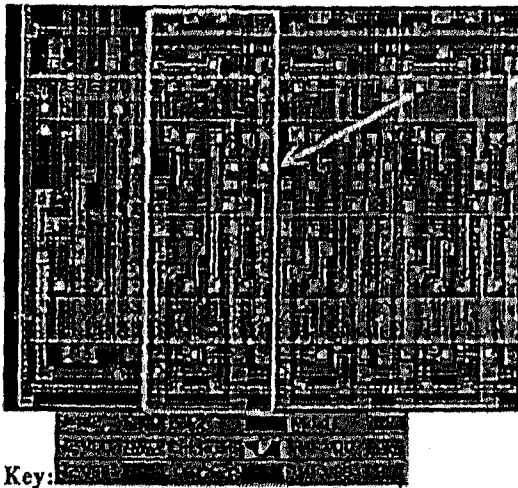
Key:  
Figure 3: Partial layout of the failing flip flop - marked in red box.

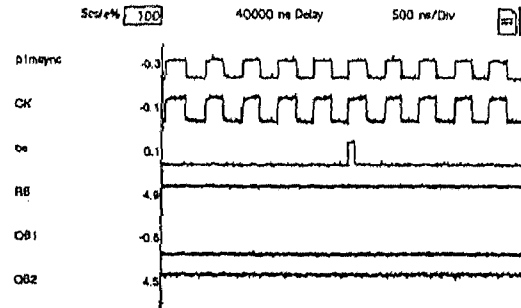
Figure 5: The various probed signals from the failing flip flop.

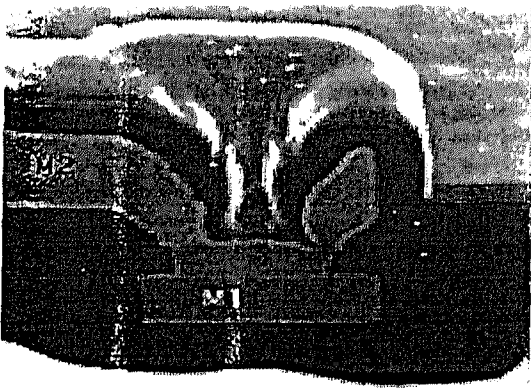
Figure 7: Voltage contrast imaging on good via.

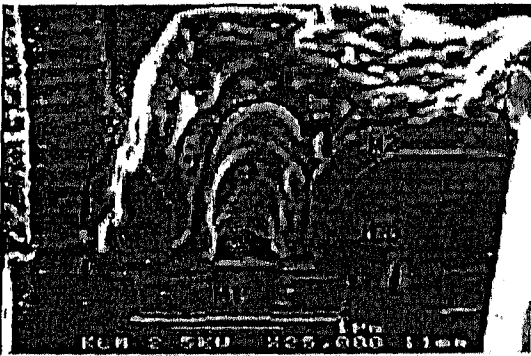
Figure 8: SEM imaging on s/n1 shows that an interlevel oxide layer was above the metal 1 layer blocking the via forming a connection.  
Note: Passivation layer removed.

Figure 7 shows a correlation voltage contrast imaging on a good via. Wright etch was used to stain the sample for better imaging. Scanning Electron Microscopy (SEM) showed what was believed to be an interlevel oxide layer above the metal 1 layer blocking the via connection to it (Figure 8 and 9). Figure 10 shows a correlation good via. Both s/n 1 and 2 were found with similar failure mechanism.

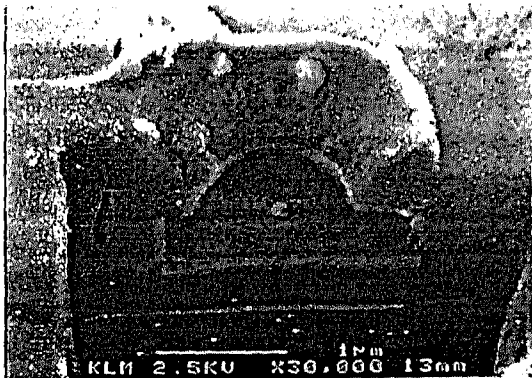
Figure 13: After metal etch, SEM image on a good via.

clearly indicates that there has a layer separating metal 1 and 2 via (Figures 12 and 13).

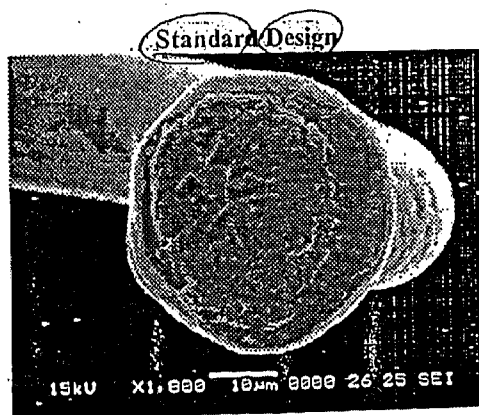
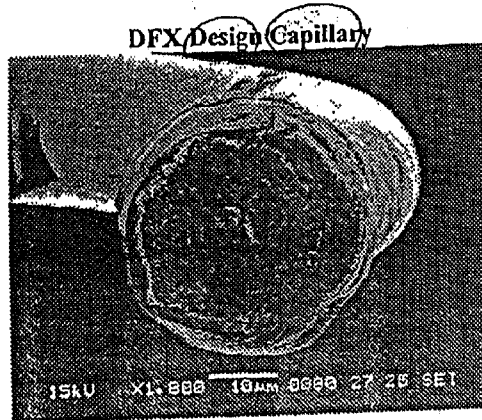
Figure 5: Intermetallic analysis for standard and DFX design capillary

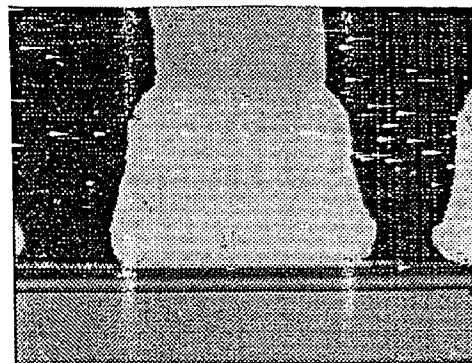
Figure 11: Cross section analysis
