## **CHAPTER 6            AN ASSESSMENT OF CAUSES, IMPACTS AND EVALUATION OF RESPONSE OPTIONS**

### **6.1     Causes of Bund Failure**

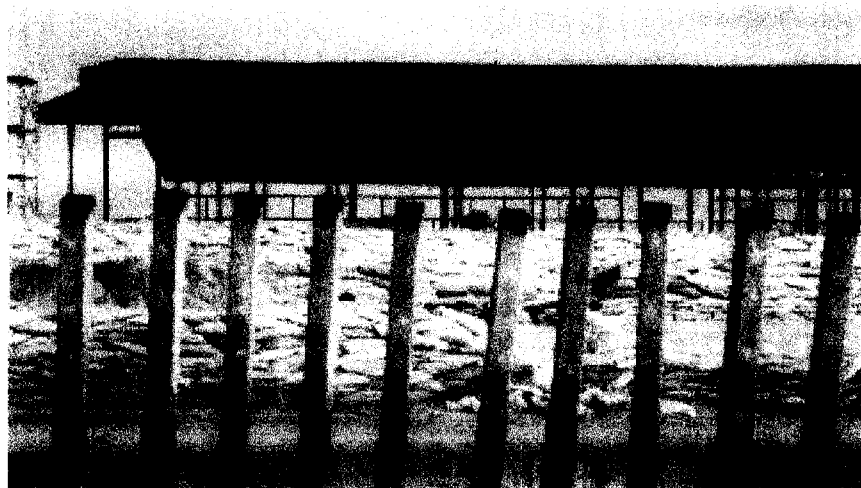
**Plate 6.1.** Used of concrete piles and sand bags to protect the land

Figure 6.30 shows the latest structural control works along Rungkup coastline which was mapped in September 2001. Nearly the whole length of the coastline of 27.4km in Rungkup is protected by bunds, 11km of which have been revetted with rocks and 0.4km with concrete piles (Plate 6.1).

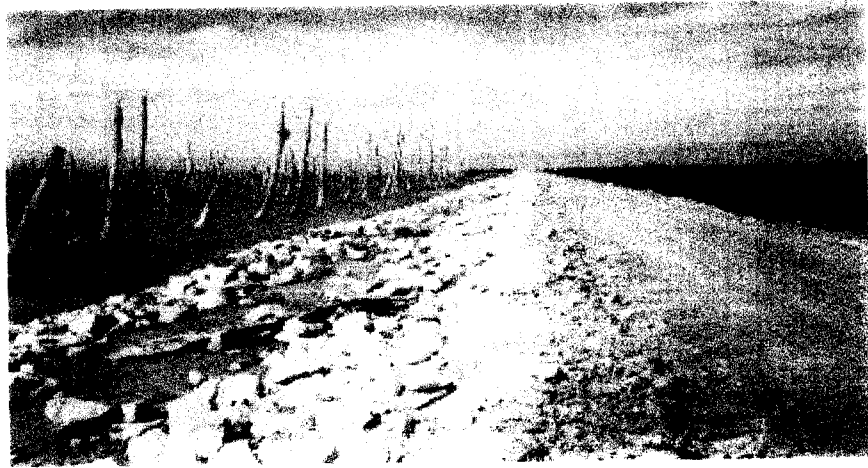
Plate 6.3. Construction of retreat bund in Sg Belukang
