## **CHAPTER 5.0**

### **Case Study**

Field measurement has been conducted in JKR 989 which is the selected former British residence in an urban environment. This is to ascertain whether the indoor thermal comfort conditions are influenced by the window designs and its current microclimate. The field study was conducted for duration of 8½ weeks between 13 May 2010 and 12 July 2010. This period was selected as it matches with the period of constant changes in mean air temperature, mean relative humidity and mean air movement based on the 2004-2008 weather data. This field measurement aims to evaluate the micro climate condition of the study site and its impact on the heat gain pattern of a selected room.

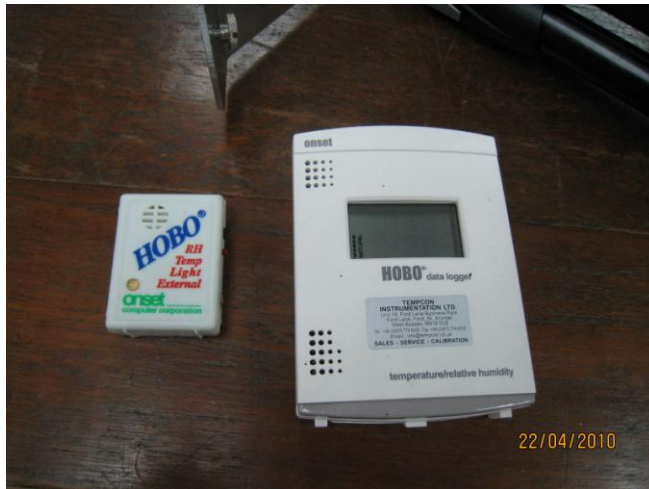
**Figure 5.5(a): HOBO data logger to measure air temperature, relative humidity and daylighting**

The thermal comfort level of the indoor environment is measured using a measuring physical quantities instrument (HOBO) data logger and BABUC showed in Figure 5.5(a)&(b) that was able to measure air temperature, relative humidity and luminance. All these equipments were calibrated before to ensure reliability and accuracy in the readings taken during the field studies.

All measurements were taken at a height of 700mm above the floor, which represents the height of the occupant at seated level. The instrument was placed at work plane level in the rooms at 1.2meters from the window.

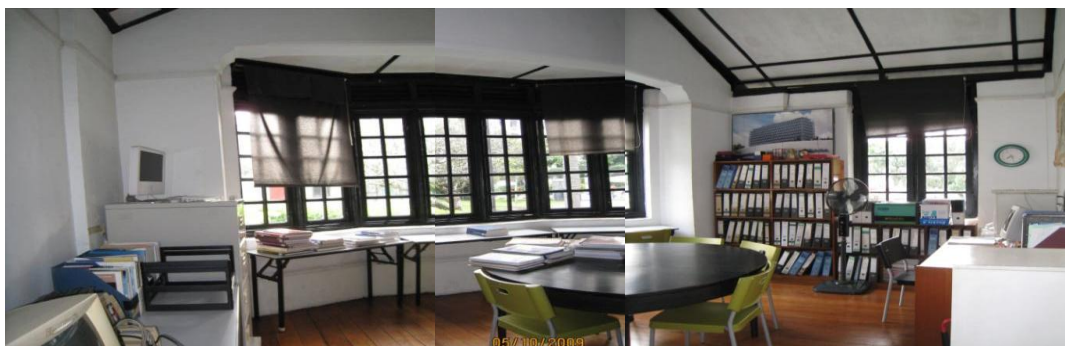
Figure 5.7(a): Resource Centre with windows closed

Experimental work was conducted in a resource centre on the ground floor of JKR 989 at No.2 Jalan Stonor which shown in Figure 5.7(a) and Figure 5.7(b). The dimension of room was: 4.6m x 5.1m x 4.2m height. The volume of room was 98.5m<sup>3</sup> and its surface area was 23.5m<sup>2</sup>. The room consists of two interior walls, interior timber raised floor, ceiling and two exterior walls with windows area. This room is normally used by researchers (students or professionals) upon appointments with a possibility to have meetings around the square tables with up to eight people taking part. This resource centre is built into the North East. Room was fitted with two window and one door. The dimension of the window area is 2.72m<sup>2</sup>.

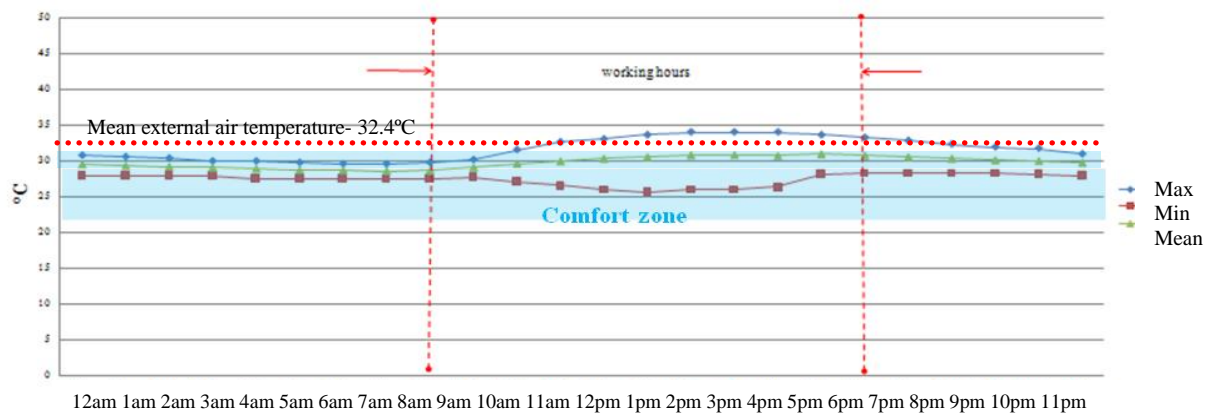
Figure 5.9(a): Graph shows air temperature zone 1 with windows close from 13 May 2010 till 31 May 2010

Figure 5.9(a) demonstrated that thick wall contributed in controlling the heat penetrated inside the room when windows are not opened.

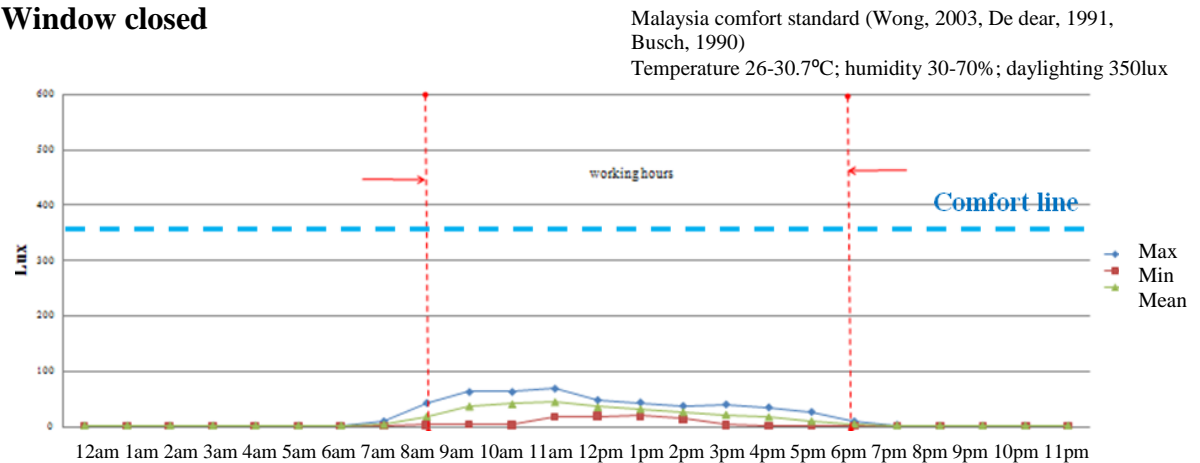
Figure 5.11 (a): Graph of Illuminance zone 1 with windows closed from 13 May 2010 till 31 May 2010

It is noted that the measurement of the internal illuminance were done without diffuser attached to the system. That explains why the light distribution is not very well distributed. There are days when the room was too bright which cause glare and discomfort. According to Window to wall ratio, daylight in this room is sufficient. From the graph showed in Figure 5.11(a), it can be concluded that using WWR to predict the performance of the daylight is reliable. The precision of the estimated daylighting performance would strongly depend on the orientation of the building and existing structure at surrounding. From the measurement, resource centre has the highest daylighting at 11.00am. The results also showed that the interior illuminance for this room was rather low in the afternoon and would not be sufficient for visual comfort. Additional lighting is required to ensure sufficient lighting.

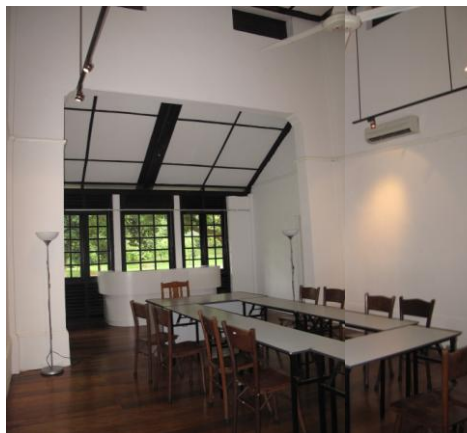
Figure 5.13(b): Meeting room with windows closed and windows opened

Experimental work was conducted in a meeting room on the ground floor of JKR 989 at No.2 Jalan Stonor. Location of measurement being taken is shown in Figure 5.13(c). The dimension of room is: 8.1m x 5.2m x 8m height. The volume of room was 337m<sup>3</sup> and its surface area was 42.1m<sup>2</sup>. The room shown in Figure 5.13(b) consists of two interior walls, interior timber raised floor, ceiling and one exterior wall with windows area. There is an internal door shown in Figure 5.13(a) that leads to zone 2. This room is normally used by council members or BWM members to have council meetings or AGM, seminar/ talk, art exhibition or even bazaar and can accommodate up to 30 people. This meeting room is facing to the North West.

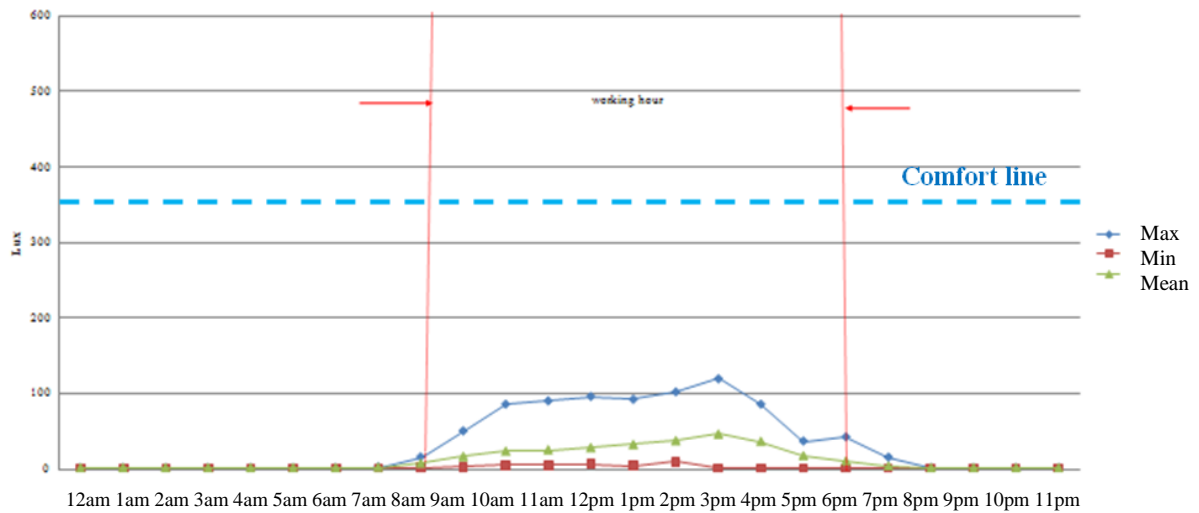
Figure 5.16(a): Graph shows Illuminance zone 2 with windows closed from 31 May 2010 till 14 June 2010

Refer to Figure 5.16(a), the illuminance levels obtained are rather low. It is noted that the measurement of the internal illuminance were done without diffuser attached to the system.

That explains why the light distribution is not very well distributed. There are days when the room was too bright which caused glare and discomfort. From the measurement, the meeting room has the highest daylighting at 11am on the 31<sup>st</sup> May 10. According to Window to wall ratio, daylight in this room is very sufficient. Thus, results from the calculation of WWR contradict with the result from measurement. This is due to additional internal shading added to windows which affect the reading. Additional artificial lighting is required to ensure sufficient lighting. There is critical increase of lighting on 31<sup>st</sup> June and 1<sup>st</sup> June due to artificial lighting which were turned on for meeting.

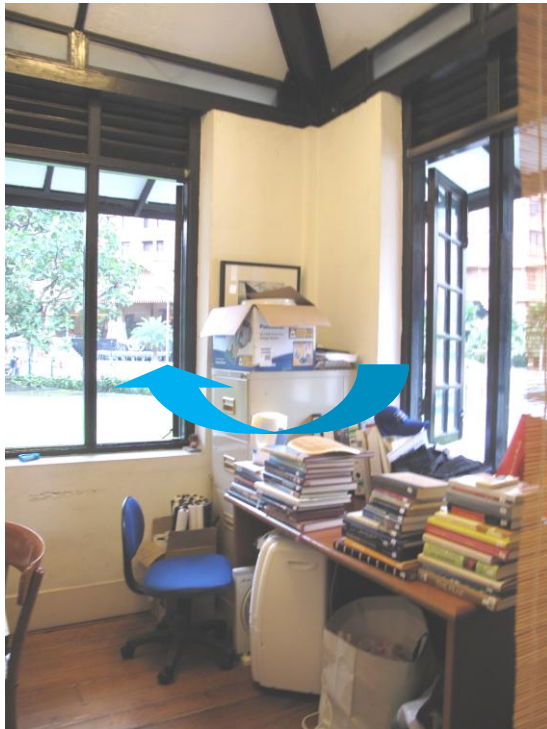
*Two Openings - Adjacent Walls*

As the windows located in this room showed in Figure 5.19(c) located too near to each other facing to the wind direction, cooler wind seldom enter this room. Consequently indoor air temperature increased.
