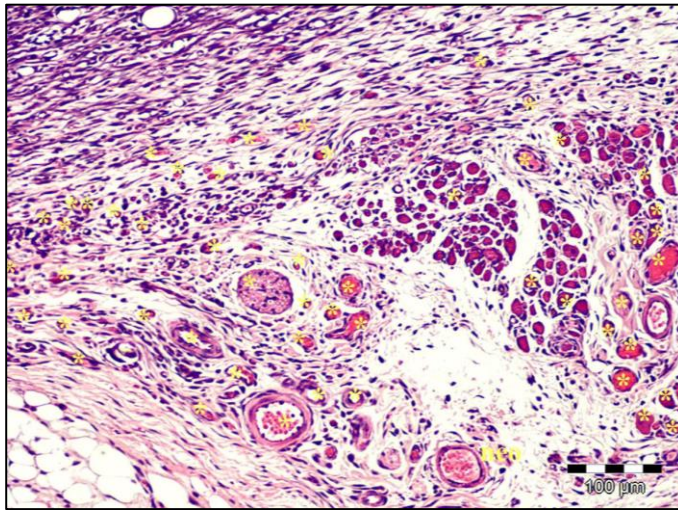
Figure 4.32: Blood in the wound area in Group GE (Gelum) on Day 5 of treatments. H&E stained section. 400X Magnification. Blood vessels (labeled with *) with various sizes saturated in the wound area.

H&E stained slide (Figure 4.18D) showed that epithelialization had started on Day 5 of treatments in the wounds treated by Gelam honey. Marked wound edges were found, the epithelial cell layer was thickening at the wound edges (Figure 4.35). Blood vessels were found saturated in the area around the wound site just as seen in MT stained sections. A lot of blood vessels in smaller size were found near the surface of the wounds. MT and VE stained slides showed that the collagen level started to increase from the bottom to the top of the wound area indicated by the increased intensity of blue color stain vertically. Collagen was stained in blue in MT stained. Fibroblasts were found accumulating in the surface of the wound area (Figure 4.35). Epithelialization had started but not completed (Figure 4.32). Thick scab was still

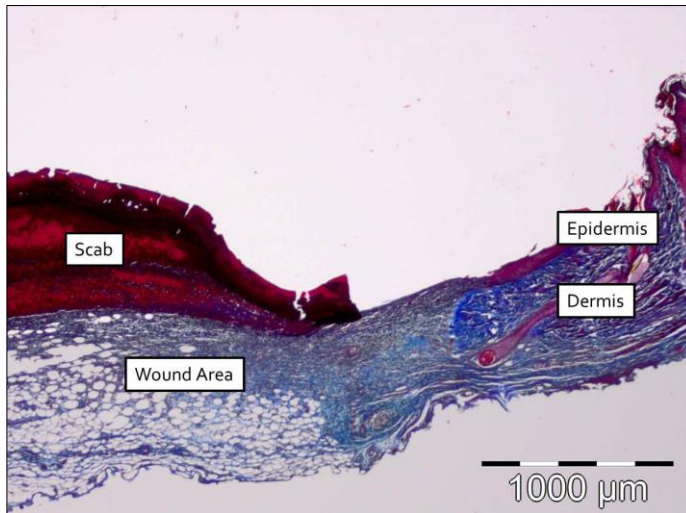
Figure 4.33: Histology of wound in Group GE (Gelum) on Day 5 of treatments. MT stained sections. 20X Magnification. Wound area was stained blue in color indicating the increase of the collagen.

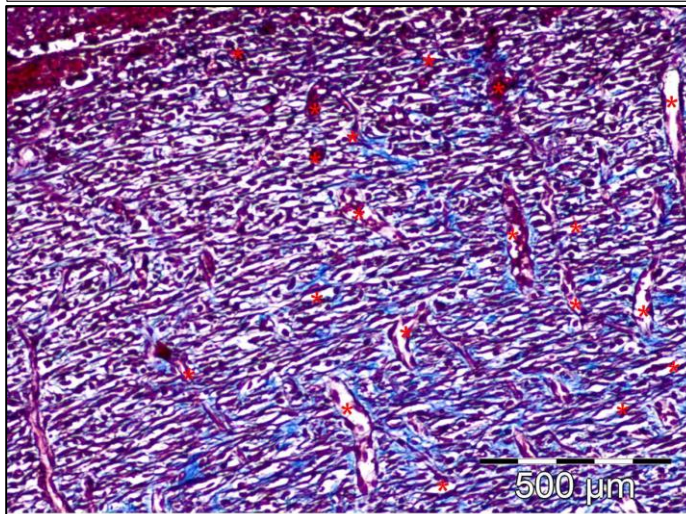
Figure 4.34: Blood vessels, collagen and fibroblast in wound area of Group GE (Gelum) on Day 5 of treatments. MT stained sections. 20X Magnification. Blood vessels (labeled with *) in smaller size saturated in wound area especially around the surface of the wound. Slides were stained in blue color indicating the collagen in the wound area had increased.

attached on the surface of the wound area. Marked wound edge was found on Group GE (Gelam) on Day 5 of treatments (Figure 4.34).

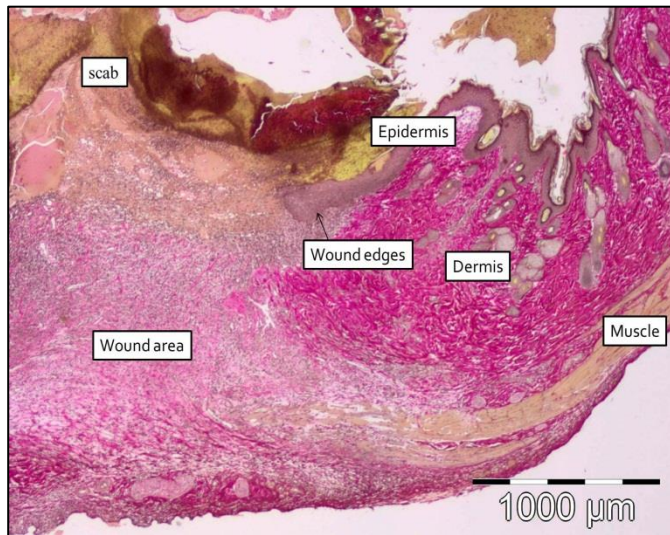
Figure 4.35: Histology of wounds in Group GE (Gelam) on Day 5 of treatments. VE stained section. 20X Magnification. Yellowish color in wound area was not obvious indicating that the exudates amount had reduced. Thick and clear wound edge was observed.

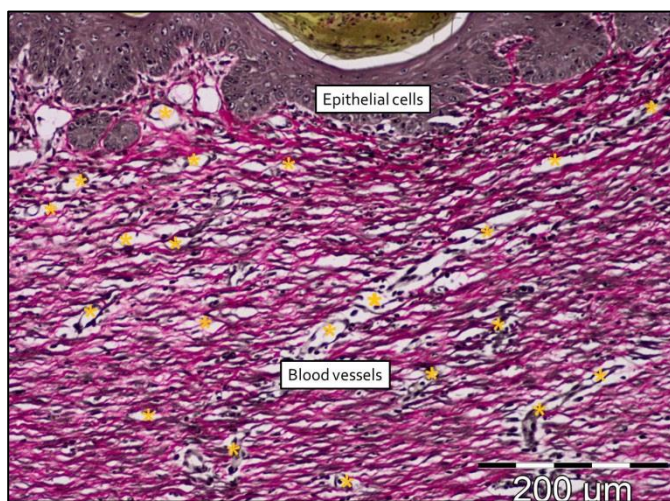
Figure 4.36: Histology of wound area in Group GE (Gelam) on Day 5 of treatments. VE stained section. 100X Magnification. Collagen and fibroblast were stained in red color. The epithelial cells become thicker. Blood vessels (labeled with *) saturated in the wound area.

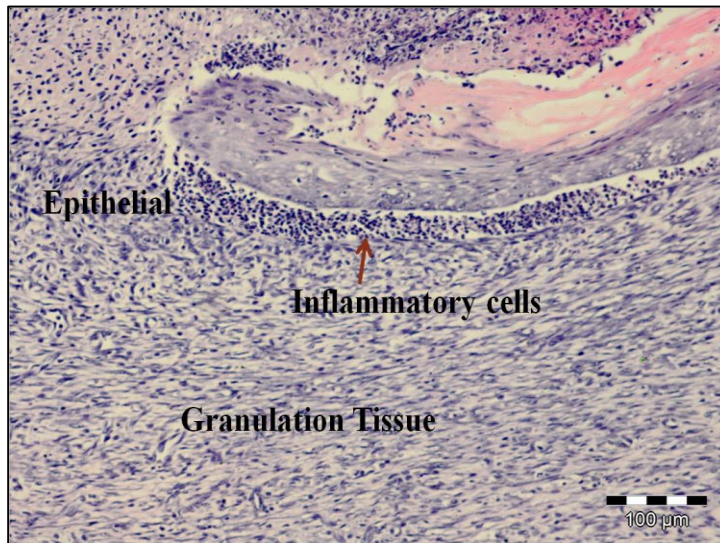
Figure 4.37: Cells migration in the wound of Group NE (Nenas) on Day 5 of treatments. H&E stained section. 400X Magnification. Abundant inflammatory cells found near the epithelial cells.

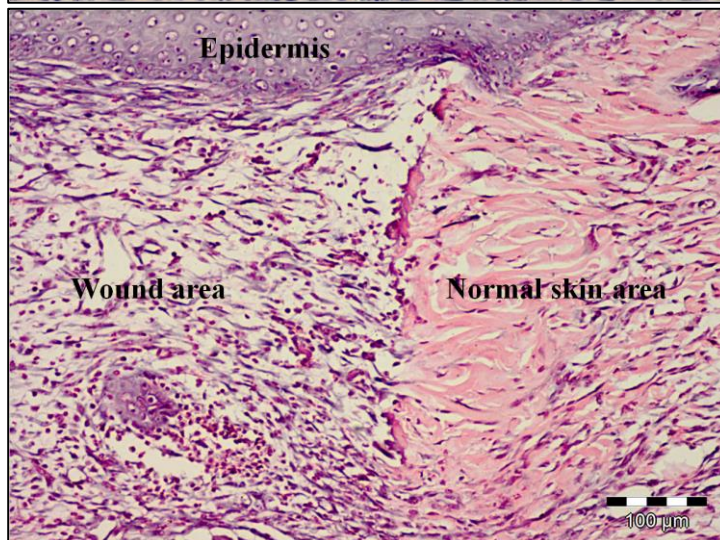
Figure 4.38: Different between the wound area and normal skin found in wound of Group NE (Nenas) on Day 5 of treatments. 400X Magnification. Clear demarcation line found.

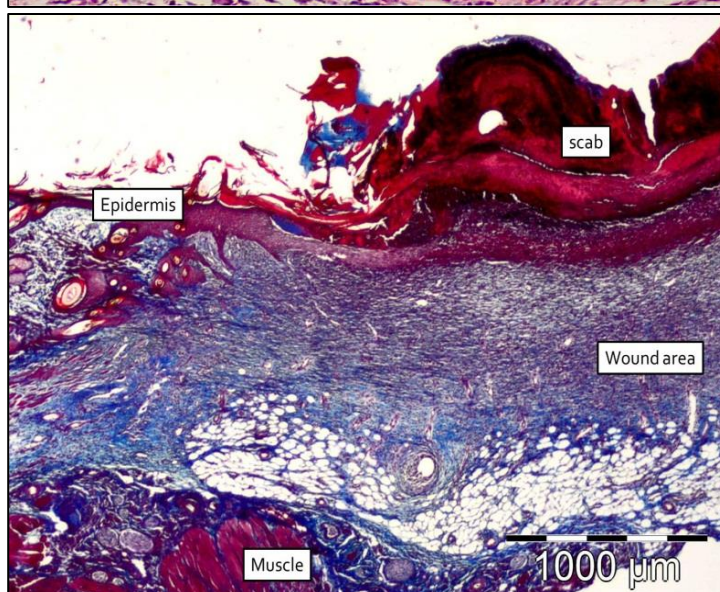
Figure 4.39: Histology of wound for Group NE (Nenas) on Day 5 of treatments. MT stained sections. 20X Magnification. Thick scab found on the surface of the wound area. Thick epithelial cells found on the wound area on the wound area. Wound area were stained blue in color indicated the level of collagen increased.

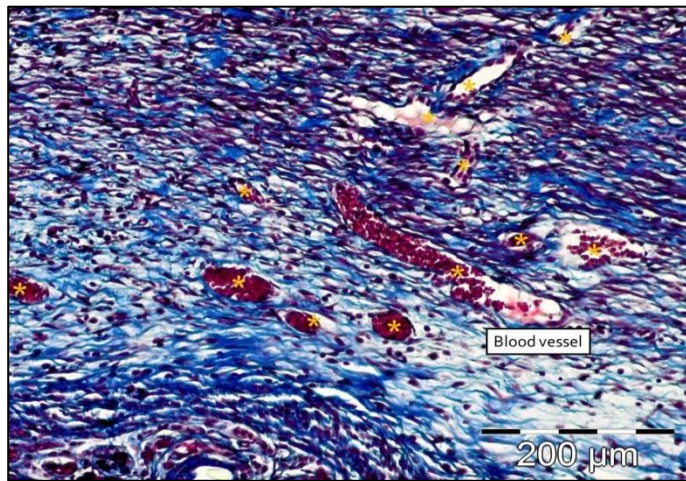
Figure 4.40: Histology of wound area in Group NE (Nenas) on Day 5 of treatments. MT stained section. 100X Magnification. Blood vessels (labeled with *) with various size saturated in wound area. Some were filled with blood cells. Collagen was stained with blue.

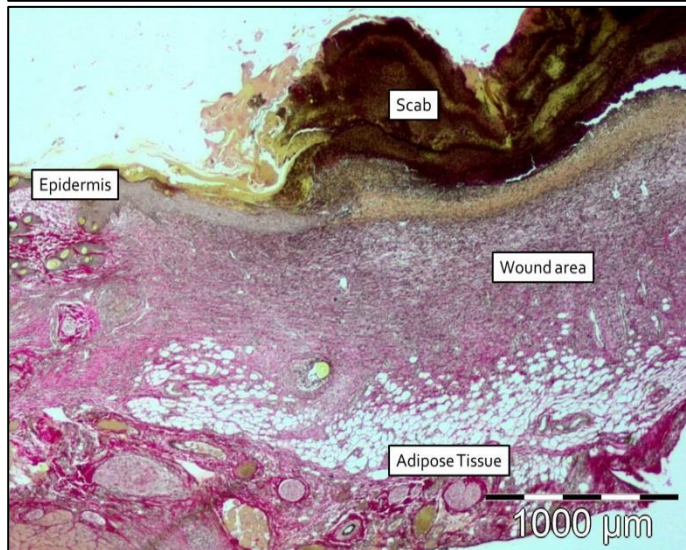
Figure 4.41: Histology of wound in Group NE (Nenas) on Day 5 of treatments. VE stained sections. 20X Magnification. Thick scab was found attached on the wound area. Wound area was stained red and brown indicating the presence of inflammatory cells and collagen.

Results showed that epithelialization had started in the wounds of Group NE (Nenas) on Day 5 of treatments. Scab formation became thicker. Epithelial cells layer of the wound edge became thicker compared to Day 1 of treatments. Macrophages infiltration was seen in the wound site. Inflammatory cells migrated to the area near to the newly formed epidermis (Figure 4.37). Thus, the wound area was in purplish blue due to the abundant number of inflammatory cells. Results of MT stained slides showed that the fibroblast level was increased and dense collagen was found in the wound area (Figure 4.38). Blood vessels were also found a lot in the wound area (Figure 4.40). Fibrosis was abundant in wound surface. In VE stained slides (Figure 4.41), wound areas were faintly stained with the staining. The wound area were stained with slightly yellowish color at the surface of the wound area indicated the presence of exudates on the wound (Figure 4.41).
