ASSESSMENT ON PRODUCTION QUALITY OF
TRADITIONAL SINGGORA TILES IN MALAYSIA

DISSERTATION SUBMITTED IN FULFILMENT OF THE
REQUIREMENTS FOR THE DEGREE OF MASTER OF
SCIENCE (BUILDING)

FACULTY OF BUILT ENVIRONMENT
UNIVERSITY OF MALAYA
KUALA LUMPUR

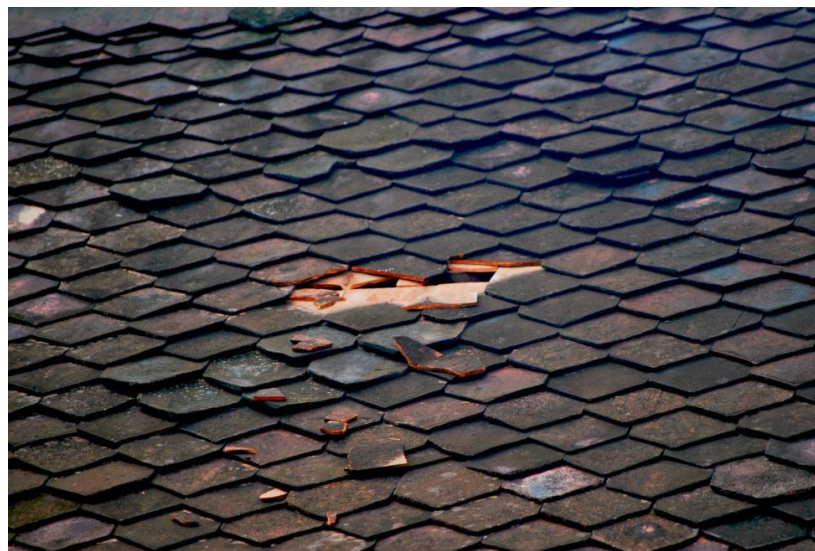
Figure 1.3: Broken Singgora tiles on the roof
Source: Field study (2013)

Killmann et al. (1994) note that Singgora tiles have low mechanical property and this creates the problem in conservation of traditional building where the dismantled and reinstalled of roof tile has to be carried out carefully. Figure 1.3 shows the example of broken tiles which happen in the middle of the roof. Briffett (1995) notes the tiles that lay on battens in old building allow the penetration of rainwater due to absence of insulation below them. The leakage due to cracked roof tiles, even small but continued over long period will be a risk to the building. The ingress of water results fungal decay to the timber and as a result, a structure may collapse (Feilden, 2003).

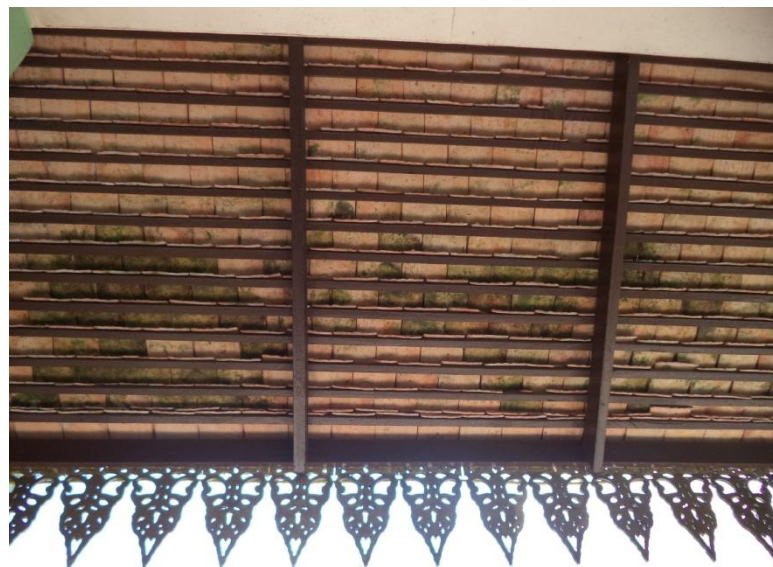
Figure 1.5: The installation of Singgora tiles on the battens
Source: Field study (2013)

In addition, the fragile property of Singgora tiles caused the maintenance work to be carried out from the inside of the building. Unlike modern roofing material, people who carried out the maintenance work cannot walk on the top of the roof due to its brittle property (Loh, 1995). Figure 1.5 shows the view of Singgora tiles from the beneath installation. The replacement of broken tiles is carried out by inserting the tiles from below of the roof. Therefore, the installation of ceiling is inappropriate for building that used Singgora tiles roof.

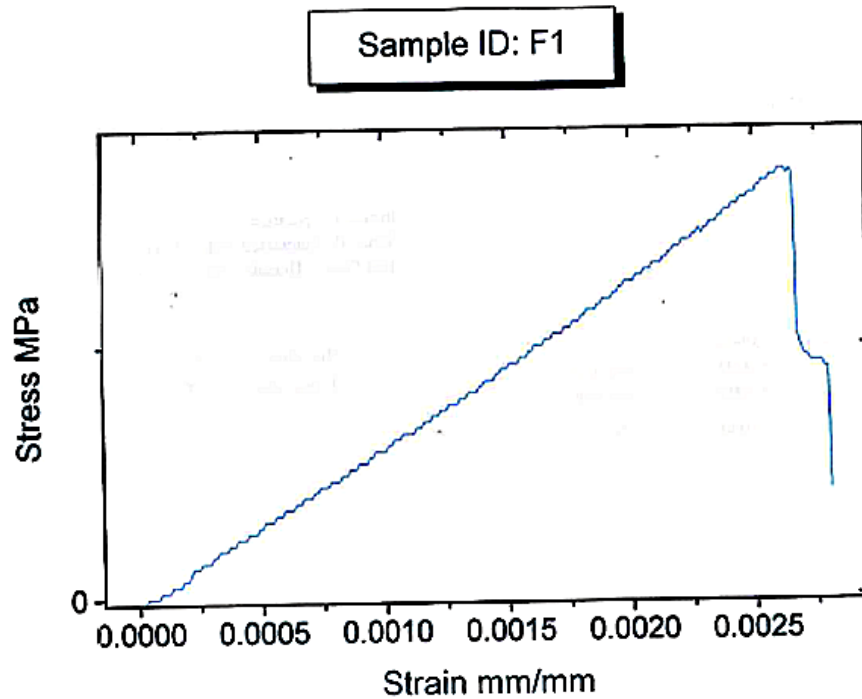
Figure 3.11: The typical flexural strength result

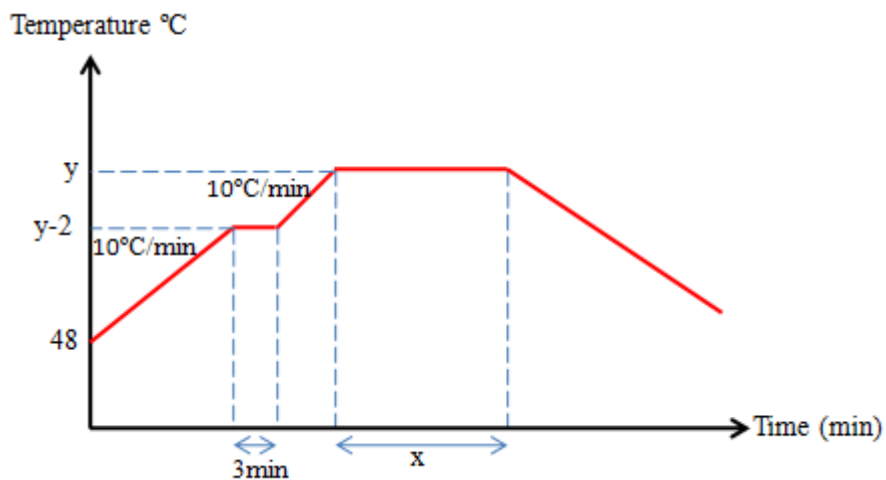
Figure 3.14: Graph maximum firing temperature versus maximum firing time.

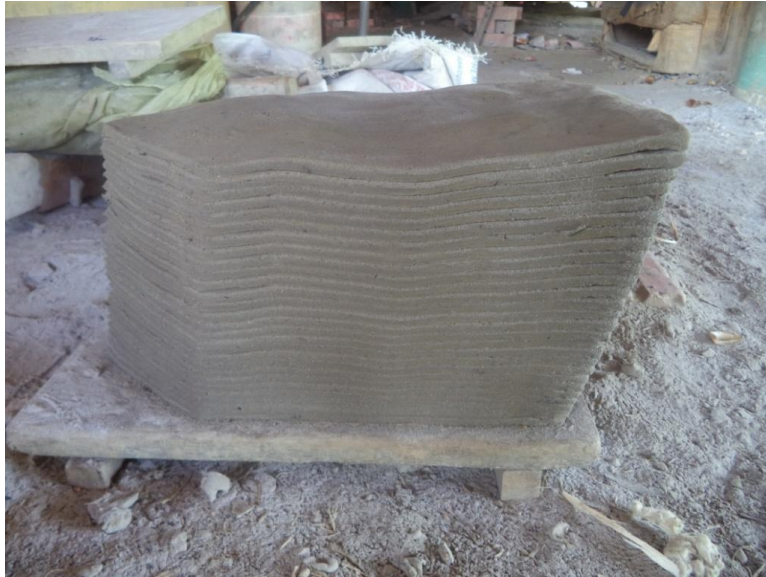
Figure 4.5: The back area of green tiles is thicker than front
Source: Field study (2013)

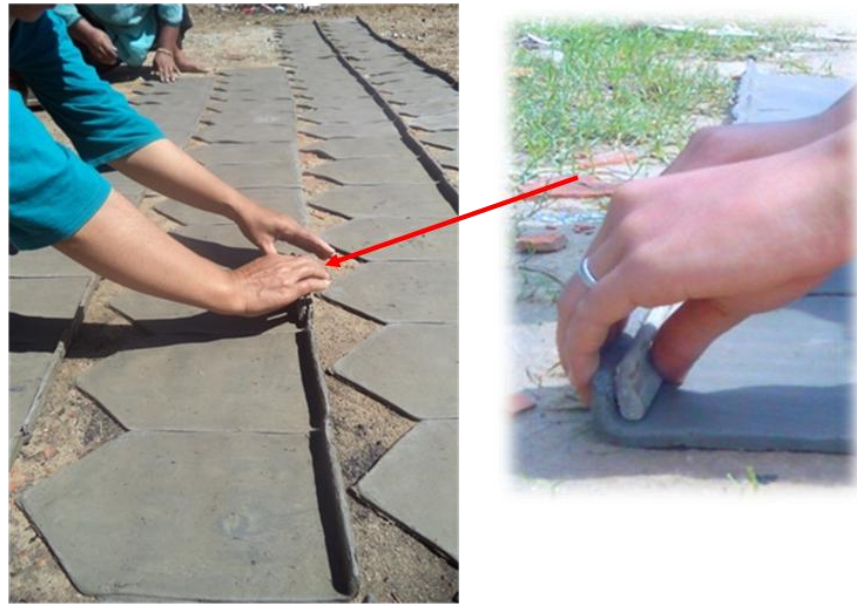
Figure 4.8: The end area of body tile was bent upright to form the hook
Source: Field study (2013)

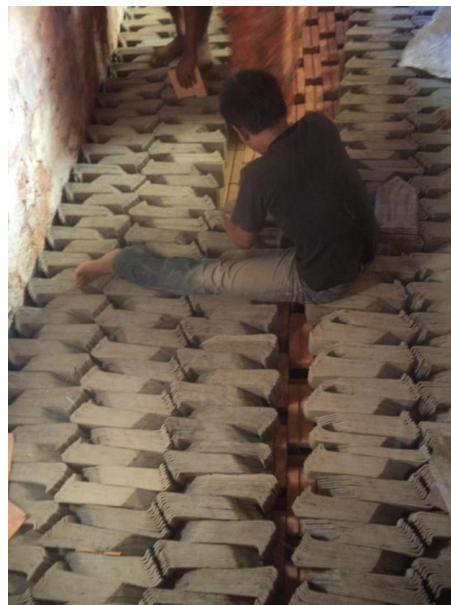
Figure 4.13: The arrangement of green Singgora tiles inside the kiln's chamber
Source: Field study (2013)

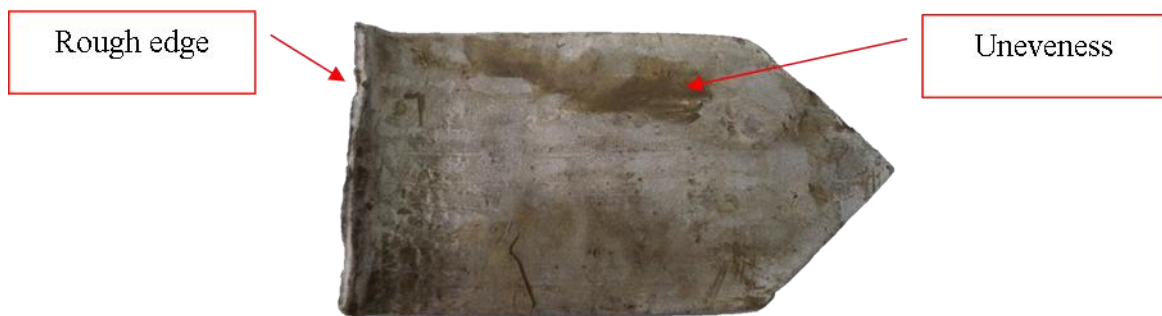
Figure 4.25: Rough edge and unevenness surface of green tile
Source: Field study (2013)

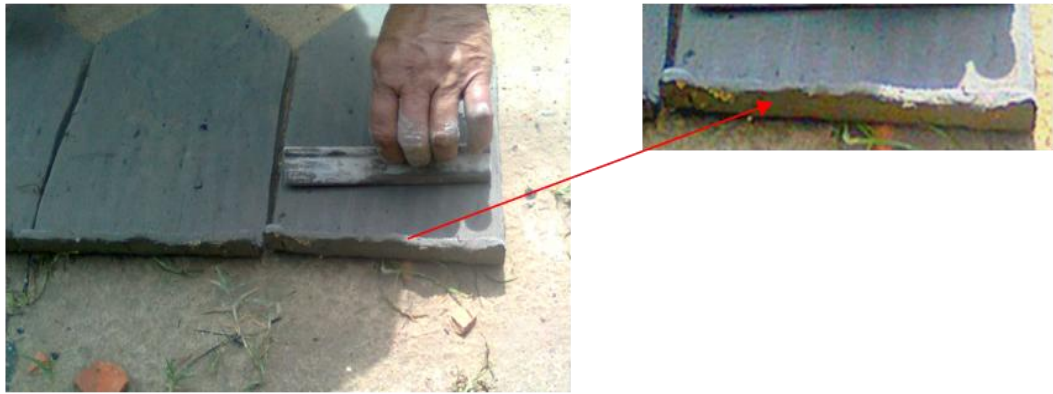
Figure 4.26: The mark of finger along the edge of hook
Source: Field study (2013)

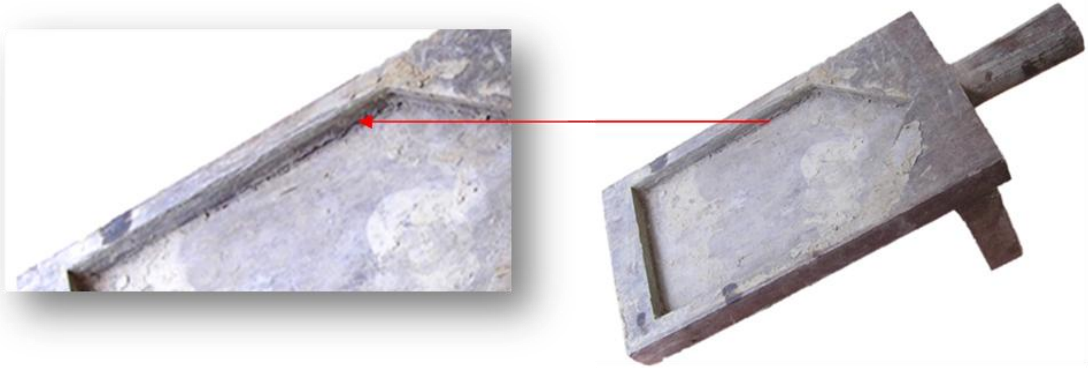
Figure 4.27: The dried clay and less joint between the corner and base of mould
Source: Field study (2013)

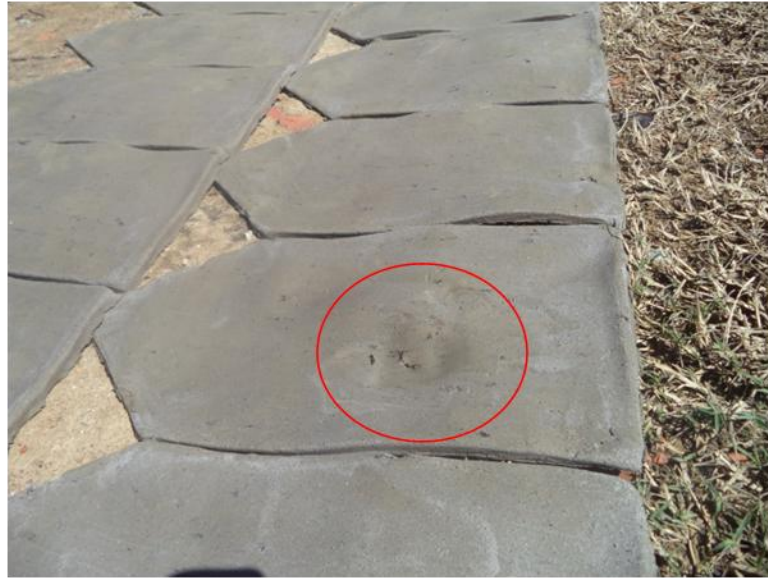
Figure 4.29: Unevenness on the surface of green tiles
Source: Field study (2013)

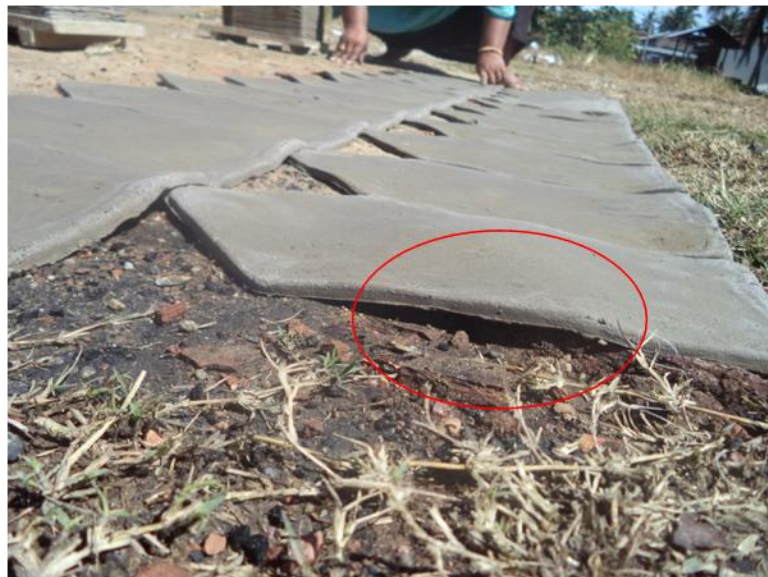
Figure 4.30: Uneven shaped of green tiles due to the improper drying area
Source: Field study (2013)

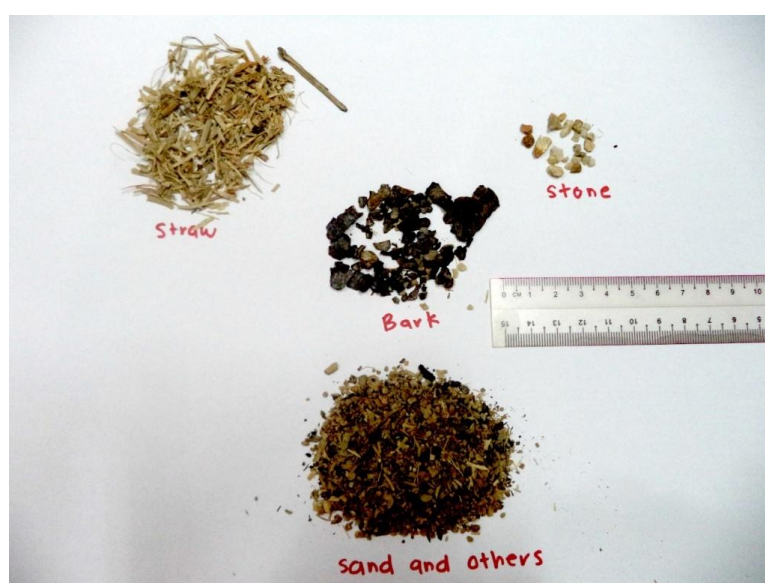
Figure 4.37: Types of impurities in five pieces of green tiles
Source: Field study (2013)
