**AN INVESTIGATION OF POTENTIAL INDUCED
DEGRADATION OF SOLAR PHOTO-VOLTAIC MODULES
UNDER MALAYSIAN CLIMATE CONDITION**

**INSTITUTE OF GRADUATE STUDIES
UNIVERSITY OF MALAYA
KUALA LUMPUR**

**THESIS SUBMITTED IN FULFILMENT OF THE
REQUIREMENTS FOR THE DEGREE OF DOCTOR OF
PHILOSOPHY**

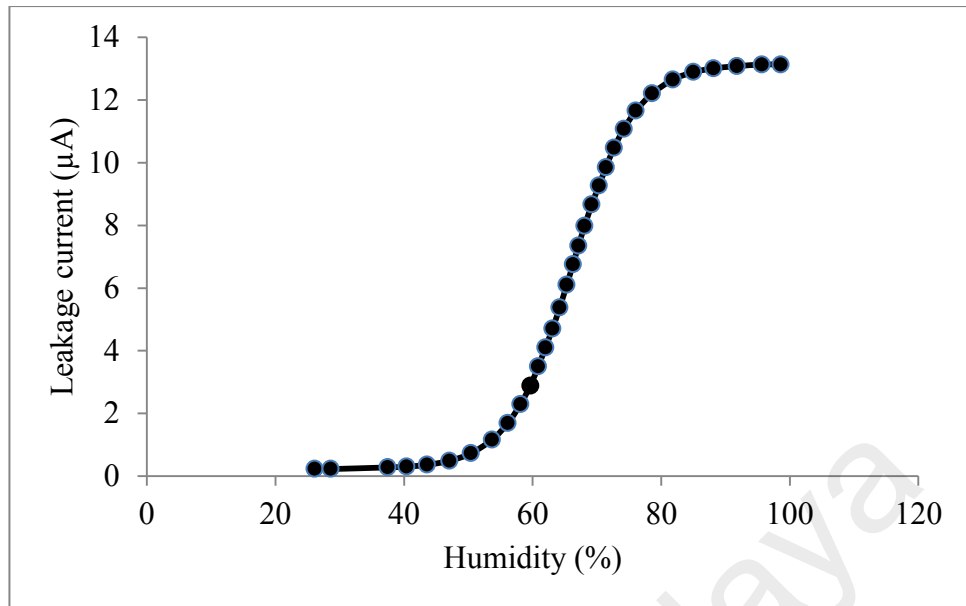
Figure 2.3: Effect of humidity on the leakage current of PV module at the stress of 300V and 85°C (Hoffmann & Koehl, 2013)

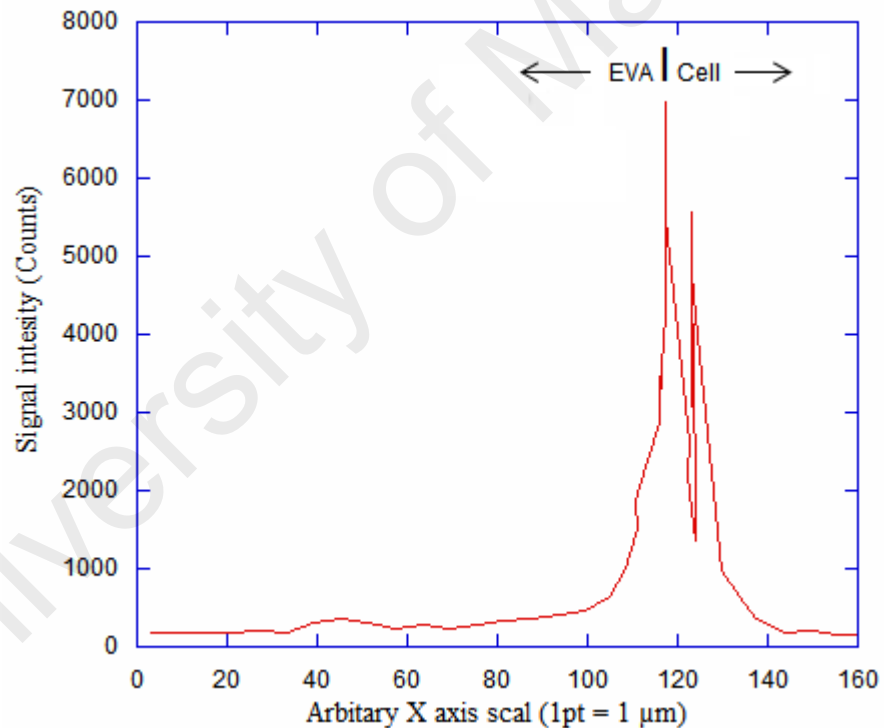
Figure 2.5: Na^+ ion profile at EVA and cell layer of a solar module after PID (Kapur et al., 2015)

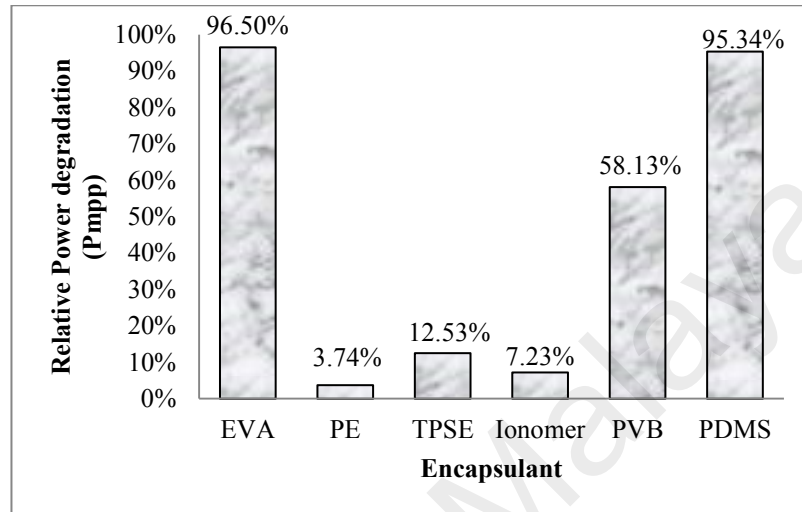
Figure 2.11: PID resistance behaviour of different encapsulant at $(-600\text{V} / 48\text{h} / 85^\circ\text{C} / \text{RH}85\%)$ stress condition

etc. material after PID testing in condition of $-600\text{V} / 48\text{h} / 85^\circ\text{C} / \text{RH}85\%$ were measured (Koch et al., 2012a). PE exposes best PID resistance behaviour, and then followed by Ionomer, TPSE, PVB, PDMS and lastly EVA display the highest degradation.

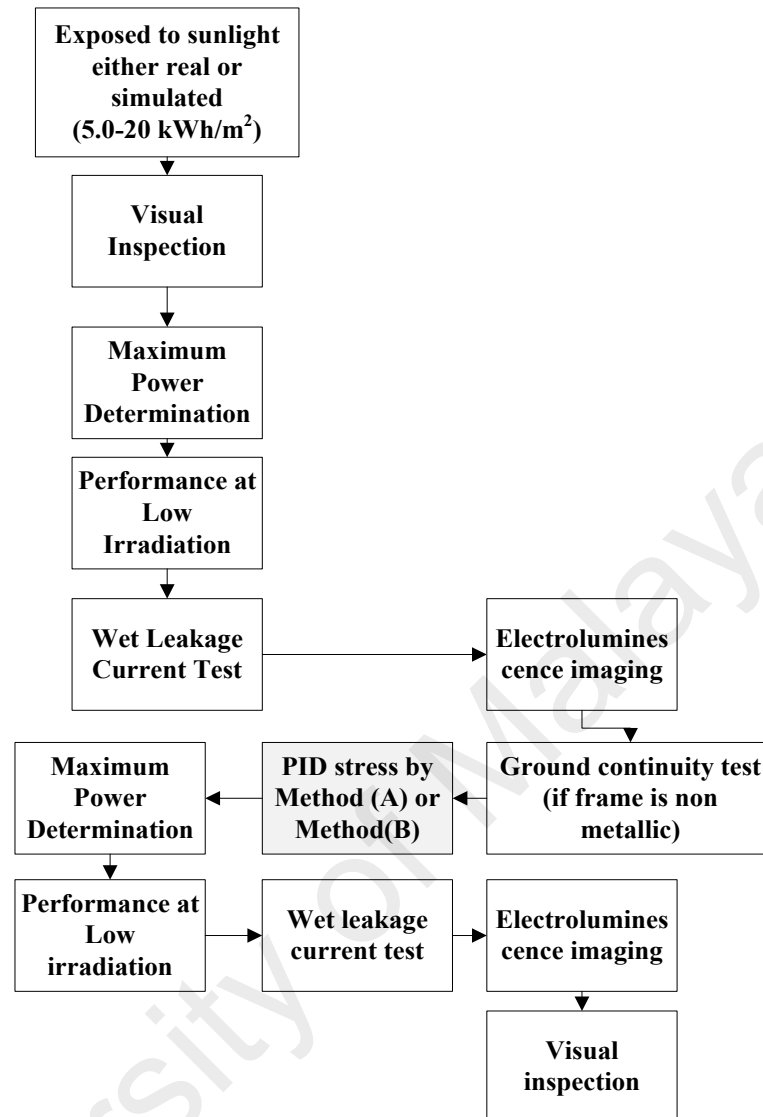
Figure 3.8: Flowchart of IEC 62804 PID characterization process (IEC 62804, 2015)

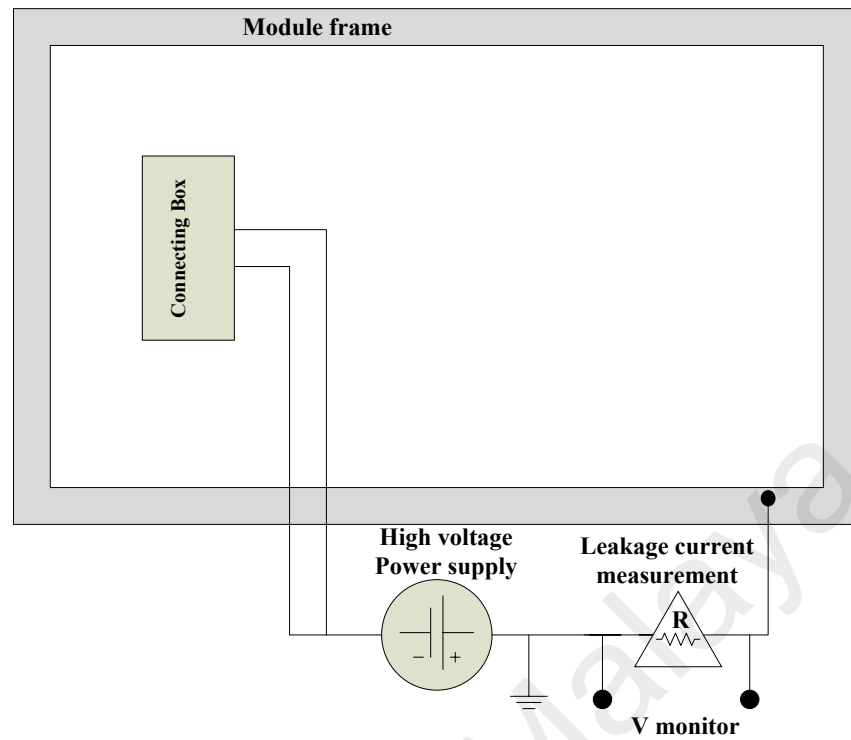
Figure 4.1: Leakage current measurement circuit
(Kang et al., 2015)

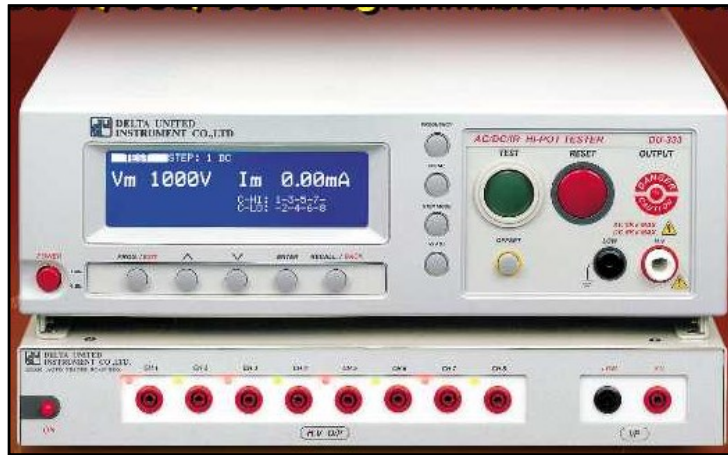
Figure 4.5: Programmable DC power supply (Hi-Pot Tester)

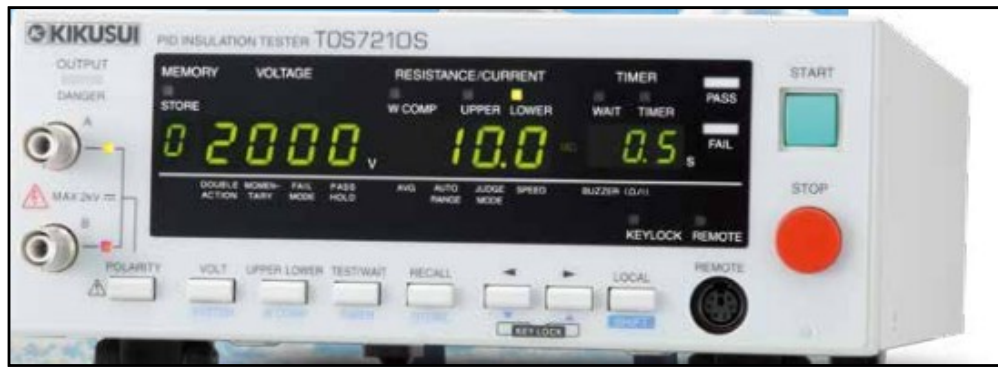
Figure 4.10: PID insulation tester (Model: TOS7210S)

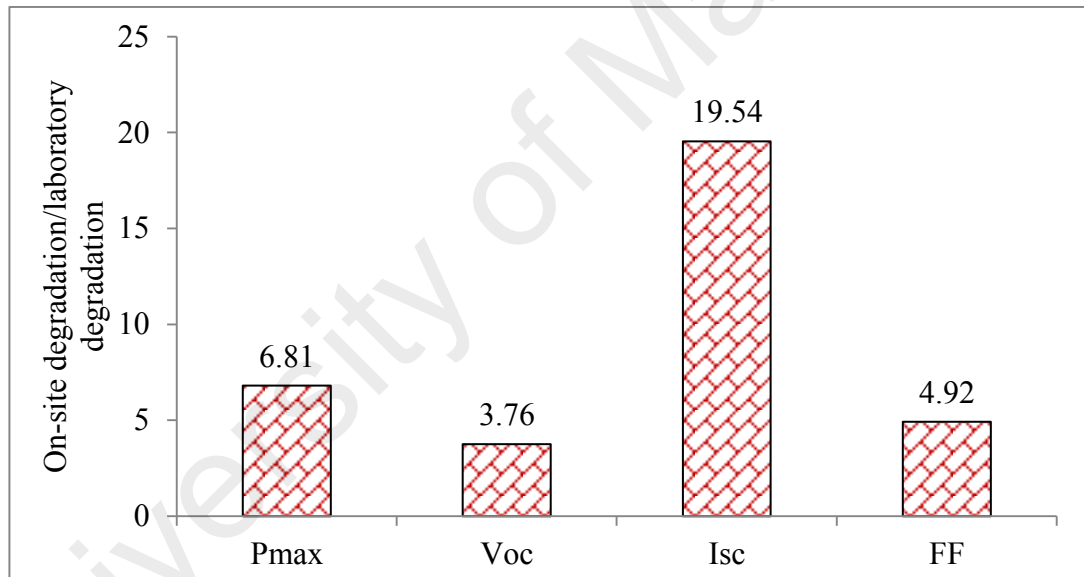
Figure 5.40: Immensity of degradation of different PV module's I-V parameters due to on-site PID over laboratory test standard
