CHAPTER 5

CASE STUDIES

5.1 Case Studies Introduction

There were some units of the case studies had been visited and viewed. They were unsold units or sample houses. All of the units remained as original condition and had not yet been renovated or altered. At the time of viewing, some of the defects photographs had been captured.

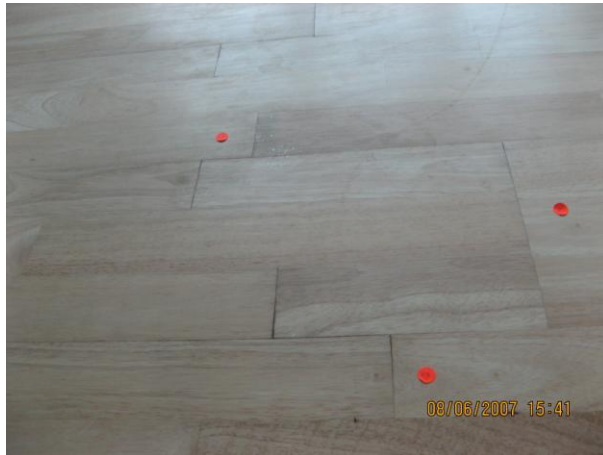
Gaps at the joint between the timber flooring.

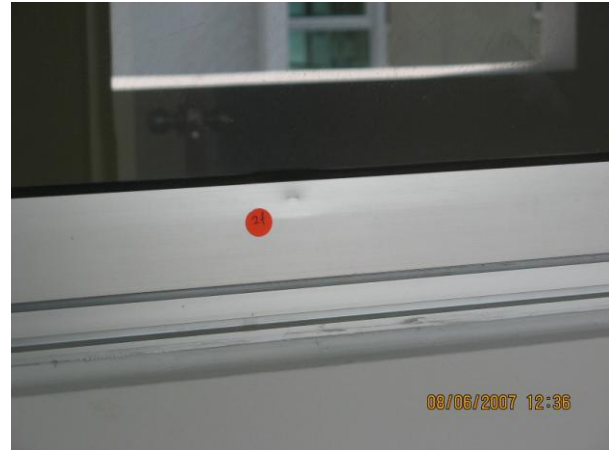
Dented on the window aluminium frame

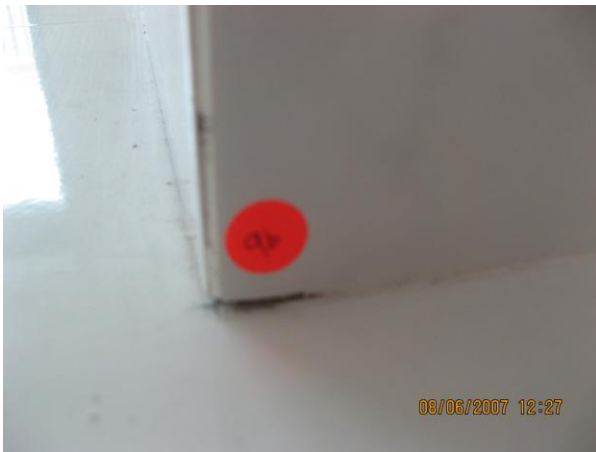
Poor workmanship of grouting works

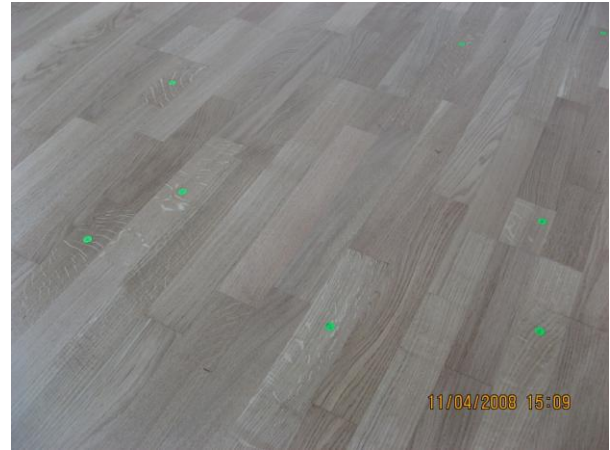
Inconsistent tonality of the timber flooring

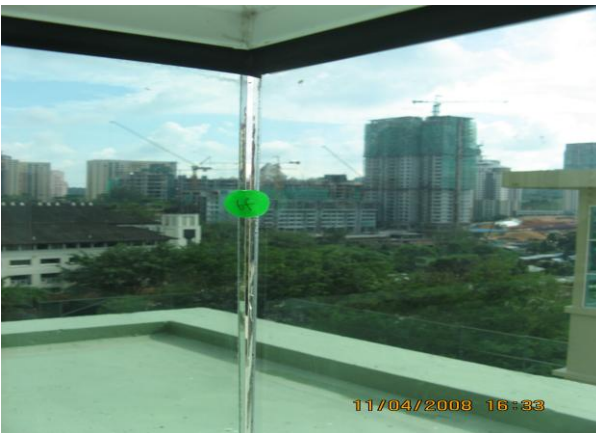
Gap at the joint between the fixed glazing panels

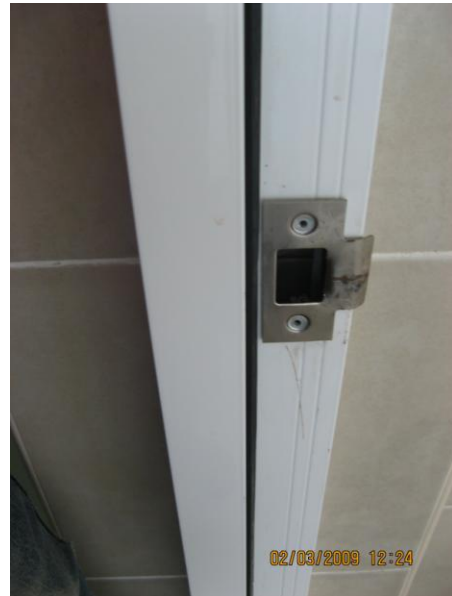
Scratches on the ironmongery of the door

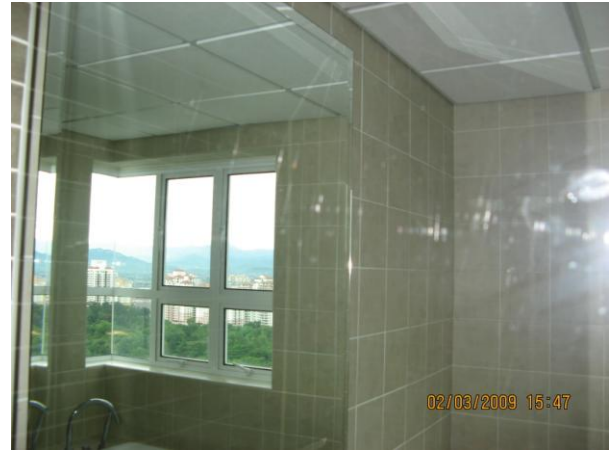
Scratches on the shower screen

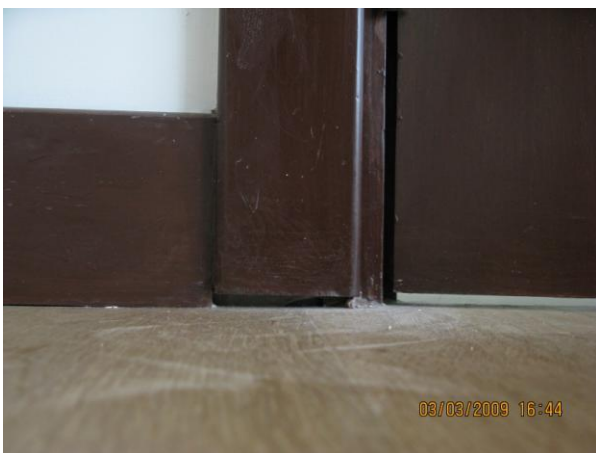
Gap at the joint between the architrave and timber flooring

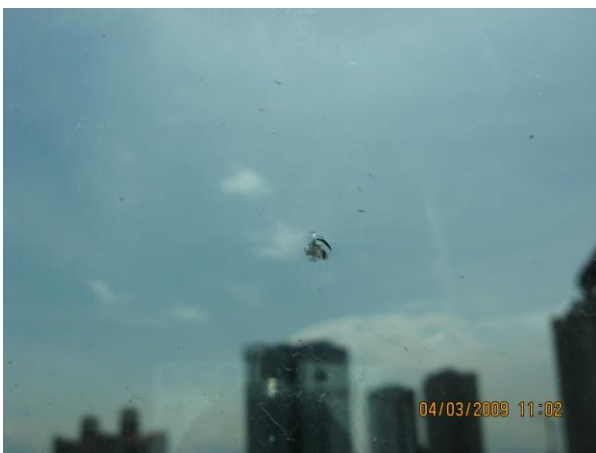
Chipped on the window glazing panel

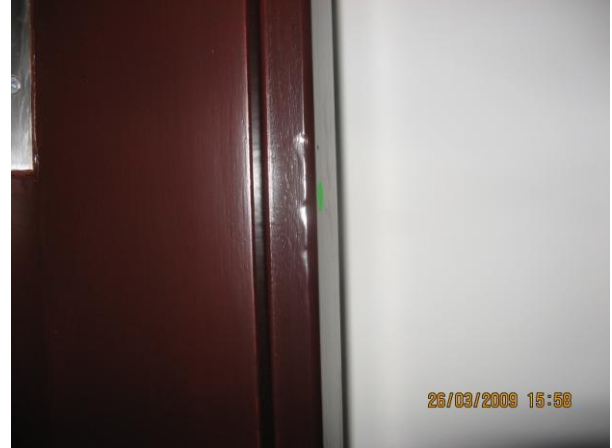
Chipped on the timber architrave

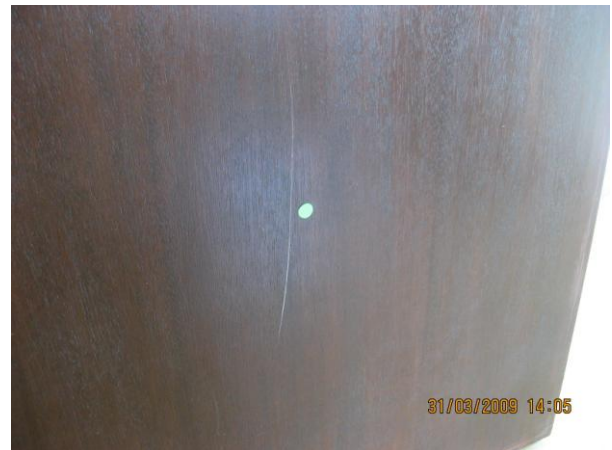
Scratches on the timber door

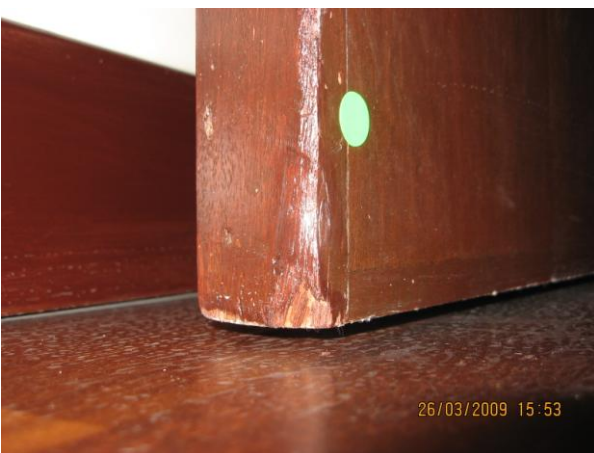
Chipped edges on the bottom part of the timber door
